Divine Textiles Ltd

Pollibiddut, Shafipur, Gazipur, Dhaka
(24.03977N, 90.25669E)

22 March 2014

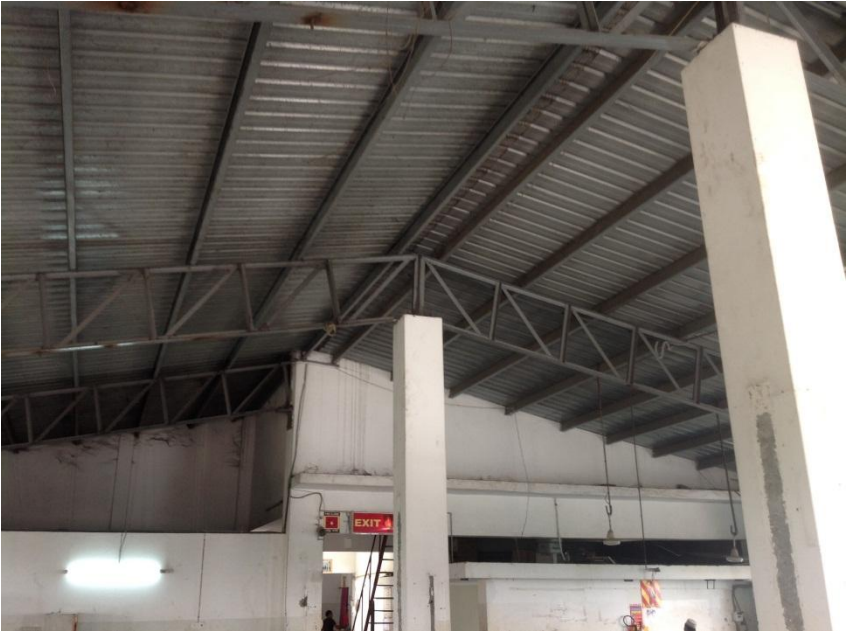
8 storey building typical plan

Inconsistencies between structural drawings and the as-constructed arrangement of the factory

Building Engineer to survey as-built structure and update drawings.
