# Babylon Casualwear Ltd

## Aboni Fashions Ltd

## Suravee Garments Ltd

Plot-23,24, Tetulzhora, Hemayetpur, Savar, Dhaka  
(23.792784N, 90.254587E)  
29 March 2014

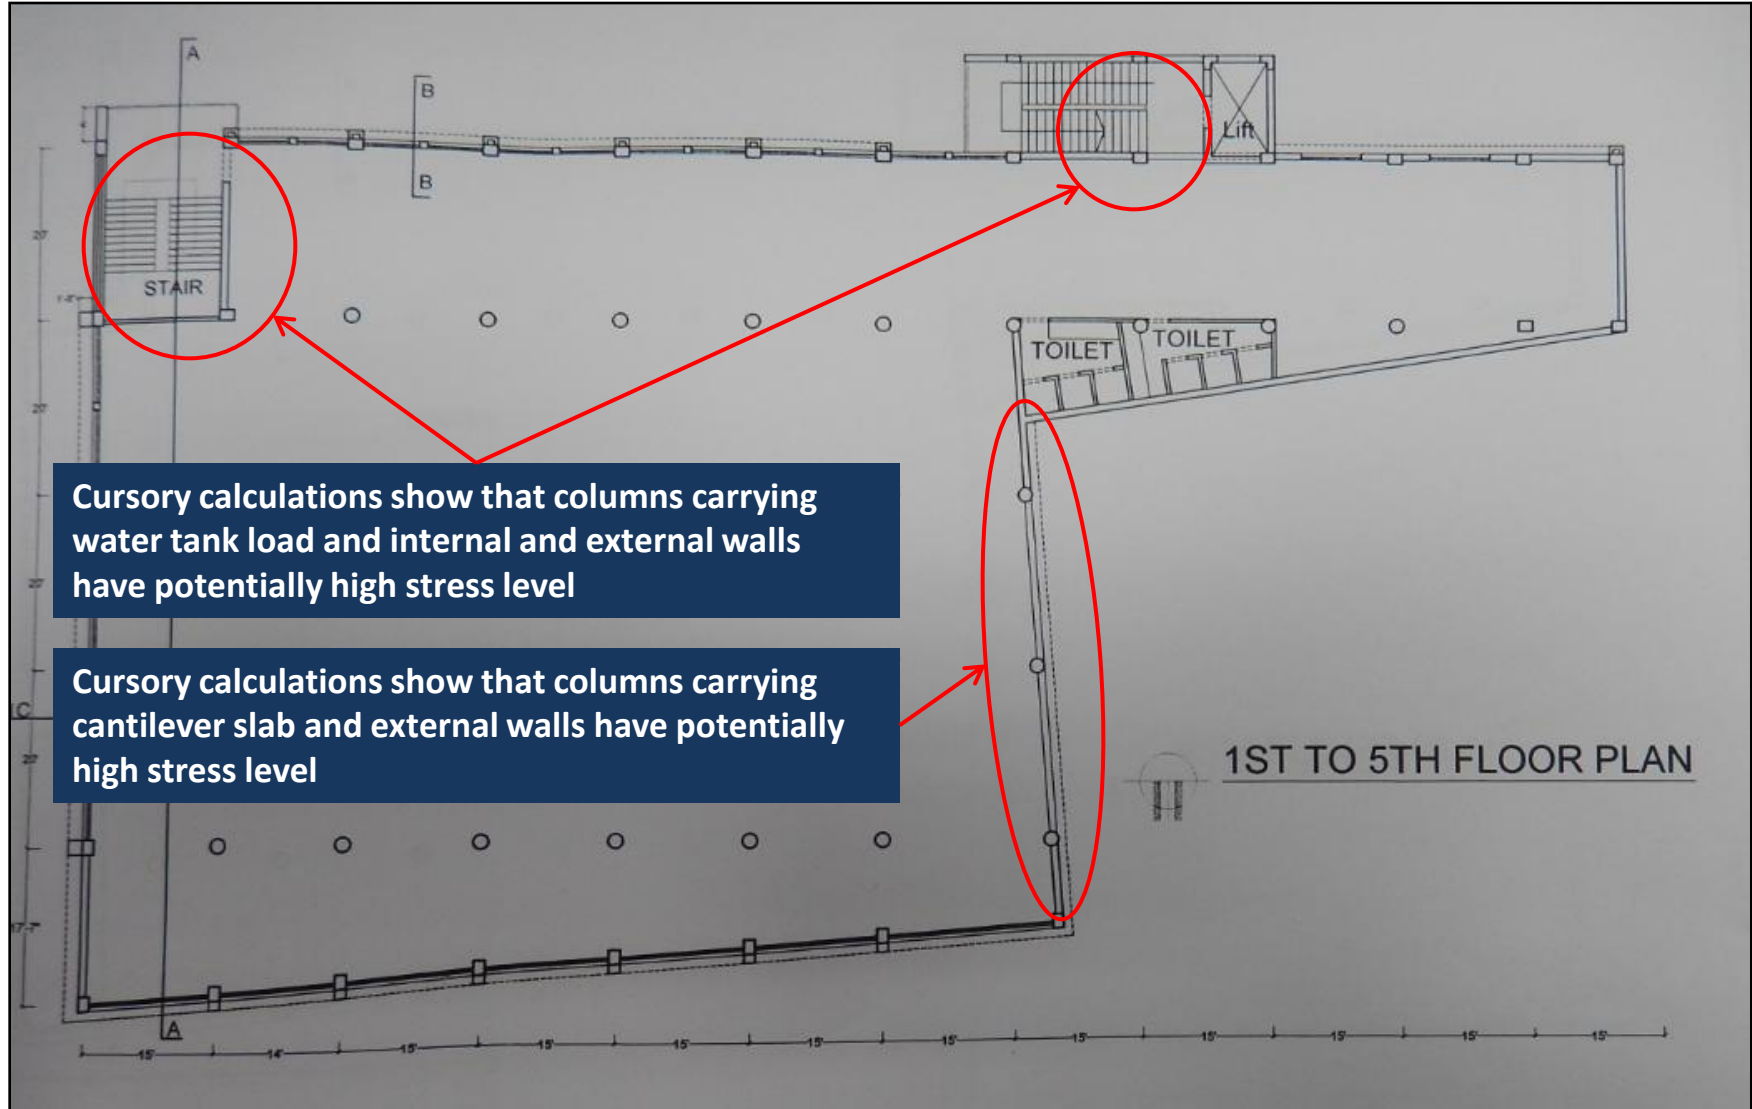
## Aboni 7-storey Building (Unit 1)

Cursory review of the stairwell column layout has changed to a cantilever carrying 7 storey loads

Photo taken of stairwell column as built

Building Engineer to check that columns have been designed to accommodate applied loads.

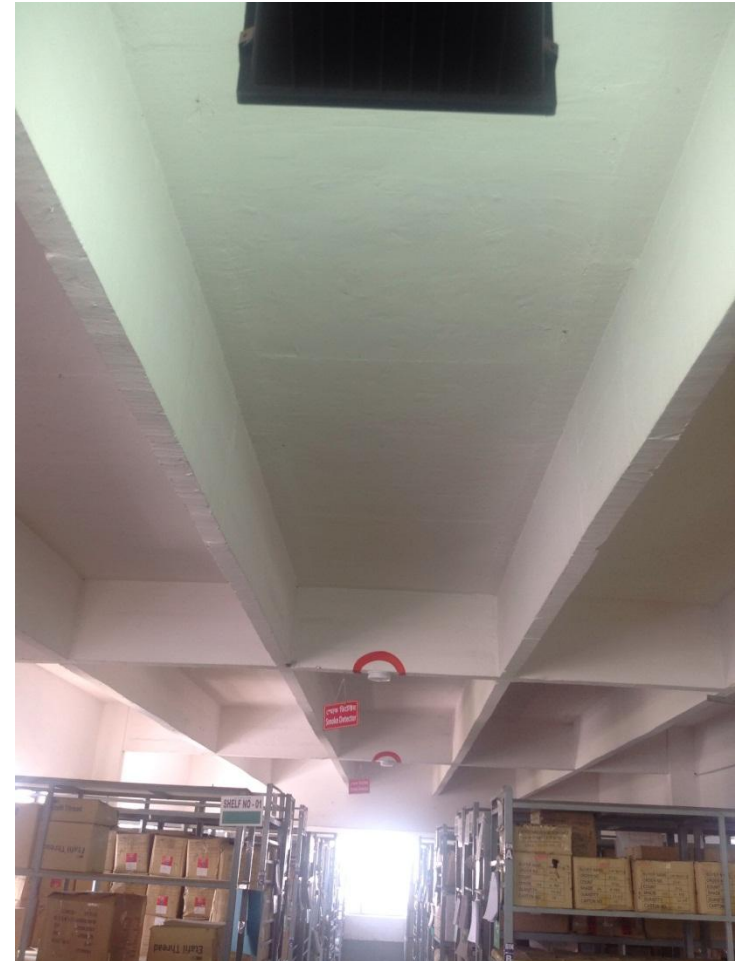
## Aboni 7-storey Building (Unit 1)

Roof level of 7 storey building has utilised pan slab & T columns in lieu of 2 way slab and circular columns. Particular focus on the transition (bottom left photo).
