# Rahmat Sweaters (BD) Ltd Logos Printing & Design Ltd

Telirchala, Mouchak, Kaliakoir, Gazipur  
(24.03152N, 90.30217E)

9<sup>th</sup> April 2014

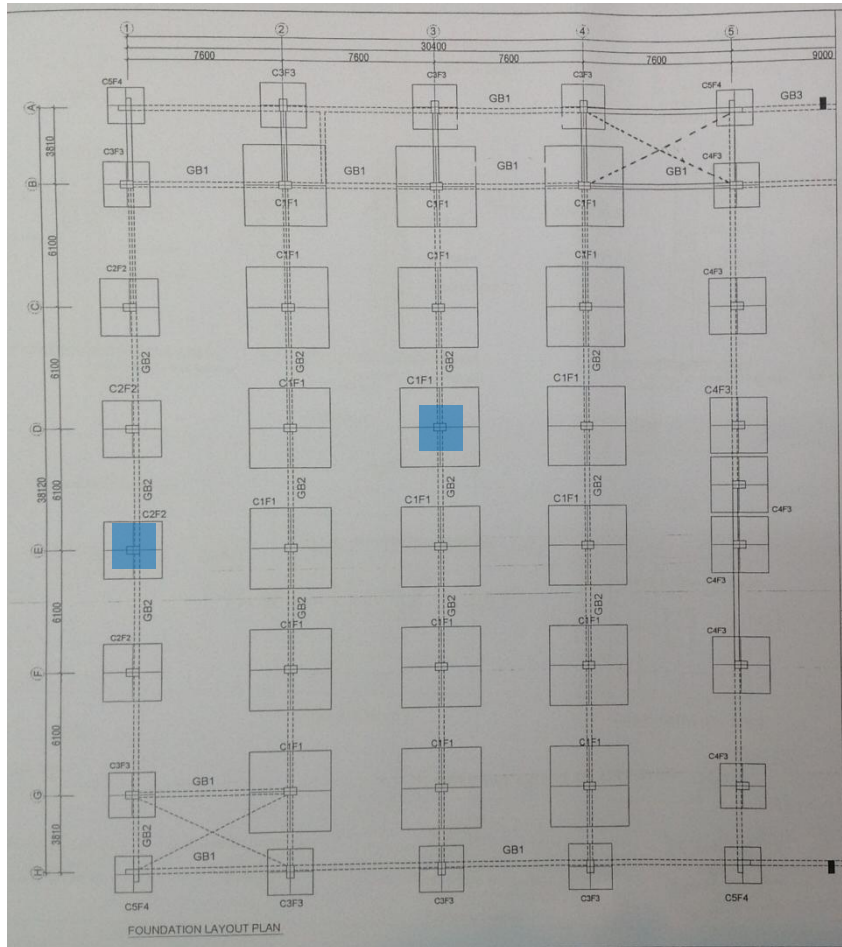
Ground Floor Plan

# Stress Levels in Columns

Cursory calculations indicate that the working stresses of the columns are at a very high level. Detail Engineering Assessment required.

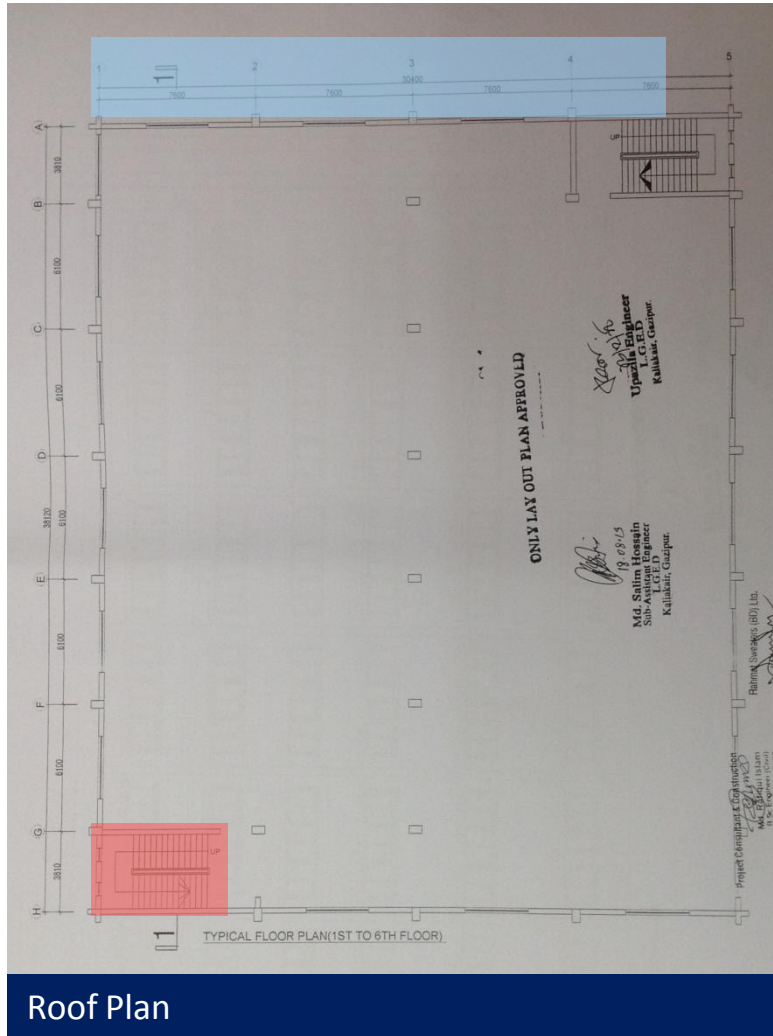
# Apparently non-engineered roof structures

Building Engineer to review the design of the lightweight roof structures to the Ground Floor Boiler / Chemical rooms to the West of the building and to the South-East staircore roof, and to implement any upgrade works as required.
