# Mascotex Limited (9505)

Shataish road, 31/32, khartail, Tongi, Gazipur  
(+23.859604N, +90.396385E)

08.April.2014

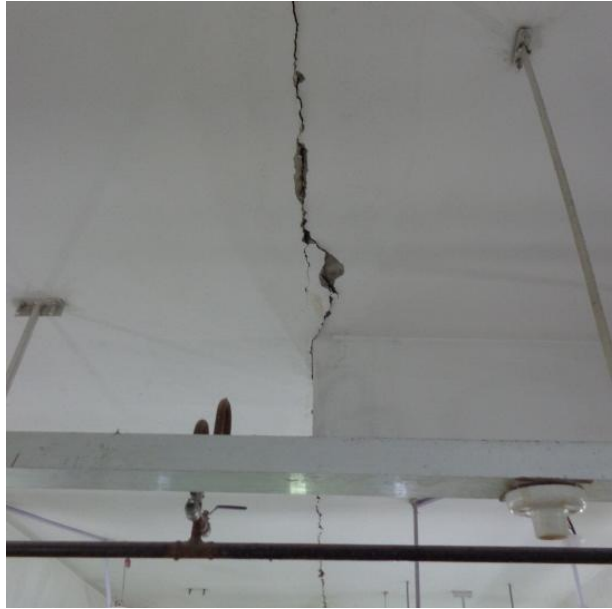
## 1<sup>st</sup> Priority 2 Concern

Movement joint to be repaired to prevent loose material from falling on workers.

The cantilevered section of the slab at the joint must be verified in a Detailed Engineering Assessment.

- Loose material at movement joint to be repaired.

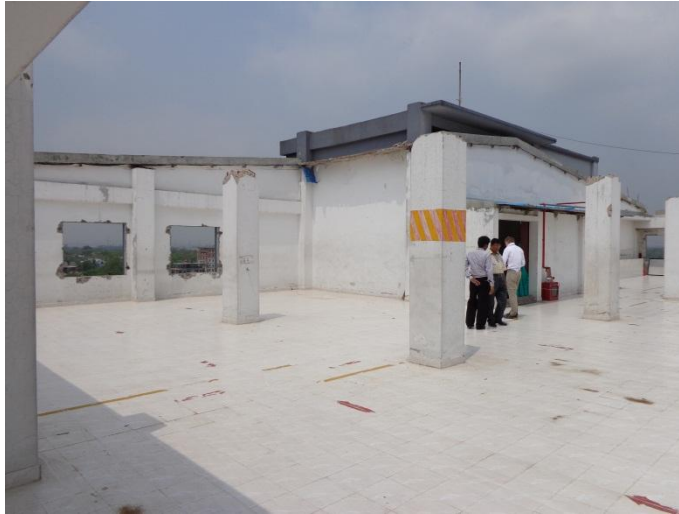
### 1<sup>st</sup> Priority 3 Concern

No waterproofing membrane was visible on the roof of the back and front buildings. This means that any cracks in the surface finishes on the roof will allow water to seep into the concrete slab and cause long-term soaking of the slab and possibly cause damage to the concrete and the reinforcement.

**Roofs floors do not appear to have any waterproof membrane to protect lower floors from water ingress.**
