# Masihata Sweaters Ltd (9506)

South Panishail, BKSP, Kashimpur

09.April.2014

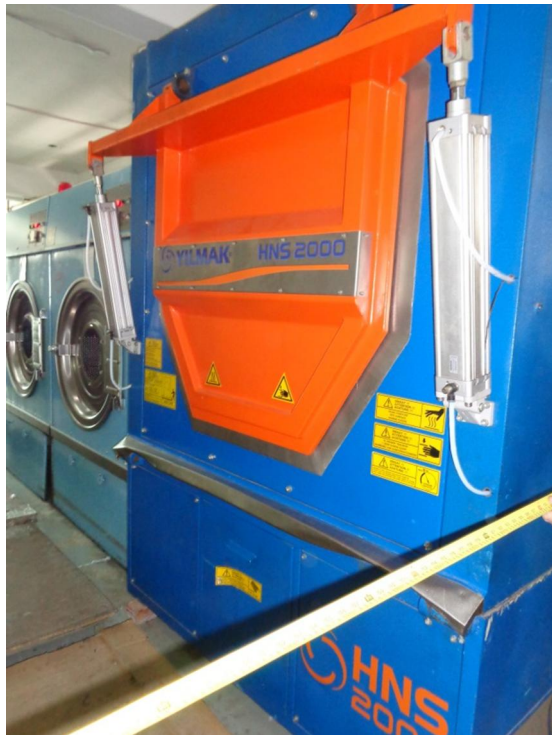
### Priority 1 – Major concern

Built in 2002 with brick stone chips , rebar strength was not provided (40ksi assumed)

Column does not reflect information provided on structural drawings which indicated 500mm dia. column with 22-20mm bars.

We surveyed a 450mm dia .column with 14-20mm bars . Two columns were Ferroscored.

Loading on typical column reflects approx 2 kPa, except in one sector where washing machines and other manufacturing equipment may be closer to 3 kPa (min). High brick partitions with plaster on both sides are also found at midspan in certain areas of building

Action is to be taken to reduce loads (Action section)
