# Russel Apparels and Ekram Sweaters Ltd.

Mouza- Katali Bhaluka Mymensingh  
(24.380522,90.377870)  
23 April 2014

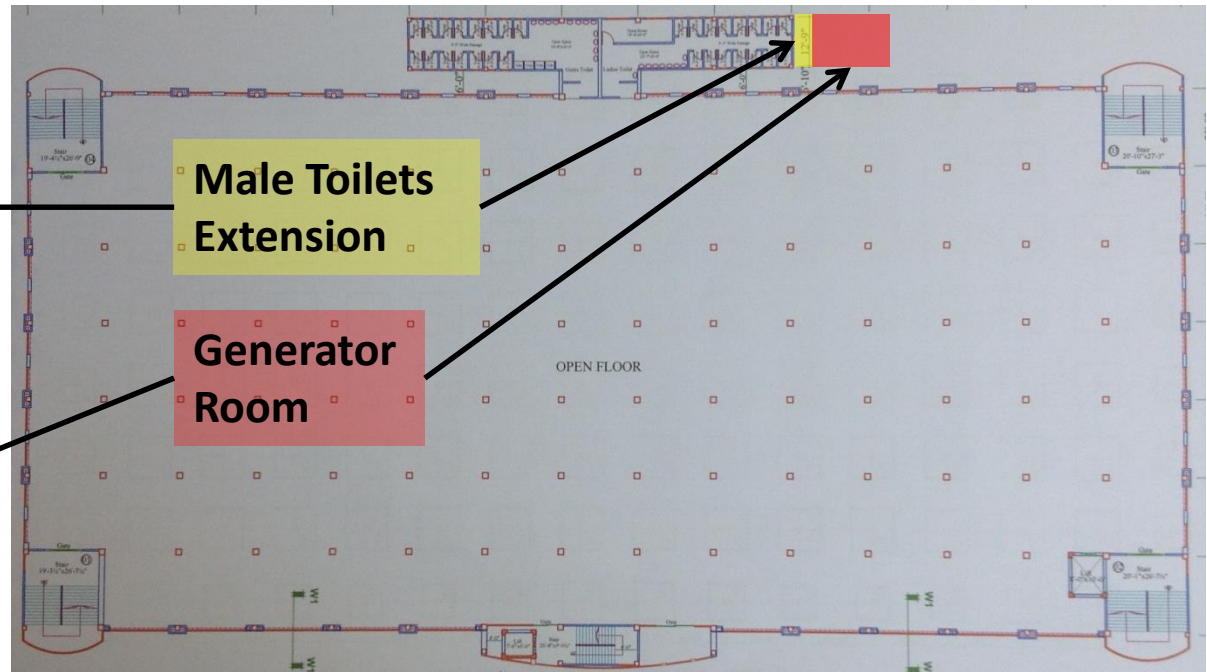
A single-storey generator room has been added to the east side of the building next to the toilets although no permit was provided. Also, construction is on-going for an extension to the male toilets, and no permit was available.

**Non-permitted additions**
