# **FIRE SAFETY INSPECTION REPORT**

**Factory Name: Day Fashions Limited**

**Date: 8th December, 2016**

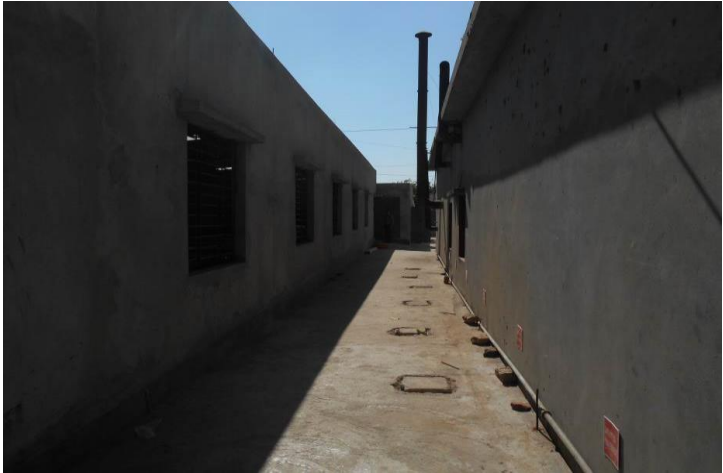
| SI No. | Category | Findings | Required Action | Remediation Time Frame |
|---|---|---|---|---|
| 7 | <b>Fire Rated Construction</b> | The exit discharge path is less than 10 ft wide and is not separated from the building interior.<br><b>Location: East exit stair discharge path</b> | Seal all penetrations and openings to the interior of the building along the discharge path, up to a height of 10 ft. to provide a minimum 1-hr fire separation. | <b>Within 3 months</b> |
