# Ashique Dress Design Ltd Ashique Jeans Apparels Ltd Nice Apparels Ind. Ltd.

43 Chalabon, Ashique Complex, Azampur, Uttara, Dhaka  
(23.86794, 90.41752)

30<sup>th</sup> March 2014

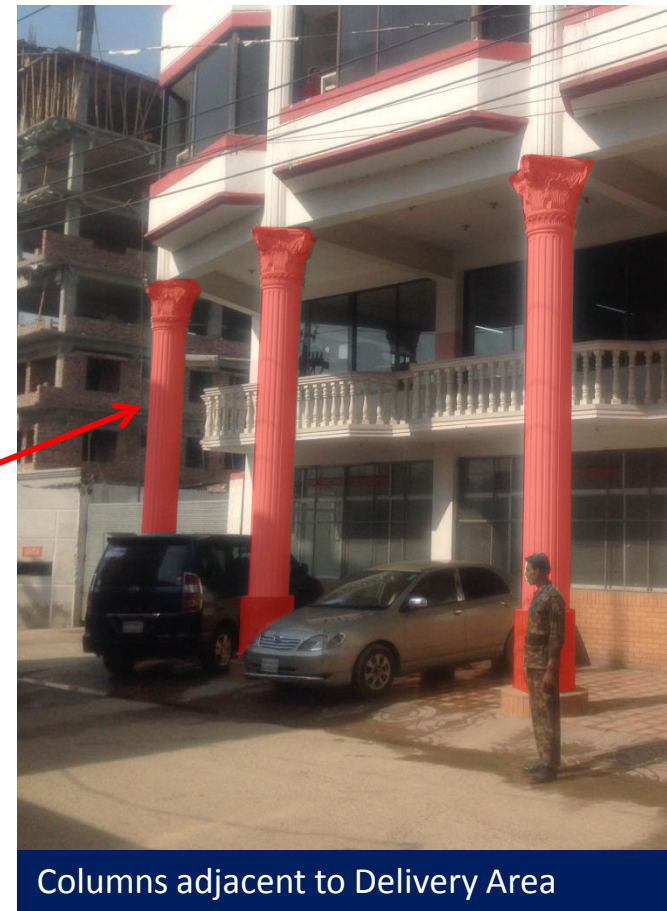
**The feature columns adjacent to the entrance and car parking area are at risk of being accidentally struck by a vehicle. The robustness of the connection of these columns to the main structure also needs investigation**

3 no. two-storey columns to the Main East elevation of the building, adjacent to the delivery entrance, are at risk of being accidentally struck by a vehicle. Column protection barriers need to be provided. Also Building Engineer to investigate the robustness of the connection of these columns to the main structure.

Two-Storey Ground Floor Columns at Risk from Impact

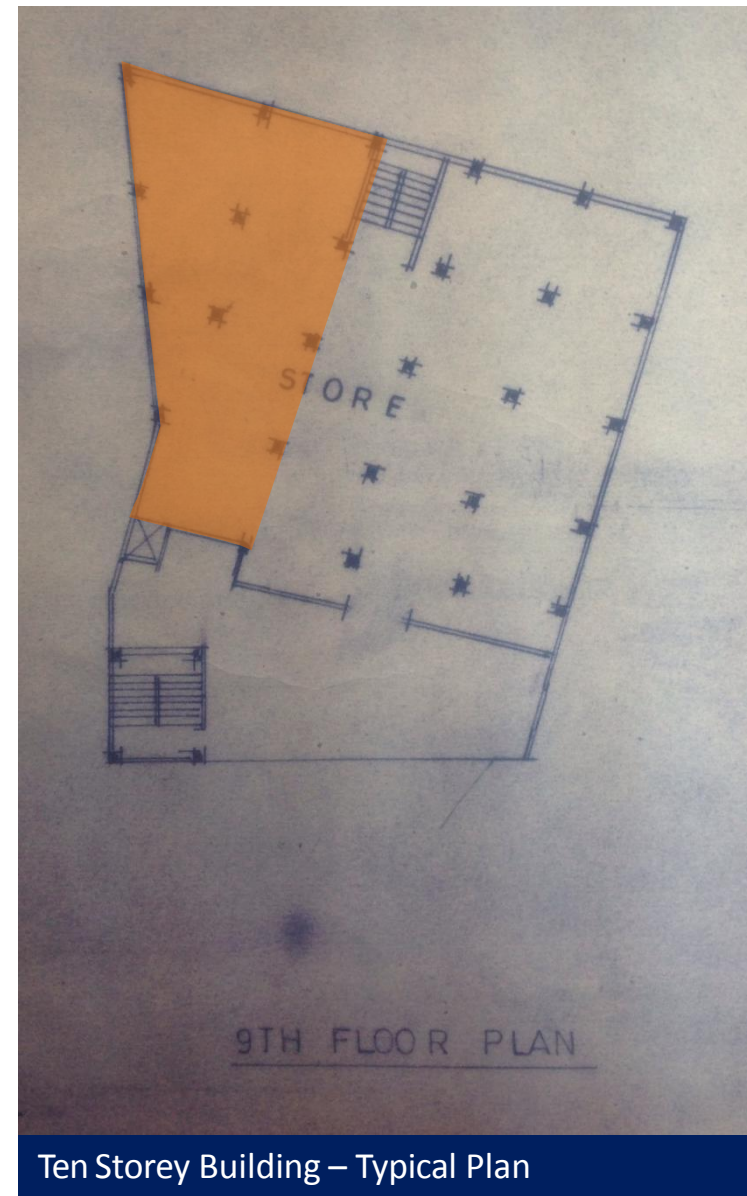
Ten Storey Building – Typical Plan

**Design Check required for the storage areas,  
particularly to the South-West corner of the  
building, to confirm the capacity of the floor  
structure**

There are large amounts of storage in the Ten Storey building, particularly in the South-West Corner, as indicated.

General Zone of Storage Area

Building Engineer to check that the beams and slabs have been adequately designed to carry the associated loading.

| Item No. | Observation | Recommended Action Plan | Recommended Timeline |
|---|---|---|---|
| 11 | Design Check required for the storage areas, particularly to the South-West corner of the building, to confirm the capacity of the floor structure | Locations of loading noted to be surveyed and capacity of floor structure to be assessed by the Building Engineer to confirm that the floor structure is designed to carry these loads | 6-weeks |

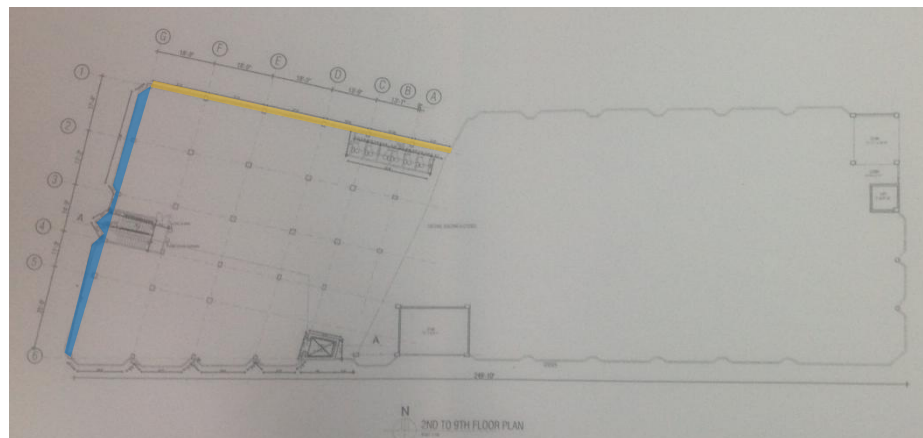
Typical Floor Plan

**Design check required for the floor cantilevers at the suspended floor levels to confirm their load capacity to support floor and façade loading**

Cantilever to all floors of East elevation

Cantilever to 8<sup>th</sup> and 9<sup>th</sup> Floors of North elevation

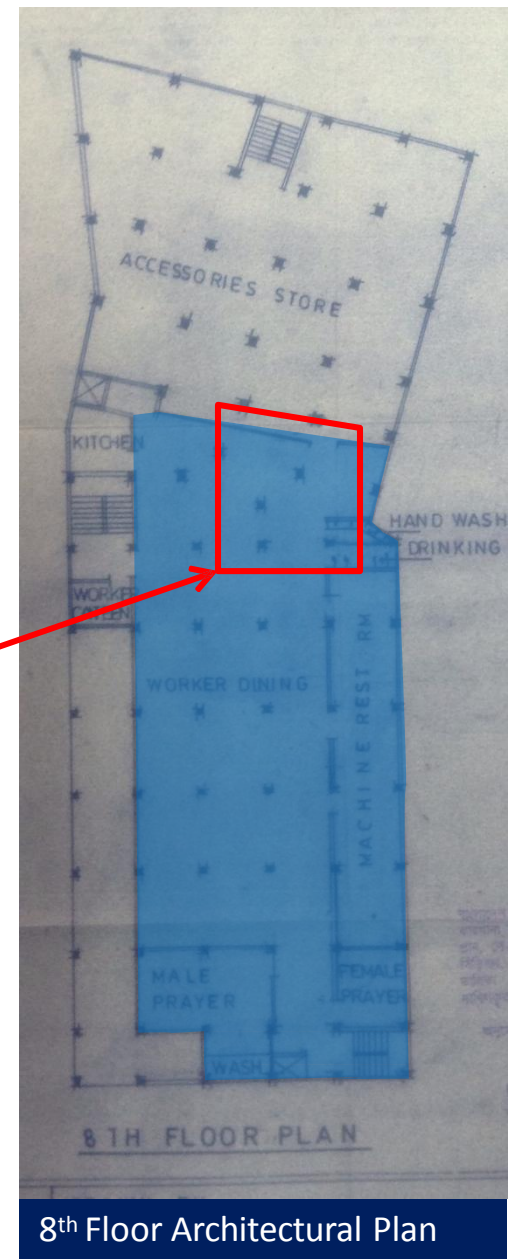
8th Floor Architectural Plan

Light-weight steel roof above dining area to 8th Floor of 9 storey building

| Item No. | Observation | Recommended Action Plan | Recommended Timeline |
|---|---|---|---|
| 15 | Design Check required for the light-weight steel roof structures to the 9-storey building dining area and the ancillary buildings as indicated | Building Engineer to provide detailed calculations for the noted structures and the associated light steel roofs. These should confirm their ability to withstand all wind loading pressure, suctions and uplift forces | 6-months |

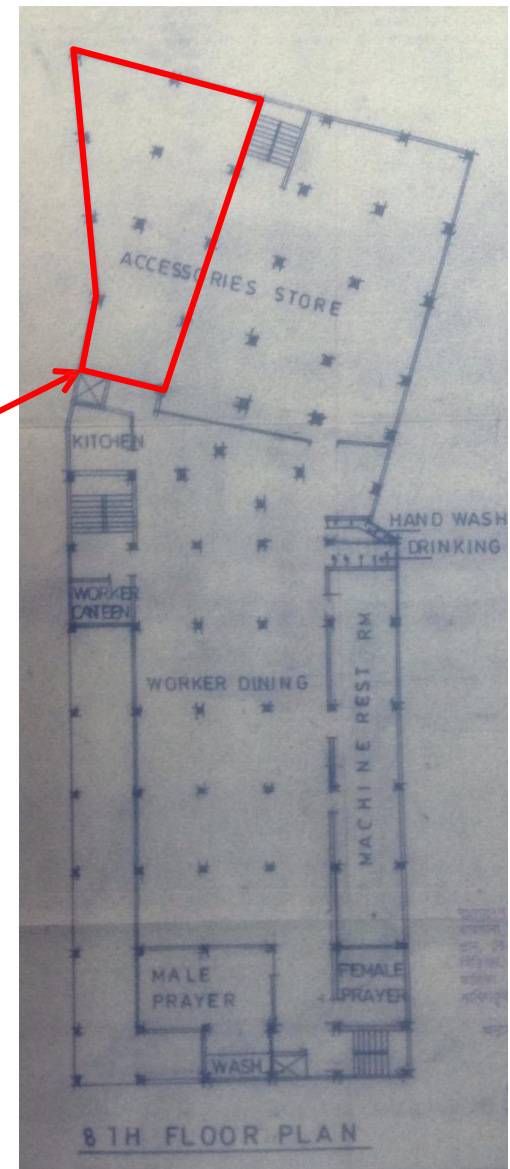
8<sup>th</sup> Floor Architectural Plan

**Building Engineer to investigate the cause of the local cracking to the 8th floor level slab in the South-West corner and to areas of the façade**

There is evidence of local cracking to the Eighth Floor slab in the South-West corner of the building.

**ITEM 6:** Building Engineer to investigate the cause of the local cracking to the 8th floor level slab in the South-West corner, and to areas of the façade.

| Item No. | Observation | Recommended Action Plan | Recommended Timeline |
|---|---|---|---|
| 16 | Building Engineer to investigate the cause of the local cracking to the 8th floor level slab in the South-West corner, and to areas of the façade | Building Engineer to investigate the cause of the cracking and implement any remedial measures deemed necessary | 6-months |

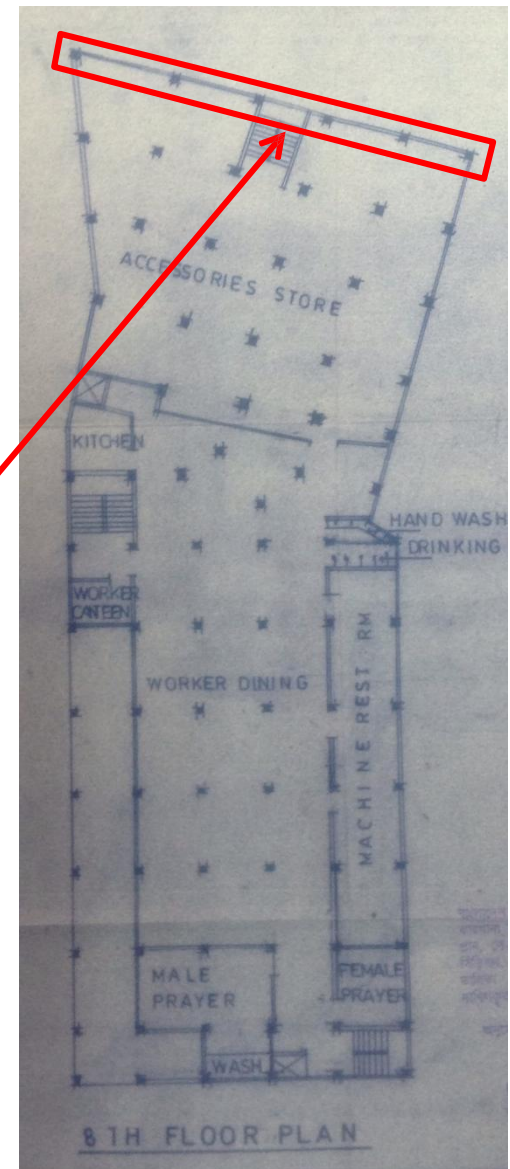
8th Floor Architectural Plan

There is evidence of local cracking to the façade to the East Elevation of the building.
