# Crown Fashion & Sweater Ind. Ltd. Crown Knitwear Ltd. (Building 3)

Plot 781/782, Vogra, Joydevpur, Gazipur.  
(23.982841, 90.38177)  
02 April 2014

# Observations

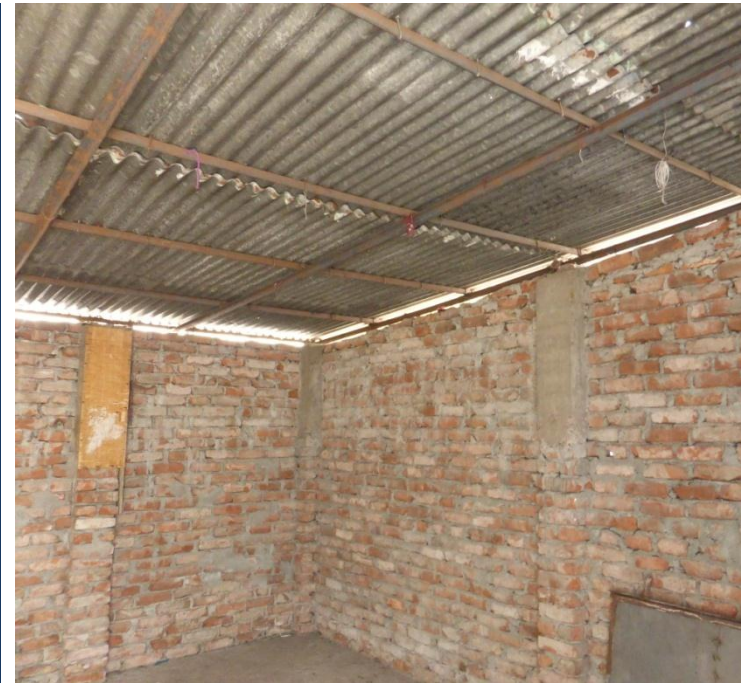
**Adequacy of tie-downs and lateral stability need to be assessed by Building Engineer.**

**Additional vertical loading applied to building below to be assessed.**
