Genesis Fashions Ltd Columbia Apparels Ltd

228/1, Tin Sarak, Luxmipura, Joydevpur, Gazipur- 1700
(23.99435N, 90.40443E)

2nd March 2014

Observations

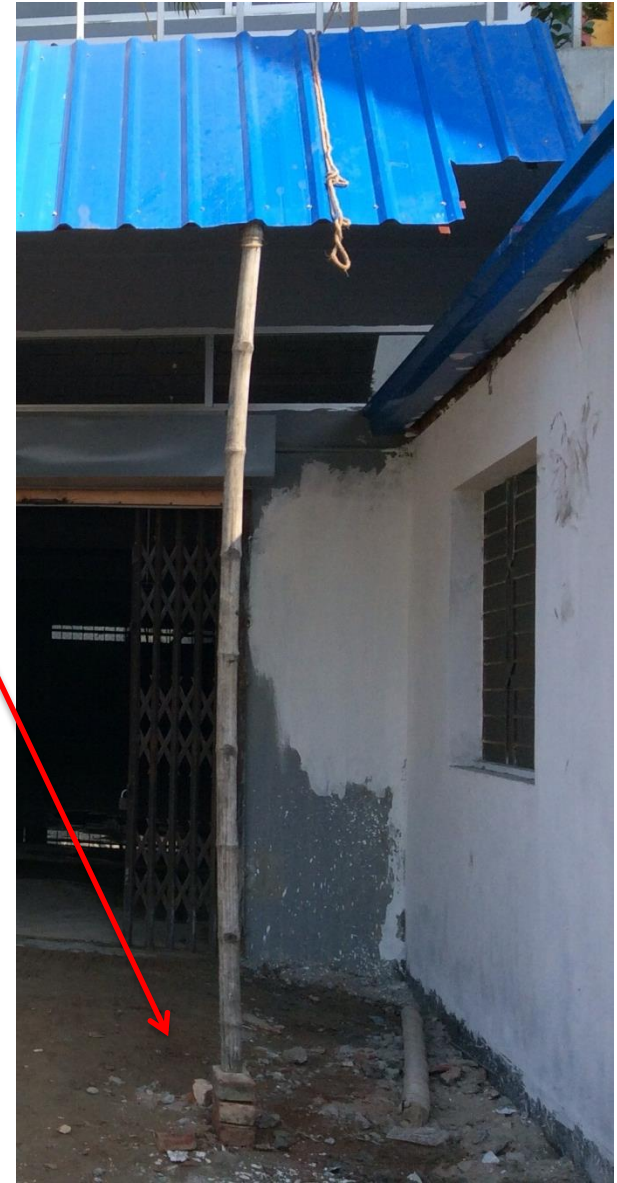
Non-engineered structures - canopies

Canopies and supports seem unstable
Danger of localised collapse

Item No.	Observation	Recommended Action Plan	Recommended Timeline
15	Canopy and supports at main building appear non-engineered	Building Engineer to check the supports and propose revised supports to ensure stability under dead, live and accidental loading.	6-weeks
16	Canopy and supports at main building appear non-engineered	Support details to be upgraded as per building engineer's design.	6-weeks
17	Water causing damage and corrosion on façade due to unmanaged drainage	Manage drainage from above levels and water tanks to downpipes to avoid structural corrosion due to continuous moisture.	6-months
18	Water causing damage and corrosion on façade due to unmanaged drainage	Exposed reinforcement not to be used for any structural applications	6-months
19	Rear wall of security hut/boundary wall appears non-engineered and leaning.	Factory engineer to check stability of wall and propose remedial actions.	6-weeks

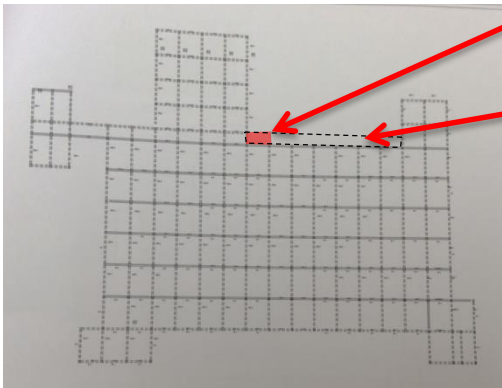
Non-engineered structures – extension onto balcony

Factory floor built out onto balcony with additional masonry walls built to full storey height

Normal balcony (not shown on drawings)
