# Day Apparels(12483) Day Fashion(12571)

M H Tower, 21, Vogra, Gazipur – 1704  
(23.981525N, 90.381451E)

8<sup>th</sup> December 2016

# Observation

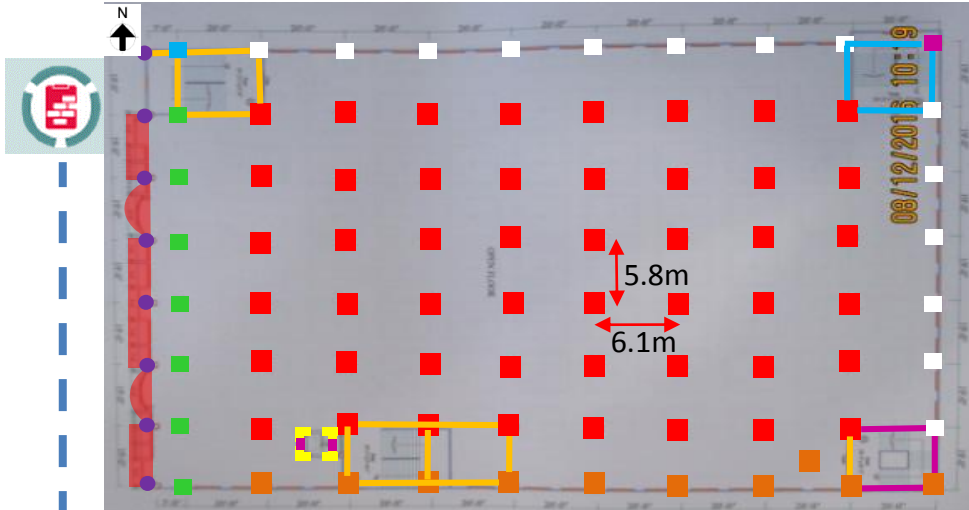
Typical flat slab with column Layout ground to 3<sup>rd</sup> floor

Due to combination of flat slab and beam column structural system, the lateral load path is not clear. Building engineer to check lateral stability of the building against lateral load as per BNBC load.

| Item No. | Observation | Recommended Action Plan | Recommended Timeline |
|---|---|---|---|
| 5 | Apparently Lack of Lateral stability | Building Engineer to review the lateral stability of the building for the BNBC recommended lateral load as part of engineering assessment. | 6-weeks |

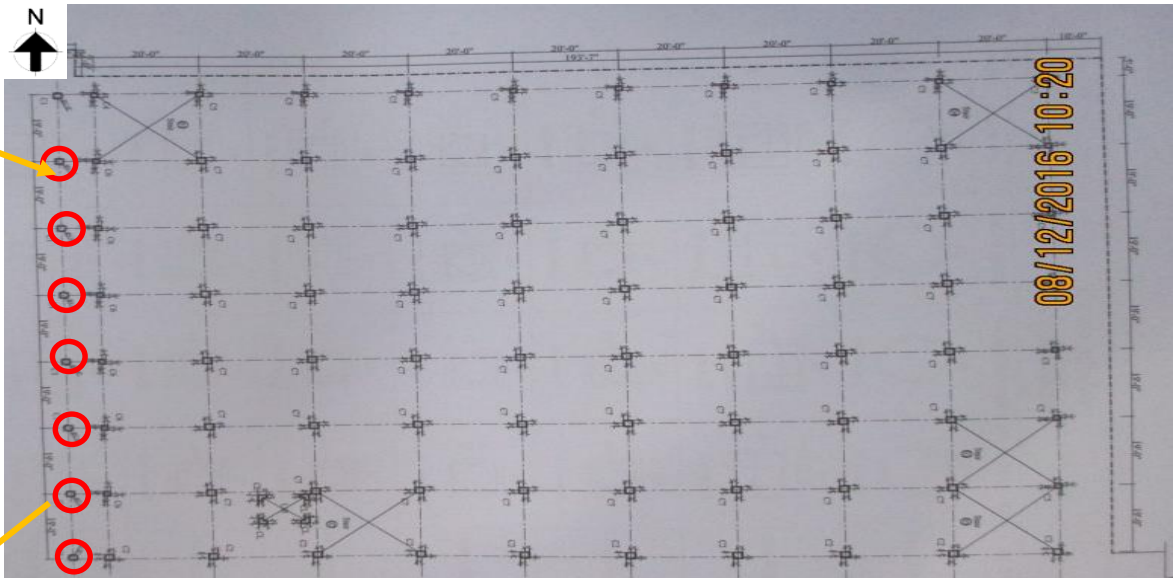
Column Layout

C1 type columns were found square shape on 3<sup>rd</sup> and 4<sup>th</sup> floor and circular shape from ground to 2<sup>nd</sup> floor where in column schedule, this column shape was shown as circular on all floor

| Item No. | Observation | Recommended Action Plan | Recommended Timeline |
|---|---|---|---|
| 7 | Discrepancy found between as built condition and provided drawing | Building engineer to survey the whole building and produce as-built documentation reflecting the as constructed condition. | 6-weeks |

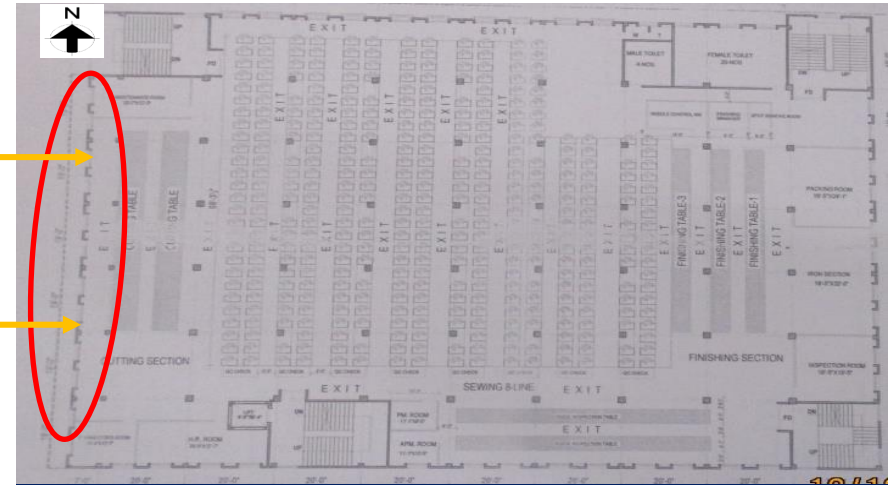
Typical floor plan

Circular shape brick wall was observed instead of straight wall in drawing

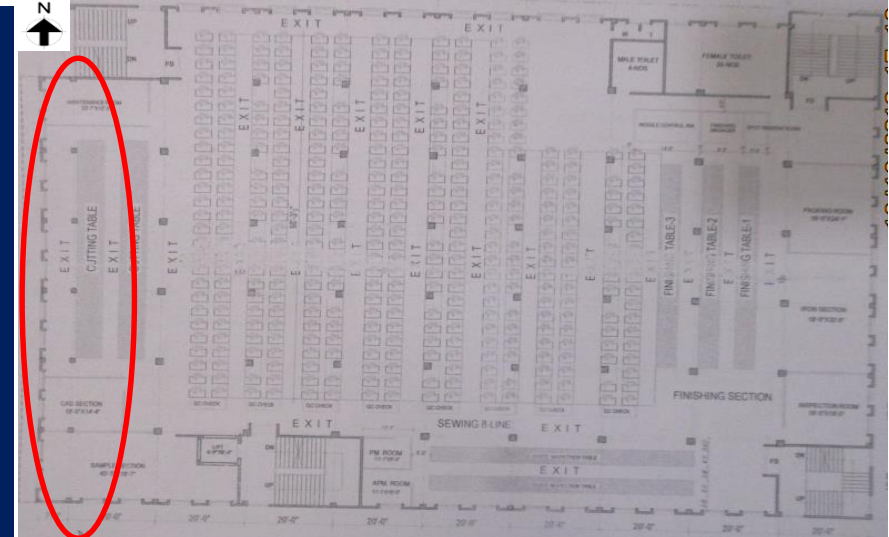
4<sup>th</sup> floor plan(existing roof top floor)

No Cantilever portion on 4<sup>th</sup> floor top Slab was observed which was present in drawing

Front elevation did not match with provided architectural drawing. Also the cantilever was absent which was shown in drawing.

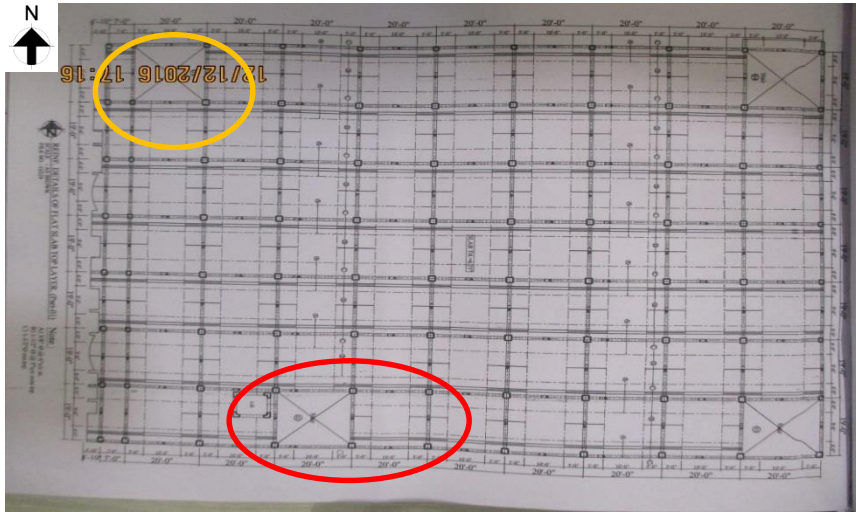
Slab reinforcement with concealed beam layout for typical floor

Beam was observed under 4<sup>th</sup> floor top slab and around stair case where as-build structural drawing showed concealed beam through the typical floor slab

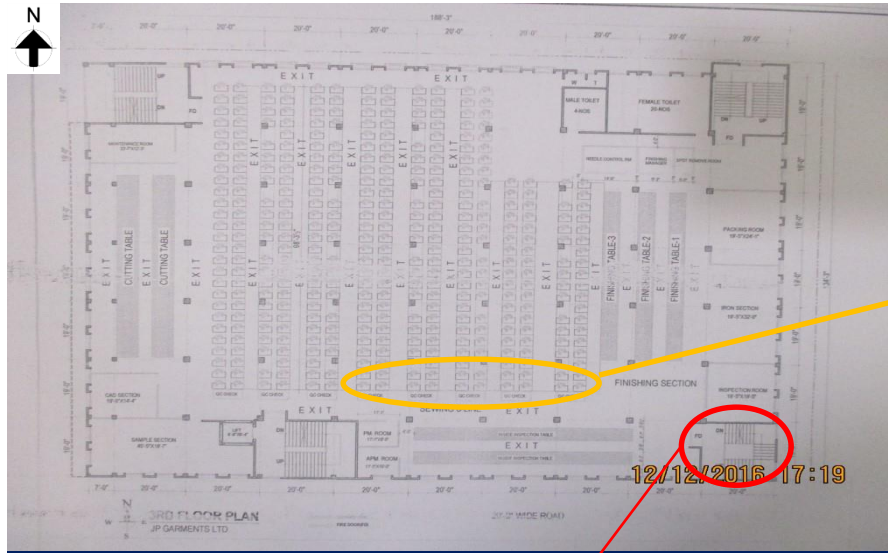
3<sup>rd</sup> floor layout plan

Hair line crack was observed on 3<sup>rd</sup> floor roof slab. Cracks were appeared under waist slab, on 3<sup>rd</sup> and 2<sup>nd</sup> floor.

| Item No. | Observation | Recommended Action Plan | Recommended Timeline |
|---|---|---|---|
| 8 | Cracks on Slab & Stair | Sections of plaster finish to be removed to investigate if cracks penetrate the building structure. | 6-weeks |
| 9 | Cracks on Slab & Stair | As part of Engineering Assessment, Factory Engineer to carry out design check on the affected areas | 6-weeks |
| 10 | Cracks on Slab & Stair | Carry out remedial works resulting from engineering assessment if necessary. | 6-months |

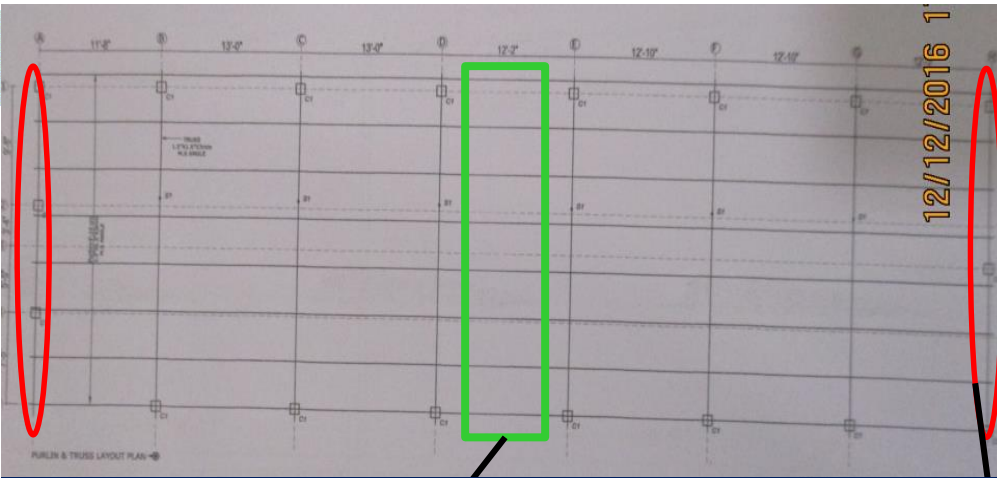
Purlin and Truss Layout Plan

During inspection, only seven purlin were found instead of eight purlin in drawing. Also no truss was observed at the both end of the shed.

| Item No. | Observation | Recommended Action Plan | Recommended Timeline |
|---|---|---|---|
| 15 | Discrepancy found between as built condition and provided drawing | Building engineer to survey the whole building and produce as-built documentation reflecting the as constructed condition | 6-weeks |

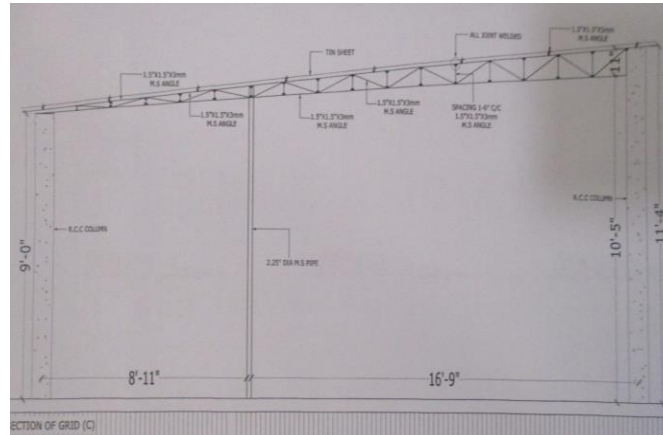
Section of steel Shed

The support condition of roof top shed was non engineered due to poor detailing.
