# Echotex (Extension) Ltd

Chandra, Palli Biddut, Kaliakoir, Gazipur

6<sup>th</sup> December ,2016

# Observations

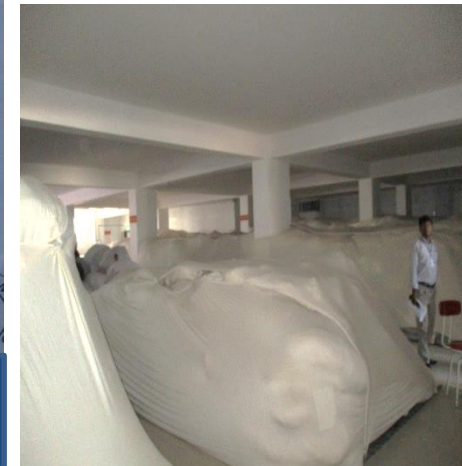
**Heavy Loading was observed on floors**

Heavy loading was observed on 9<sup>th</sup> floor which was measured as 102 psf on typical floor panel. Besides, Heavy loading was also found on several floors which exceeds 42 psf. A load plan was found where mentioned the floor capacity was 80 psf which required to review.

Item No.	Observation	Recommended Action Plan	Recommended Timeline
1	Column to be stressed above normal design limits	Factory Engineer to review design, loads and columns stresses in area identified above.	6-weeks
2	Column to be stressed above normal design limits	Verify in-situ concrete strength (using min. 4 nos. 100mm dia. Cores and/or assessment of available concrete strength data) and as constructed reinforcement for all columns.	6-weeks
3	Column to be stressed above normal design limits	Implement any remediation work if required	6-months
4	Heavy Loading was observed on floors	Loading must be kept within 2Kpa on all floor area.	6-weeks
5	Heavy Loading was observed on floors	Produce and actively manage a loading plan for all floor plates within the factory giving consideration to floor capacity and column capacity.	6-weeks
6	Heavy Loading was observed on floors	Continue to implement load plan.	6-months

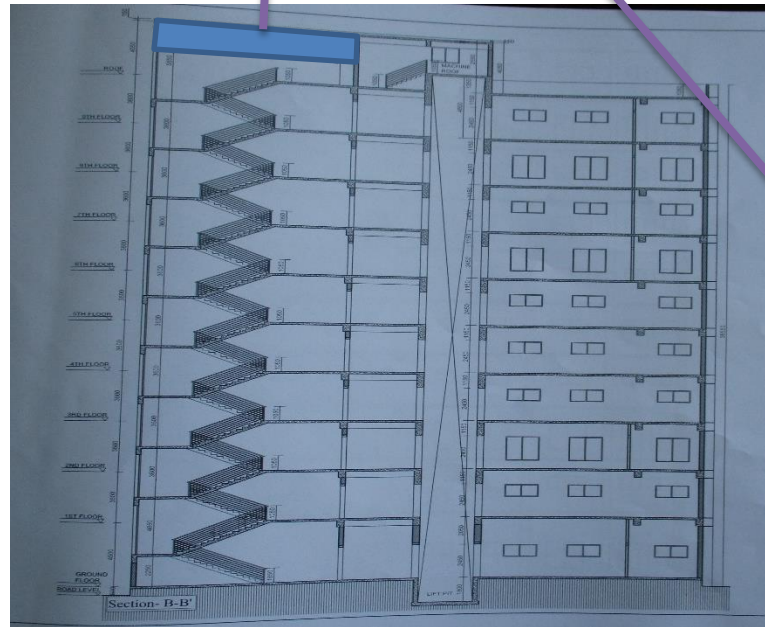
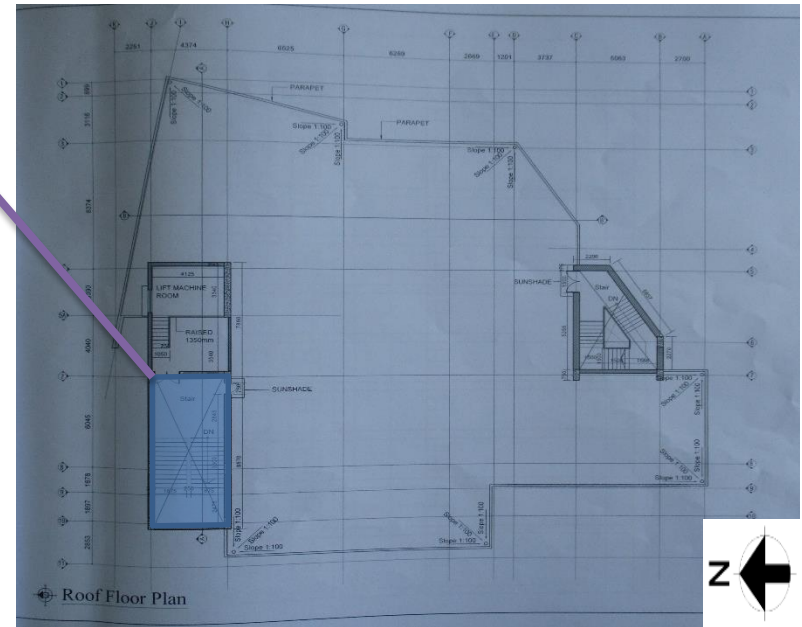
During inspection, RCC water Tank was observed on Roof which was not mentioned on As-Built Drawing

7	Inconsistency between As Built Drawings and on-site condition	Update As- Built drawing in accordance with actual condition and Incorporate the changes in As- Built Drawings.	6-weeks
8	Exposed Rebar on roof	All exposed reinforcement is to be protected from corrosion which may cause degradation of the concrete.	6-weeks
