# Jamuna Knit Concern. Patriot Fashion Ltd.

Road# 1 House#34 Kutubail, Fatullah, Narayanganj 1400 ,Bangladesh.  
(23.644765, 90.495215)

08<sup>th</sup> January 2017

# Observations

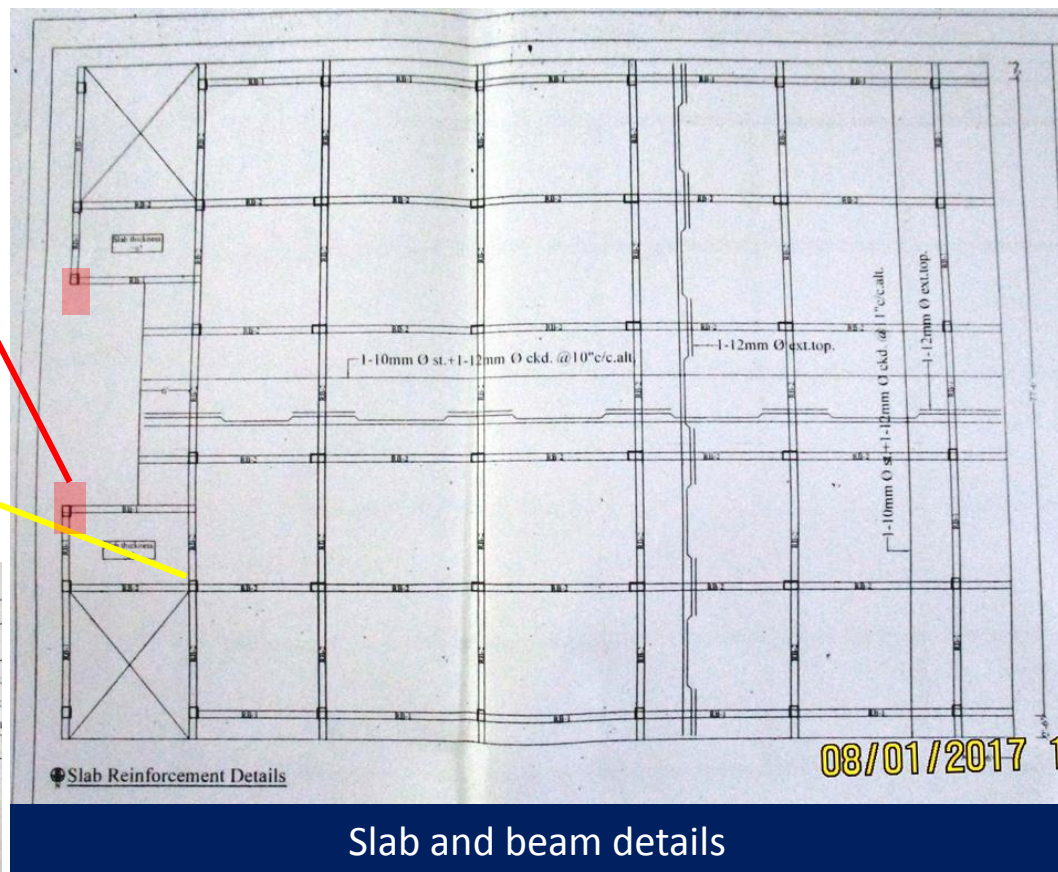
Column layout didn't fully matched with as built condition. Also (corner & stair) column size and nos. of rebar were not matched with column schedule. At east side two columns are not found and which is marked as red on drawings.

Both beam slab and flat slab were shown in provided structural drawing. But during inspection flat slab found in all floors.

| Item No. | Observation | Recommended Action Plan | Recommended Timeline |
|---|---|---|---|
| 5 | Discrepancies between provided drawings and on site condition | Building Engineer to survey as-built structure and prepare accurate as-built survey information, including all columns, beams and slabs. | 6-weeks |
