# Fame Apparels Ltd.

Plot # B- 188, 189, 210,211 BSCIC Hosiery Shilpanagary, Fatulah, Narayanganj, Bangladesh  
(23.626406, 90.481306)

26<sup>th</sup> December 2016

# Discrepancies between provided drawings and on site condition

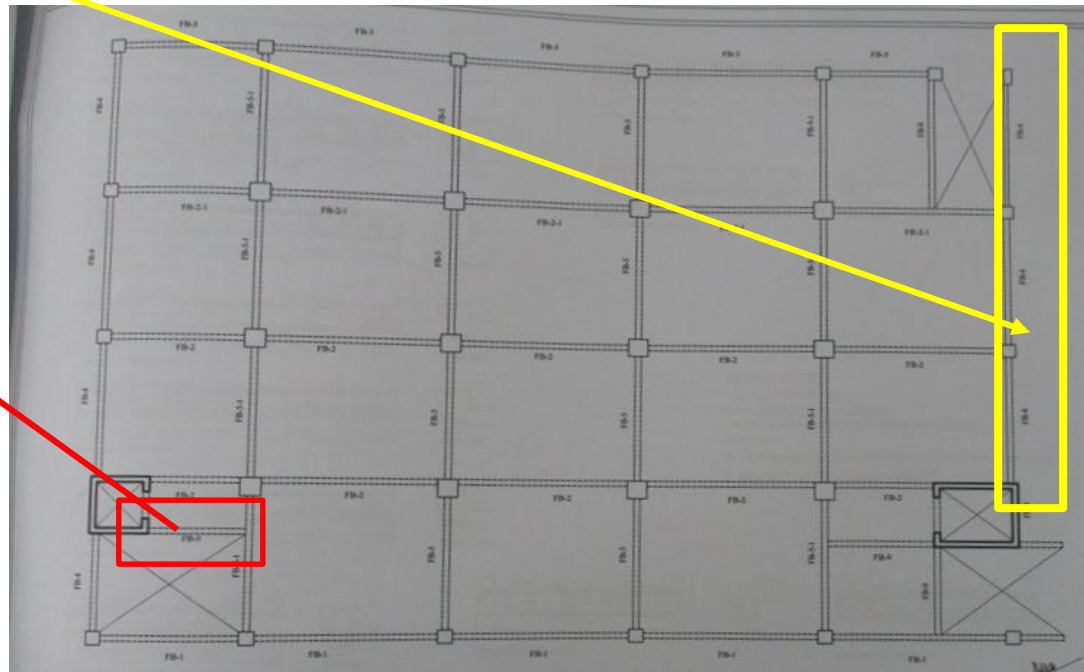
Beam Layout from as built structural drawing

As built architectural drawings were not prepared. As built structural drawings are not fully matched with as built condition.

Cantilever beam at north side not shown in drawings and near south lift core a sub beam shown in as built structural drawings which does not exist. Also mezzanine floor at GF not fully updated in structural drawings.

| Item No. | Observation | Recommended Action Plan | Recommended Timeline |
|---|---|---|---|
| 1 | Discrepancies between provided drawings and on site condition | Building Engineer to survey as constructed building and prepare a set of as-built drawings. | 6-weeks |

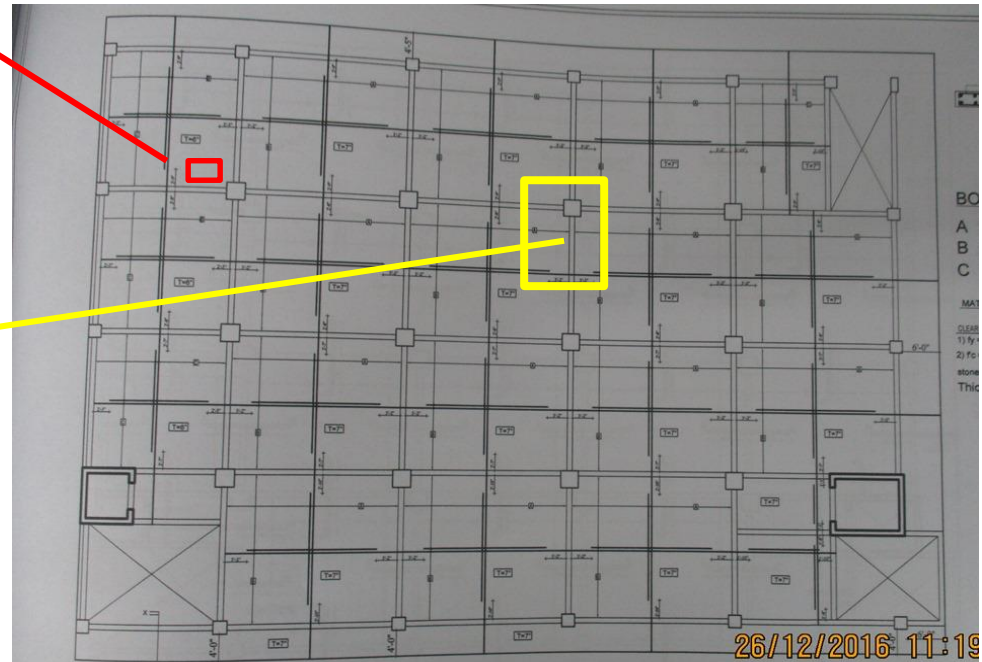
Slab details

Opening found on 9<sup>th</sup> floor roof slab which is not shown in structural drawing. A beam at same floor was found damaged due to installed hydrant pipe.

| Item No. | Observation | Recommended Action Plan | Recommended Timeline |
|---|---|---|---|
| 2 | Opening in slab and damaged beam found at 9th floor | Factory engineer to investigate damaged beam & the slab opening. | 6-weeks |
| 3 | Opening in slab and damaged beam found at 9th floor | Provide slab and beam adequacy check. | 6-weeks |
| 4 | Opening in slab and damaged beam found at 9th floor | Remedial works to be carried out if required. | 6-months |
