# RGR Sweater Ltd

VIII Madhakhala, post- Boiragirekala, Shreepur, Gazipur, Dhaka

# Building Observations

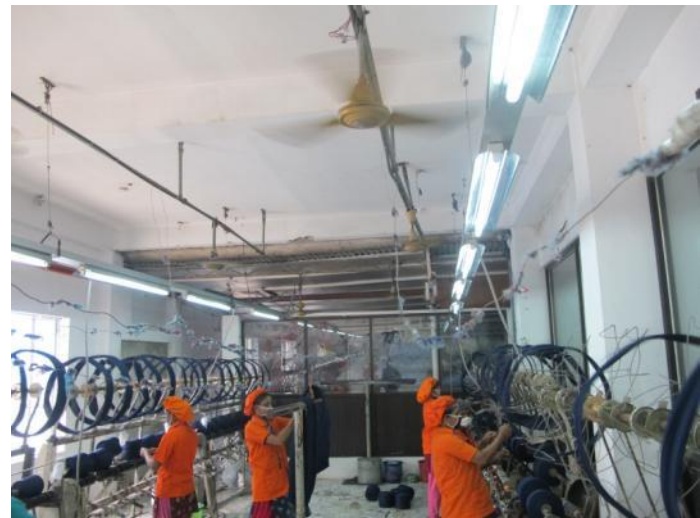
# Building 1

**Structure not in accordance with design**

| Item No. | Observation | Recommended Action Plan | Recommended Timeline |
|---|---|---|---|
| 7 | Discrepancies between designed and as-built structures | Prepare documentation that is missing for existing structures. | 6-months |
