# Fancy Fashion Sweaters Ltd.

1153-54, Shahid Siddique Road, Khailkur, Board Bazar, Gazipur-1704, Bangladesh  
(23.942443N, 90.388539E)

23 March 2014

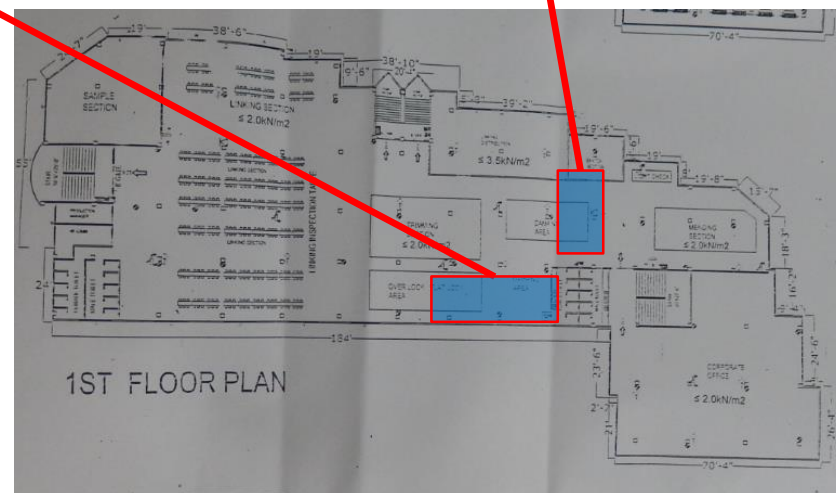
Uncontrolled loading on 1<sup>st</sup> floor

## Uncontrolled loading

All loading to be managed according to loading plan.

| Item No. | Observation | Recommended Action Plan | Recommended Timeline |
|---|---|---|---|
| 8 | Loading in uncontrolled areas | Reduce loads where noted previously. Loading not to exceed 2kN/m <sup>2</sup> | <b>Immediate - Now</b> |

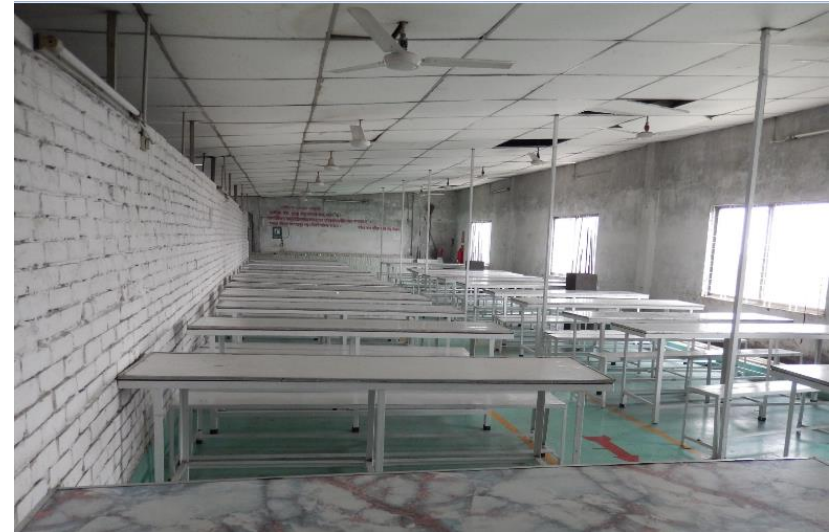
Dining rooms.  
40x40mm RHS posts and beams  
insufficient for loads in severe winds.  
Engineered structure required.  
Current structure to be removed

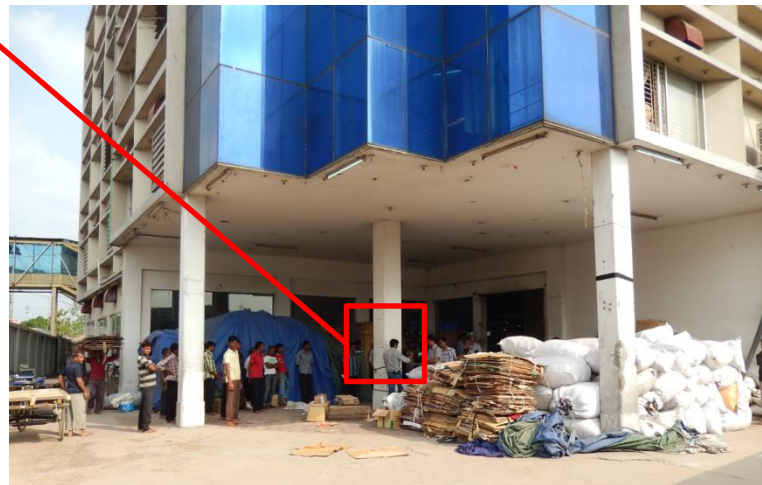
Ferrosan tests carried out on several ground floor columns.
