# Euro Jeans Ltd

Chowdhury Bari, Vogra ,Gazipur  
(23.9789348N,90.3802407E)

14th May 2014

# Observations

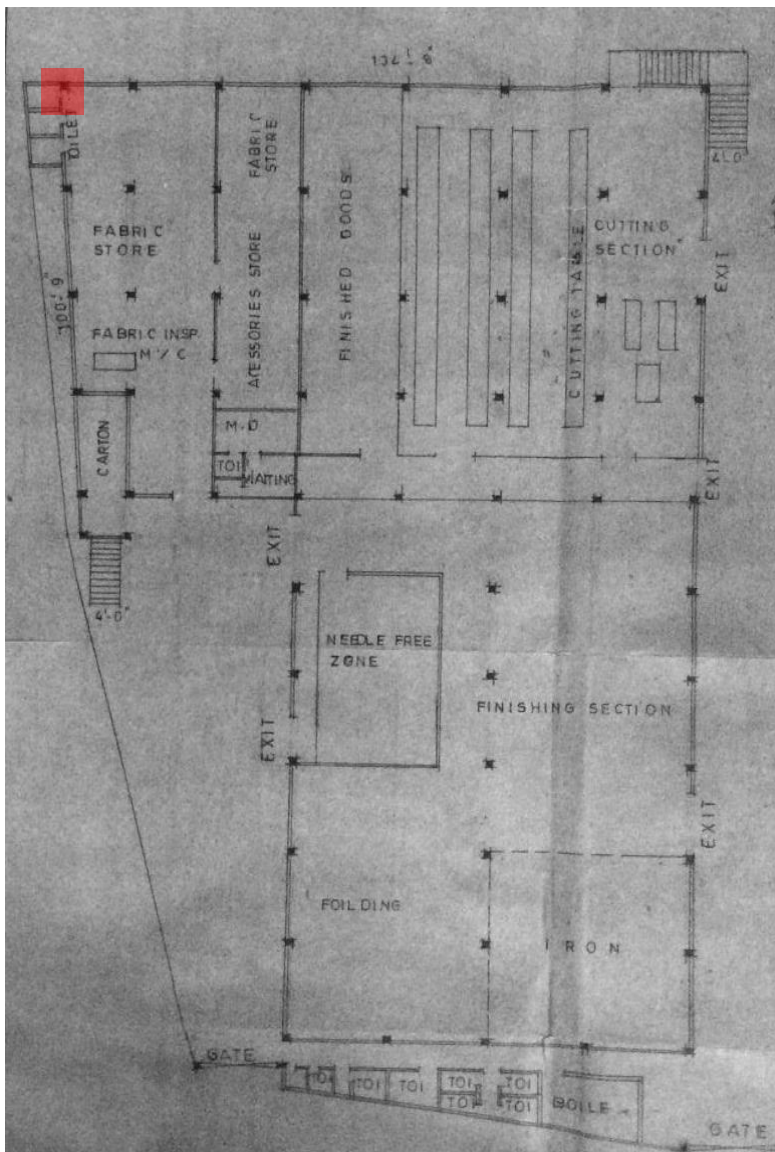
Shed 2 – Ground Floor Plan

Location of buckled end plate

Shed 2 – Buckled end-plate to First Floor edge beam. The plate appears to have buckled either from overstressing and / or inadequate connection

| Item No. | Observation | Recommended Action Plan | Recommended Timeline |
|---|---|---|---|
| 1 | Defects and poor workmanship to the steelwork connections in Sheds 1 and 2 | Building Engineer to review all connection details in Sheds 1 and 2 with immediate effect as part of Detailed Engineering Assessment, refer to attached scope. | Immediate - Now |

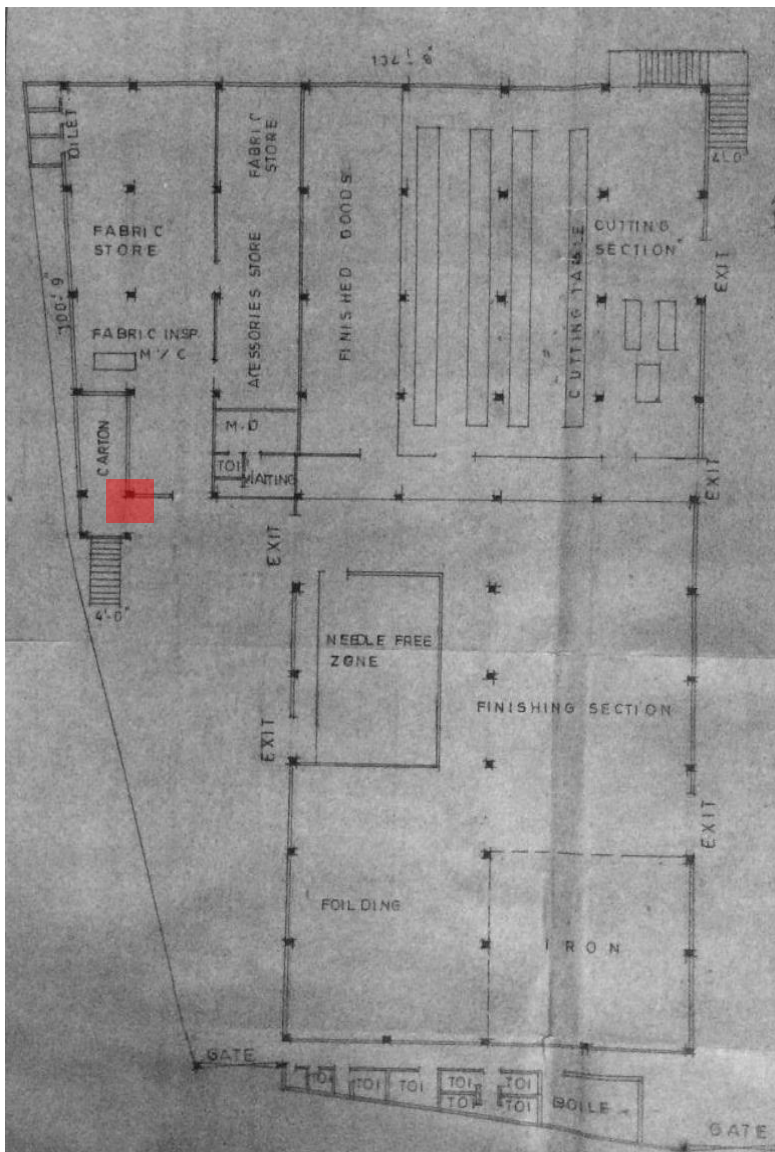
Shed 2 – Ground Floor Plan

Corroded / pitted steel column

Shed 2 – Column appears to have been painted without adequate remedial work to treat corrosion.

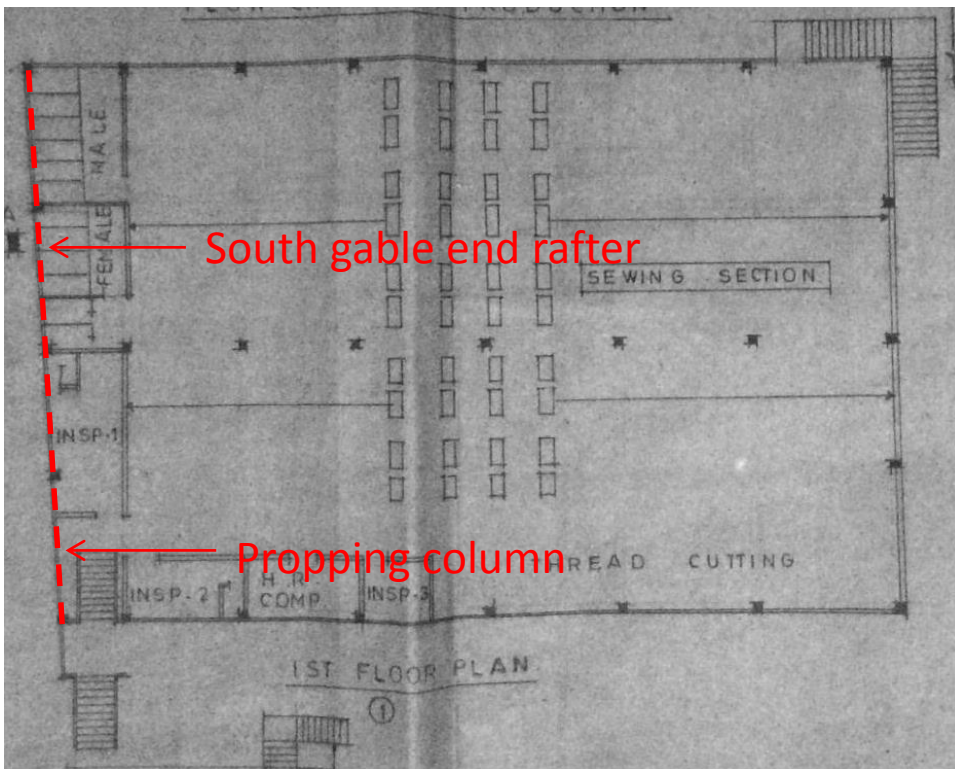
Shed 2 – 1<sup>st</sup> Floor Plan

There are concerns over the structural adequacy of the rafter to the south gable end of Shed 2. The detail of the portal frame to the South-East corner is atypical: the rafter butts up against the water tank wall instead of a column, and there is no connection to the water tank wall. The rafter is instead propped up by a cantilevering steel column and cantilevers approximately 3m beyond the prop to where it meets the water tank wall. The connection detail between the rafter and the prop is unclear, although the moment capacity of the portal frame appears to have been lost. Detailed Engineering Assessment required.

Unconnected end of rafter to South-East corner; rafter propped by a cantilevering steel column

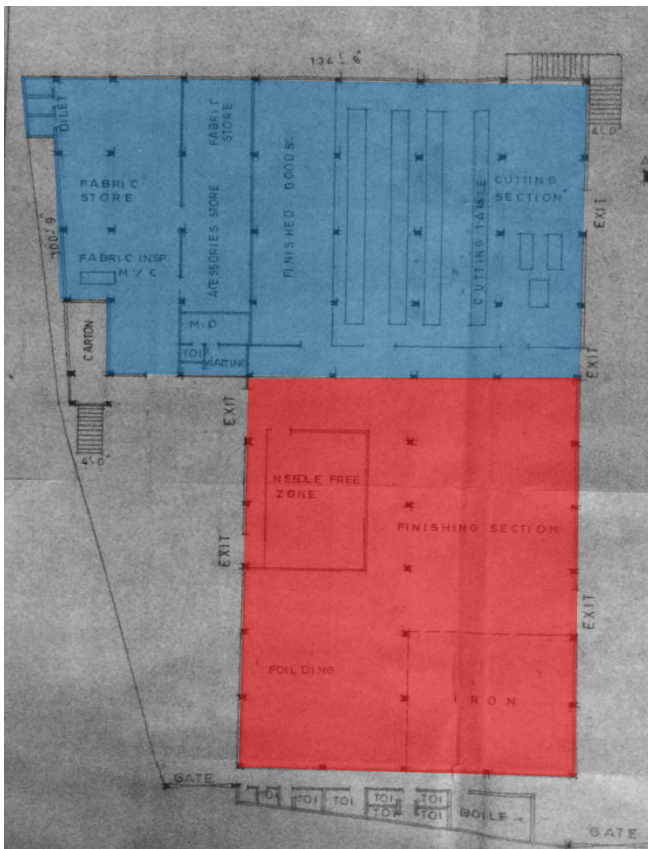
Shed 2 – Ground Floor Plan

Shed 2 – Two-storey structure – Horizontal and vertical cable bracing missing.

Shed 2 – Single -storey structure – Vertical cable bracing missing. Horizontal bracing appears loose.

| Item No. | Observation | Recommended Action Plan | Recommended Timeline |
|---|---|---|---|
| 8 | Lack of / inadequate stability members in Sheds 1 and 2 | Building Engineer to provide necessary vertical and horizontal bracing to Shed 2 and to tighten bracing to Shed 1. | 6-weeks |

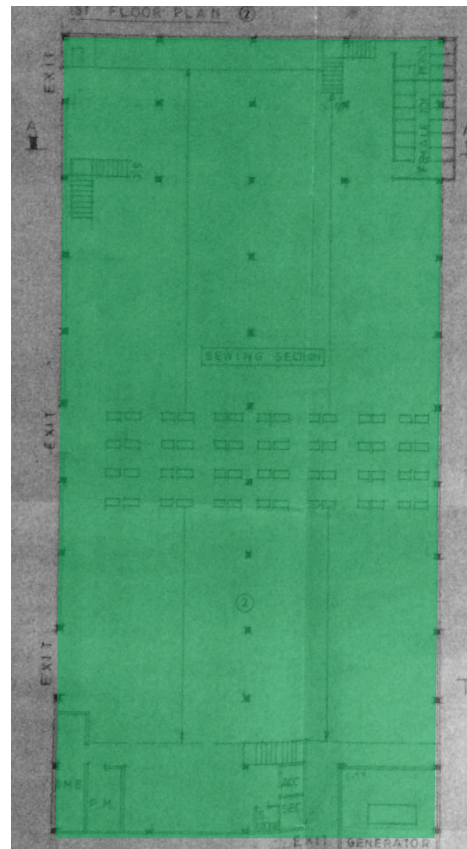
Shed 1 – Ground Floor Plan

Shed 1 – Horizontal and vertical cable bracing provided, but loose and ineffective.

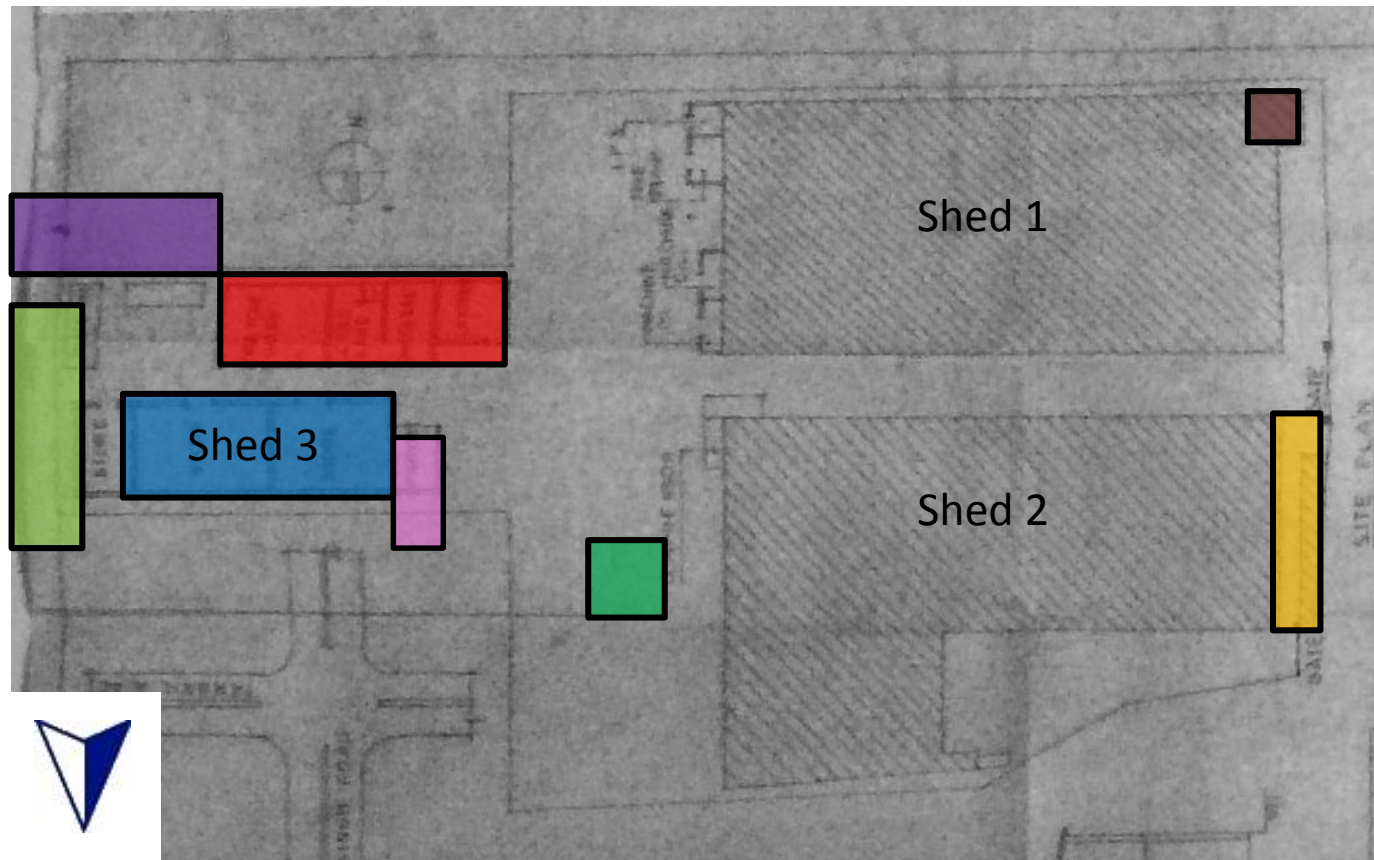
Site Layout – Extent of Lightweight Structures / Roof Structures

The factory compound comprises a number of lightweight structures, namely to Sheds 3 and 5, and lightweight roof structures, namely to sheds 4 and 6, as well as to other ancillary structures as indicated. These lightweight structures / roof structures appear to be non-engineered. The design of all lightweight structures will need to be checked against uplift and lateral instability, with particular emphasis on connections and bracing.

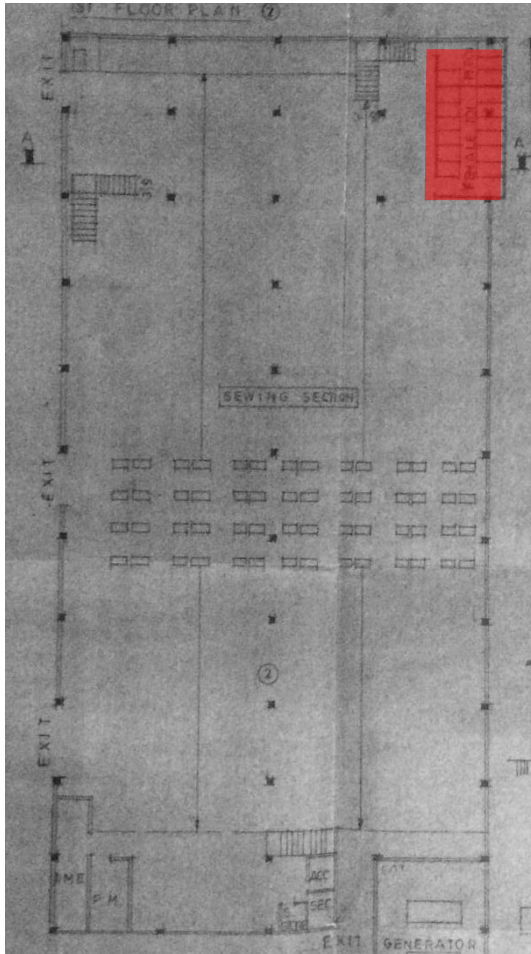
Shed 1 – Ground Floor Plan

Water ingress, believed to be from leaking services, was observed in the toilet extension to the North-West corner of Shed 1, resulting in corrosion to the portal frame steelwork members and to the reinforcement steel which has become exposed in the RC slab. Remedial works are required.

Location of toilet extension to North-West corner of Shed 1. Leaking services and resulting corrosion of steelwork was observed.

| Item No. | Observation | Recommended Action Plan | Recommended Timeline |
|---|---|---|---|
| 17 | Water ingress from leaking services into Shed 1 | Building Engineer to identify the cause of leaking and carry out any necessary remedial works. | 6-weeks |
| 18 | Water ingress from leaking services into Shed 1 | Building Engineer to review affected steelwork and prepare a schedule of remedial works as required. | 6-weeks |
| 19 | Water ingress from leaking services into Shed 1 | Building Engineer to implement any actions / supervise any remedial works as identified following the review. | 6-months |
