# Russel Garments Ltd.

Osman Tower, 56/1, S.M. Maleh Road, Narayanganj, Dhaka

20 April 2014

# Building Observations

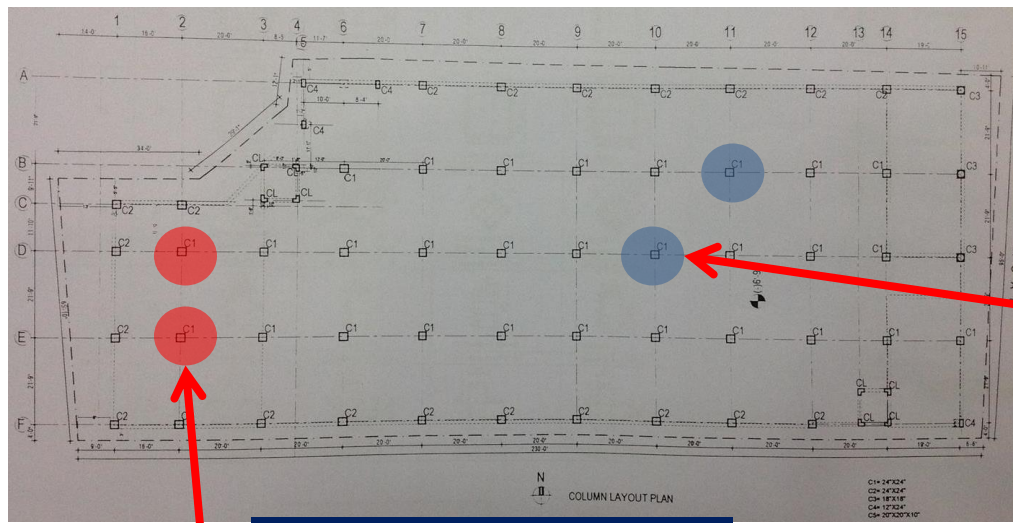
# Cracking in slab finishes

Cracks to be reviewed by removing floor finishes to investigate if they extend into structure.

There was a toilet nearby with heavy buildup – engineer to confirm that this has been allowed for in design.

| Item No. | Observation | Recommended Action Plan | Recommended Timeline |
|---|---|---|---|
| 11 | Cracking in slab finishes | Remove finishes to investigate if cracking extends into structure. | 6-weeks |
| 12 | Cracking in slab finishes | If the cracks do extend into structure engineer to review current loading and usage of adjacent areas with respect to what was assumed in design. | 6-weeks |
| 13 | Cracking in slab finishes | If necessary remove heavy plant in substation room on ground floor and toilet build-up on all floors deemed overloaded. | 6-weeks |
| 14 | Cracking in slab finishes | Building engineer to design strengthening as required. | 6-weeks |
| 15 | Cracking in slab finishes | Implement any strengthening specified by the building engineer. | 6-months |
| 16 | Cracking in slab finishes | Any cracks found should be repaired. | 6-months |
| 17 | Cracking in slab finishes | Continue to monitor building for signs of cracking on on-going basis and take appropriate action. | 6-months |

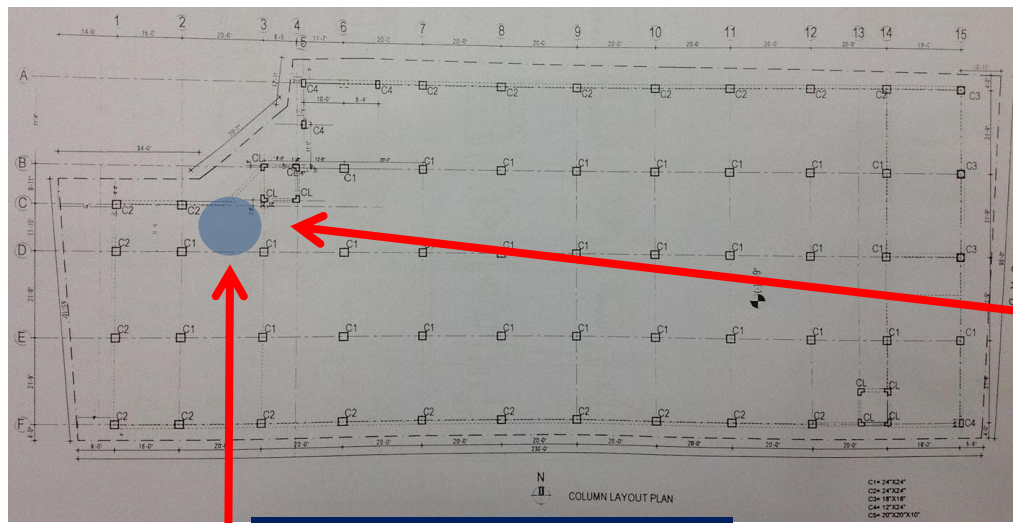
**Locations of cracking**

**Cracks to be reviewed by removing floor finishes to investigate if they extend into structure.**

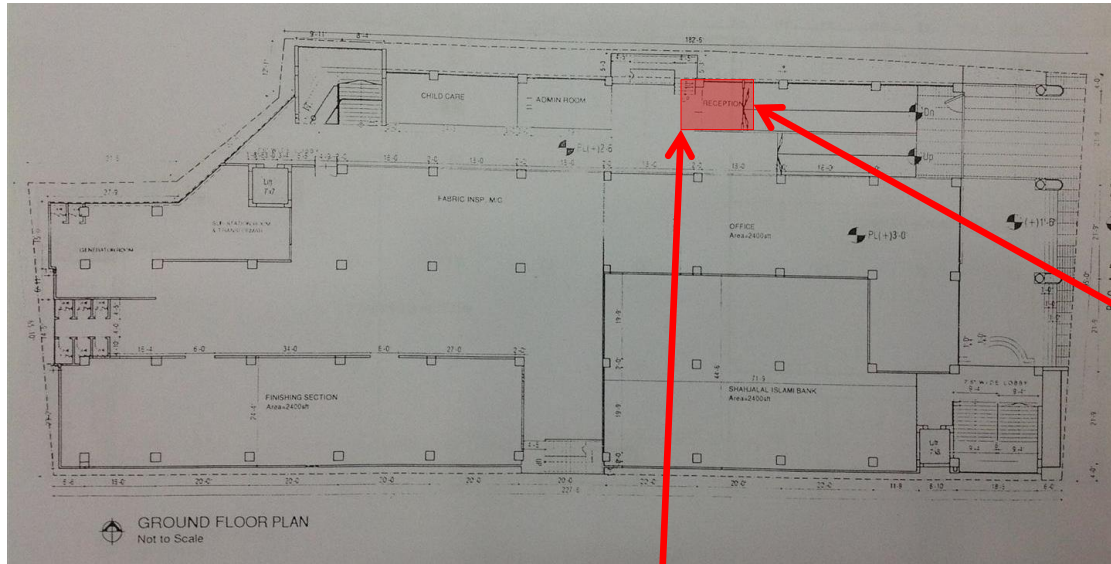
## Defects to ramp structure

**Load path for mezzanine structure over ramp is not logical and signs of distress in ground floor slab are evident.**

**Cracking to ground floor slab.**

**Column built off edge of ramp slab (support?)**

| Item No. | Observation | Recommended Action Plan | Recommended Timeline |
|---|---|---|---|
| 18 | Defects to ramp structure | Building engineer to review design of ramp structure, mezzanine floor and adjoining ground floor structure and design strengthening as required to support the codified design loading. | 6-weeks |
| 19 | Defects to ramp structure | Implement strengthening specified by the building engineer. | 6-months |

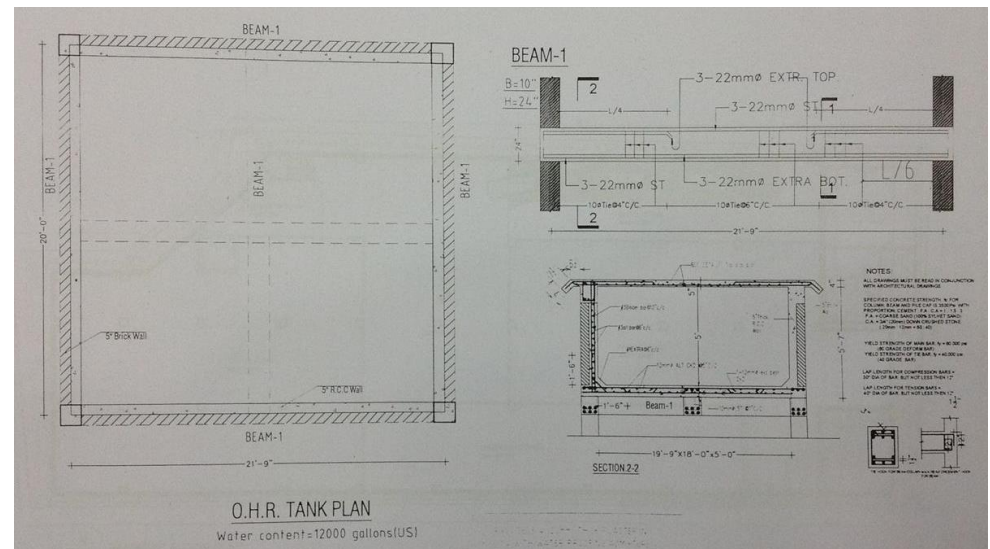
**Tank at roof level**

**Tank currently under construction on roof is bigger than shown on structural drawings.**

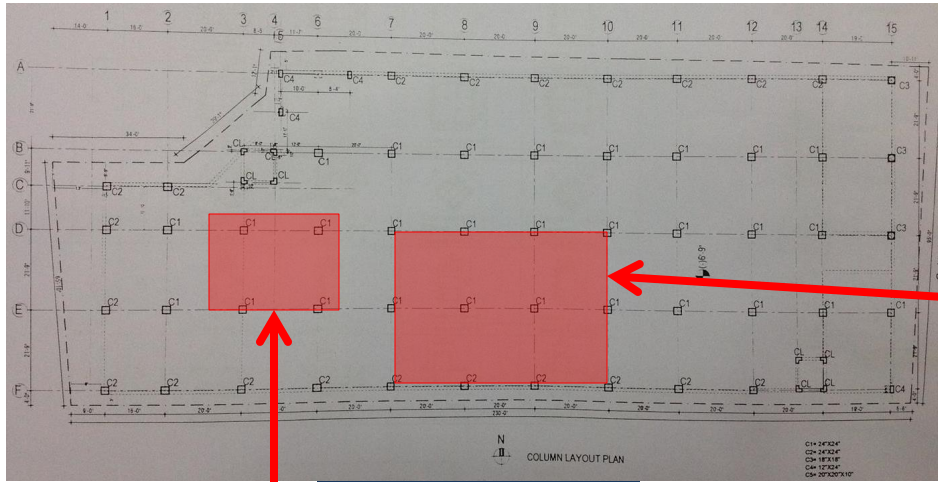
**Localised areas of high loading**

**Uncontrolled stacking of materials.**

**Areas of high loading on suspended structure. Floor load management system incomplete as no loading plans or loading height limits displayed.**

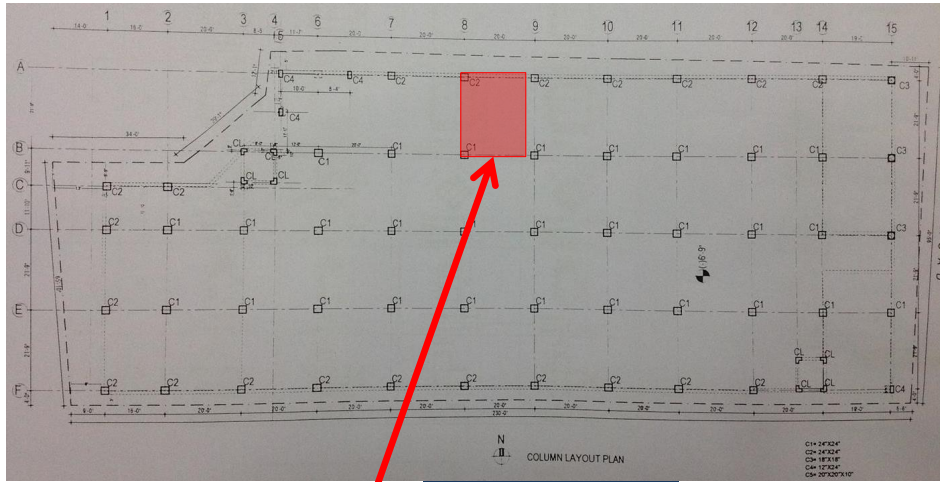
1<sup>st</sup> Floor Plan

Uncontrolled stacking  
of materials in bank  
leading to cracking of  
infill brickwork wall.

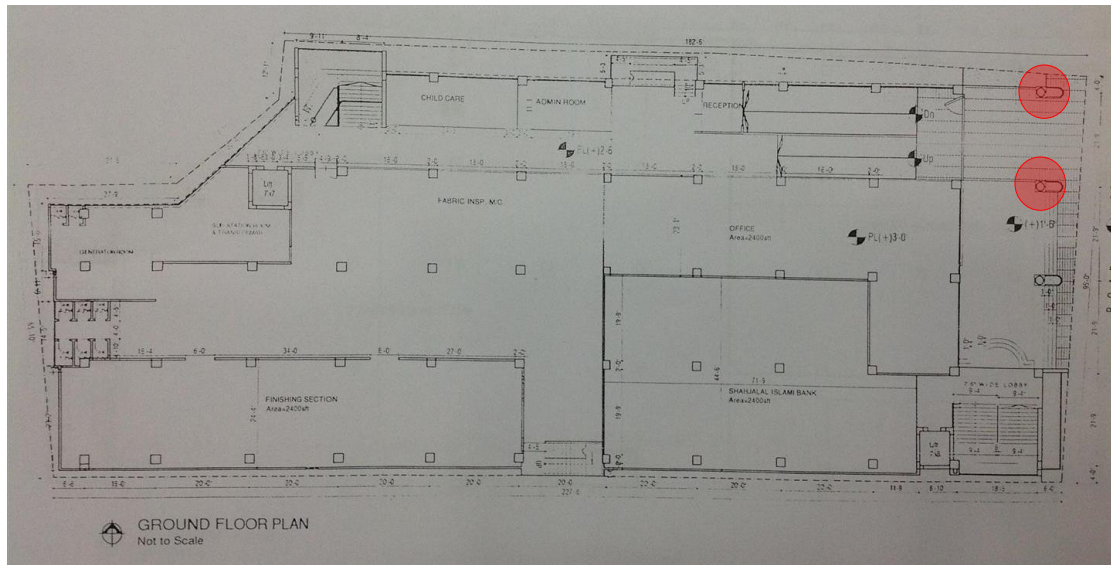
# Columns susceptible to impact loading

**Columns at front entrance are susceptible to impact loading from vehicles.**
