# East Coast Knitwear Pvt. Ltd.

Takkarmath, Sehachar, Fatullah, Narayanganj-1420, Bangladesh.

1st November, 2016

# Observations

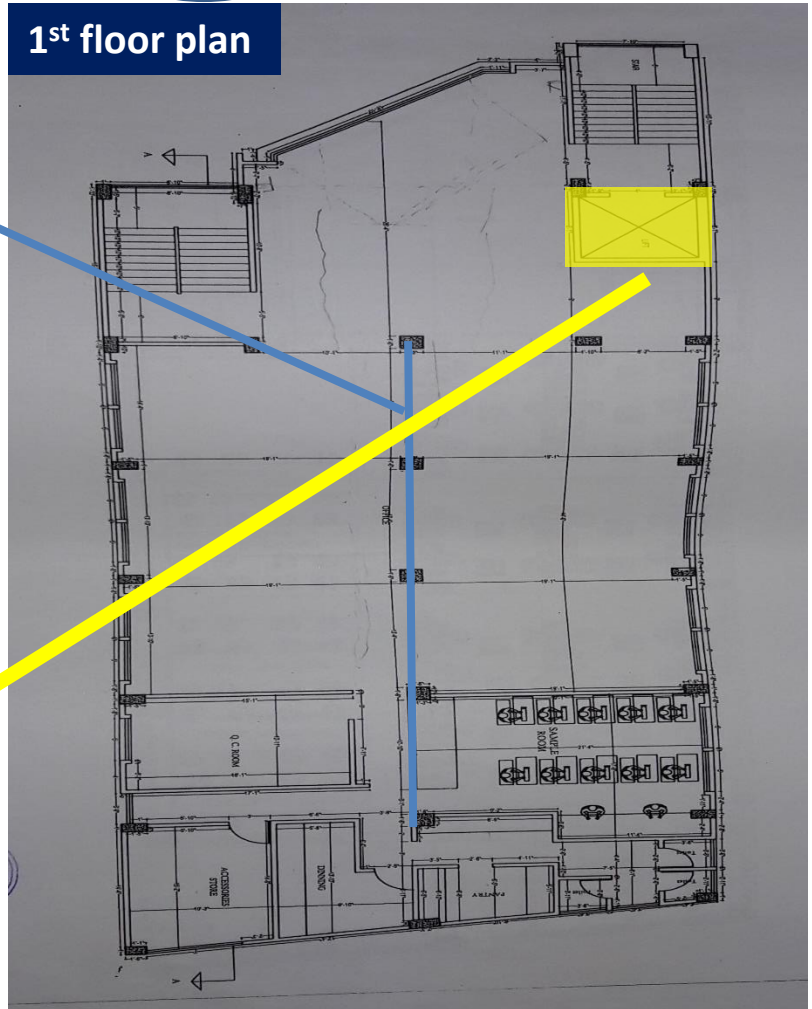
# **Underground Water Tank slab located under loading-unloading area**

This place is being used as loading  
unloading area and parking place, which is  
likely to undergo huge impact load.  
Building engineer to verify slab capacity
