Knit Radix Ltd.

Shasongaon, Enayetnagar, Fatulla
(23.625139, 90.470706)

09th January 2017

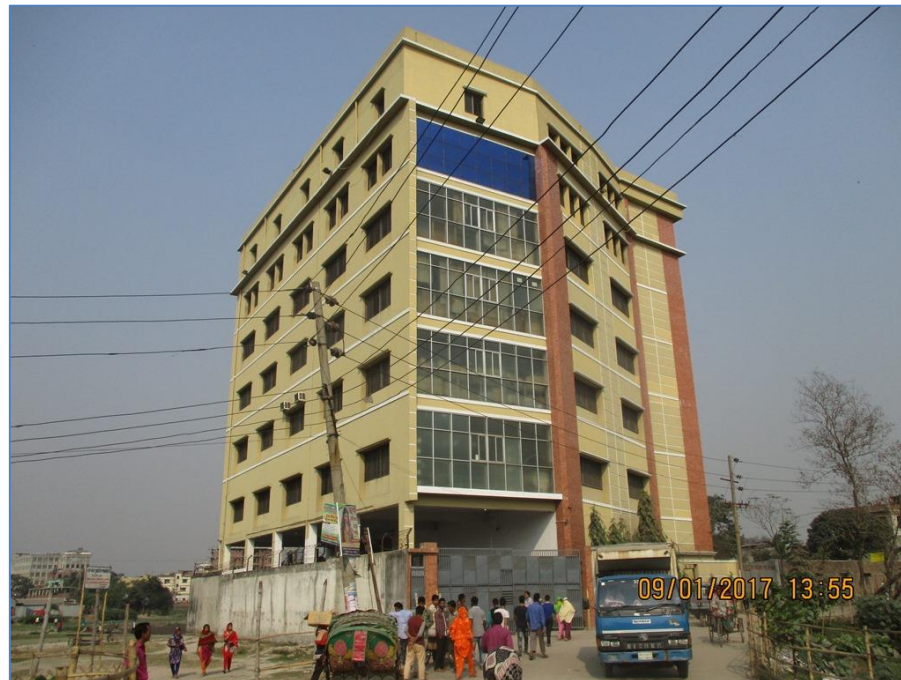
Column to be stressed above normal design limits

Cursory calculations indicate that the working stress of the ground floor columns are at a level that requires design review.

Item No.	Observation	Recommended Action Plan	Recommended Timeline
1	Column to be stressed above normal design limits	Factory Engineer to review design, loads and columns stresses.	6-weeks
2	Column to be stressed above normal design limits	Verify in-situ concrete stresses by 100mm dia. cores from min. 4 no. column from ground floor level.	6-weeks
3	Column to be stressed above normal design limits	Produce and actively manage a loading plan for all floor plates within the factory giving consideration to floor capacity and column capacity.	6-weeks
4	Column to be stressed above normal design limits	Make any structural alterations as advised by Building Engineer.	6-months
5	Column to be stressed above normal design limits	Continue to implement loading plan.	6-months
6	Discrepancies between provided drawings and on site condition	Building Engineer to survey as-built structure and prepare accurate as-built survey information for steel part.	6-weeks
