# Lumbini Ltd

Meghla, Bandarban, Chittagong  
(+22.178294N, 92.190958E)

24<sup>th</sup> June 2014

# Observations

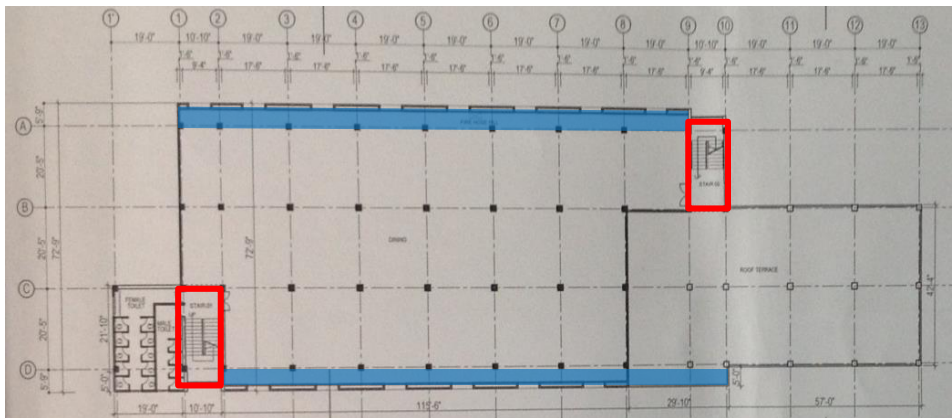
Typical Floor Plan

- There is a concern about the stability system for lateral loading conditions. The lateral stability of the building would appear to be provided primarily by moment-frame action; however, there is insufficient information in the design documents about the connection details between the primary steel beams and the RC columns – design check required.

- The foundation recommendations provided in the soil investigation report make reference to a 3 storey building, not a 5 storey building – clarification required.

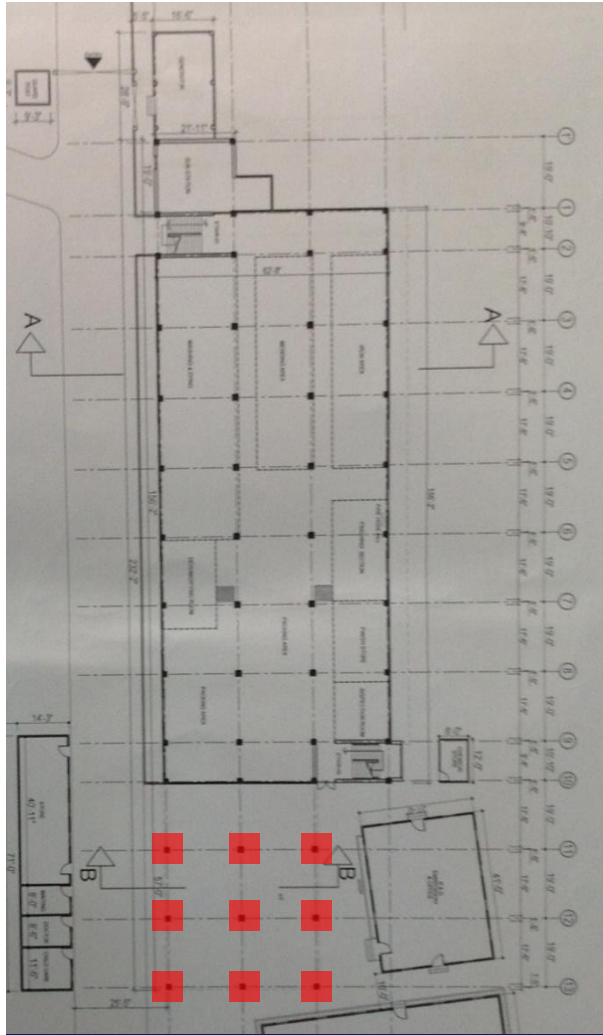
Ground Floor Plan

# Double-height columns at risk of impact loading

The double-height columns to the south of the building, adjacent to the delivery entrance, are at risk of being accidentally struck by a vehicle. The existing column protection appears inadequate.
