# **FIRE SAFETY INSPECTION REPORT**

**SQUARE FASHIONS LTD**

**ROKEYAPUR, JAMIRDIA, HABIR BARI, VALUKA**

July 16, 2014

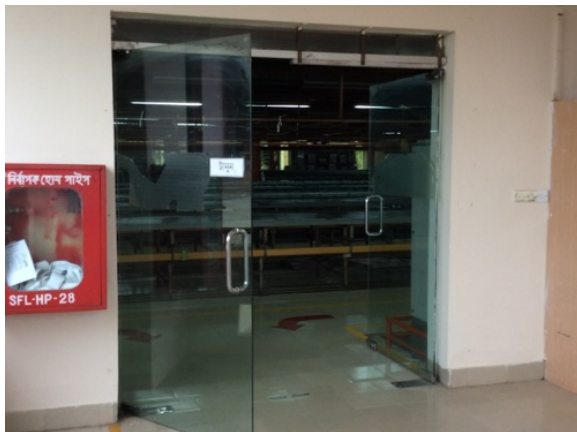
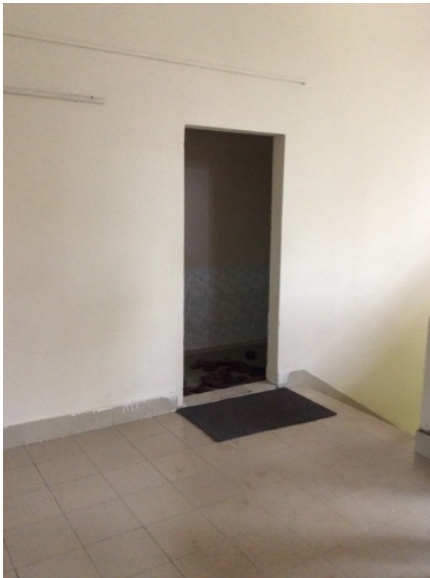
| F-2 | Fire Rated Construction | The exit stairs are not separated from work areas and other spaces on each floor by fire-rated construction. | Provide minimum 1.5-hr fire rated doors and seal all unprotected openings to separate the exit stairs from work areas and other building spaces on all floor levels. Ensure that the fire doors are self-closing and positive latching and that they are provided with fire exit (panic) hardware where serving production floors.<br><br>If fire doors are required to be held open for functional reasons, provide automatic-closing devices tied to the fire alarm system. | Within 3 months |

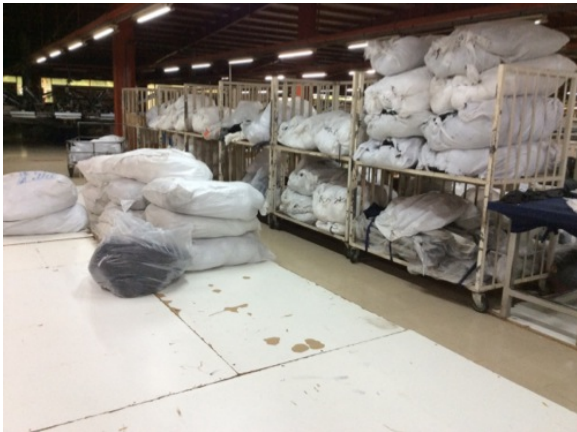
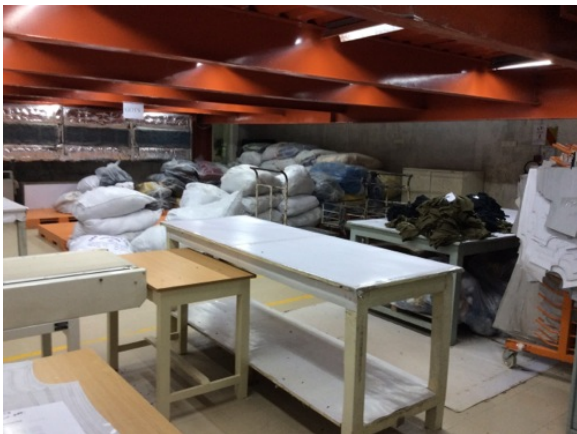
| F-3 | Fire Rated Construction | Areas used for combustible storage, open to the factory floor on the ground and second floors, were not separated by fire-rated construction. | <p>Provide dedicated storage rooms separated by minimum 1-hr fire-rated construction.</p> <p>Where separate storage rooms are not feasible, provide defined storage areas and limit the storage arrangement as follows:</p> <ul style="list-style-type: none"><li>- Maximum height of 2.4m and maximum area of 23m<sup>2</sup></li><li>- If sprinkler protected: maximum height of 3.66m and maximum area of 93m<sup>2</sup></li></ul> <p>Separate areas of unenclosed combustible storage by a minimum clear distance of 3m.</p> | Within 3 months |

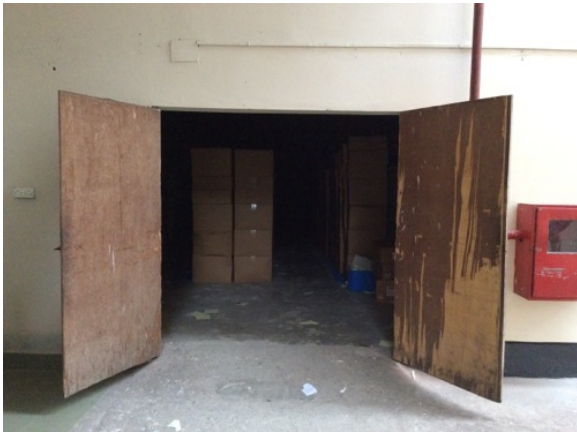
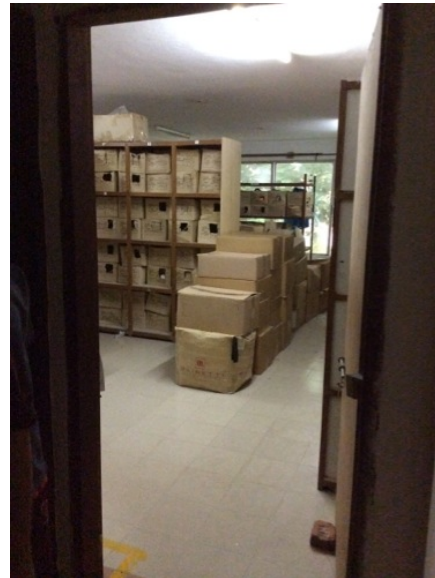
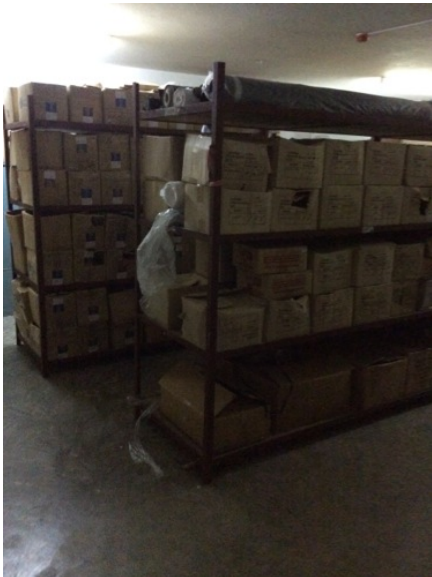
| F-4 | Fire Rated Construction | Rooms used for combustible storage on the ground (embroidery store, finished goods store), first two (2) sample accessory rooms), and mezzanine 1 (chemical store room) floors were not separated by fire-rated construction. | Provide dedicated storage rooms separated by minimum 1-hr fire-rated construction. | Within 3 months |

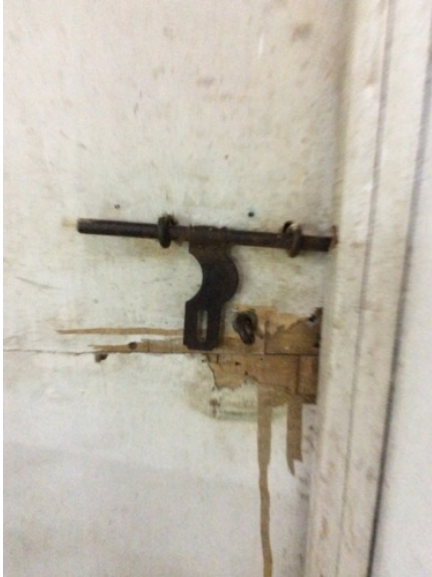
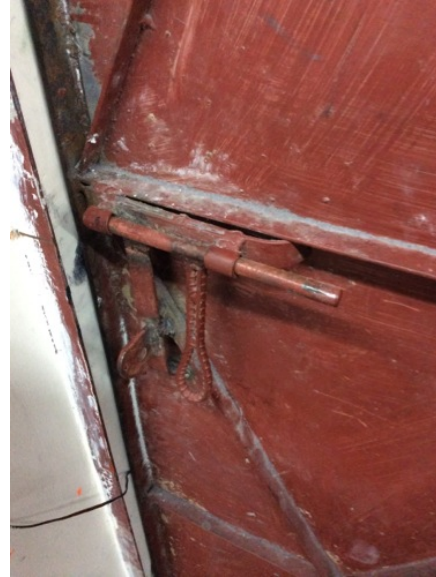
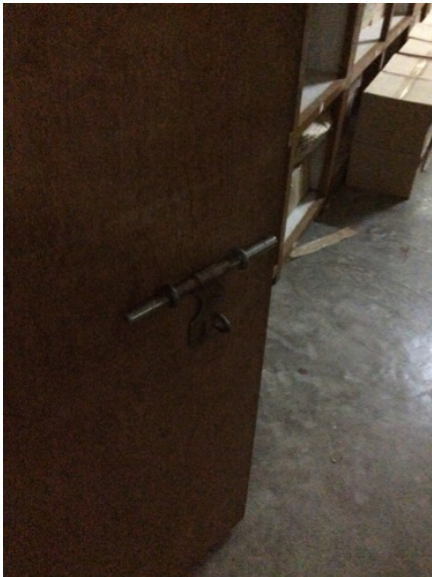
| F-5 | Egress | Egress doors with locking features are provided at building exits and along egress routes. All doors were open and unlocked during the inspection. | Remove locking features from all egress doors.<br><br>If locks are required for security reasons, utilize special door locking features complying with NFPA 101. | Immediate |

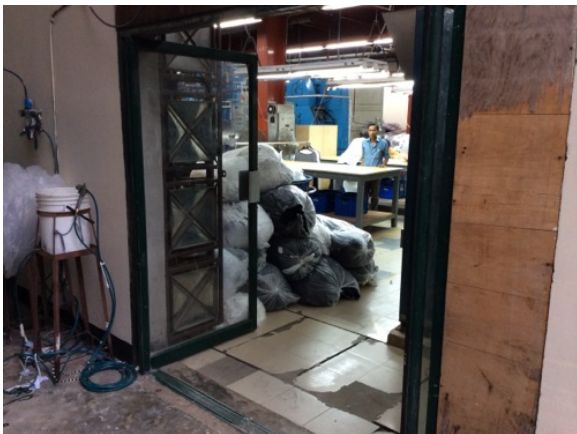
| F-8 | Egress | Egress door from the ground floor washing room does not swing in the direction of egress travel. | Modify the egress door to swing in the direction of egress travel. | Within 3 months |

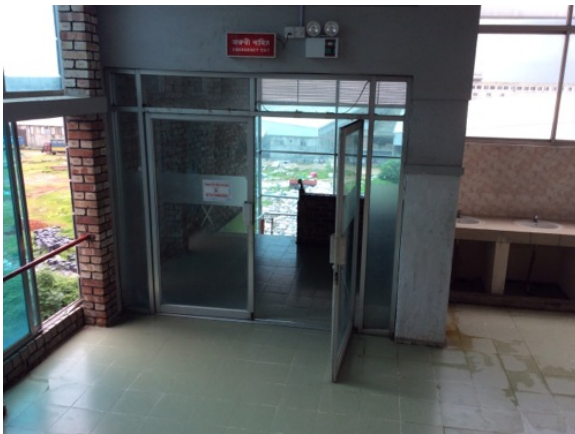
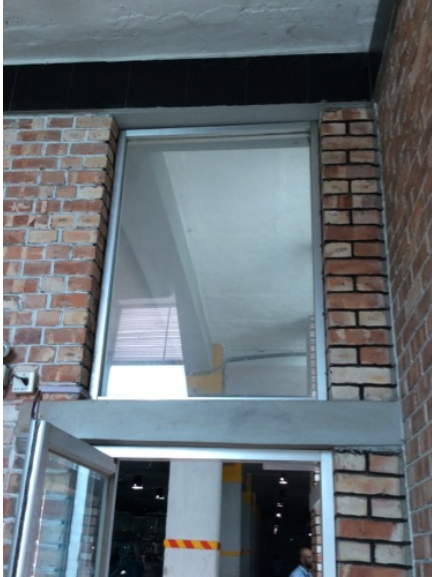
| F-2 | Fire Rated Construction | The exit stairs are not separated from work areas and other spaces on each floor by fire-rated construction. | Provide minimum 1.5-hr fire rated doors and seal all unprotected openings to separate the exit stairs from work areas and other building spaces on all floor levels. Ensure that the fire doors are self-closing and positive latching and that they are provided with fire exit (panic) hardware where serving production floors.<br><br>If fire doors are required to be held open for functional reasons, provide automatic-closing devices tied to the fire alarm system. | Within 3 months |

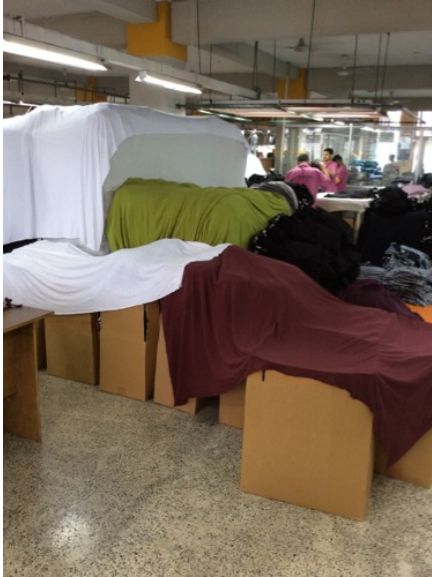
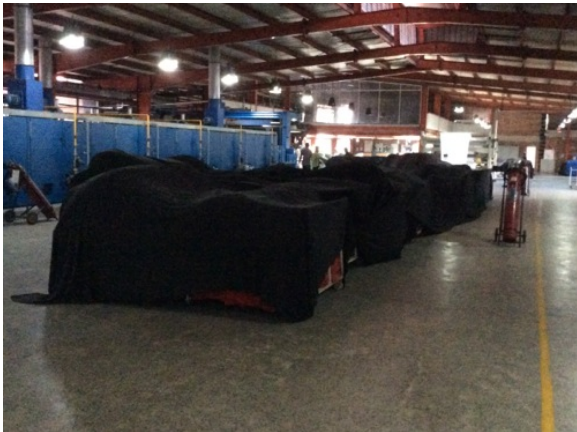
| F-3 | Fire Rated Construction | Areas used for combustible storage, open to the factory floor on the ground, first, and second floors, were not separated by fire-rated construction. | <p>Provide dedicated storage rooms separated by minimum 1-hr fire-rated construction.</p> <p>Where separate storage rooms are not feasible, provide defined storage areas and limit the storage arrangement as follows:</p> <ul style="list-style-type: none"><li>- Maximum height of 2.4m and maximum area of 23m<sup>2</sup></li><li>- If sprinkler protected: maximum height of 3.66m and maximum area of 93m<sup>2</sup></li></ul> <p>Separate areas of unenclosed combustible storage by a minimum clear distance of 3m.</p> | Within 3 months |

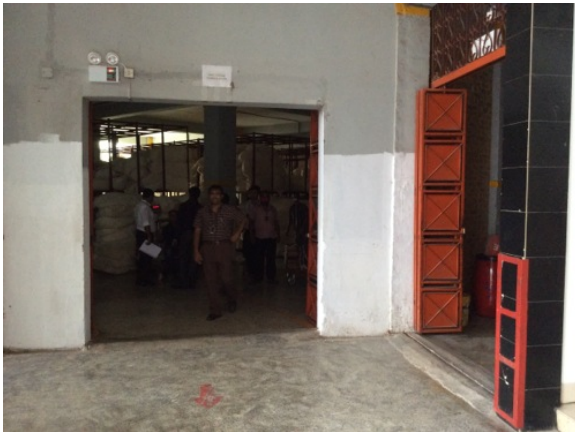
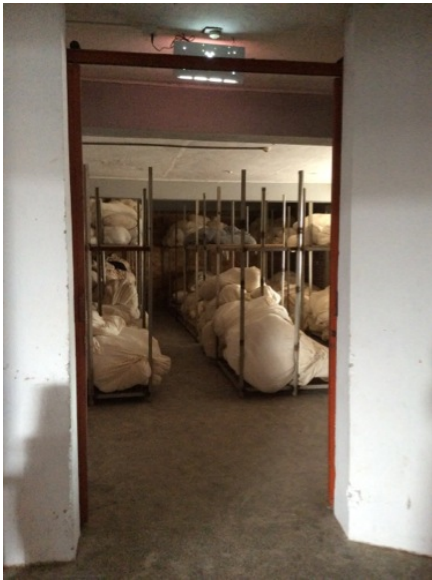
| F-4 | Fire Rated Construction | <p>Rooms used for combustible storage on the ground (engineering store, finished fabrics store), west mezzanine (fabric store), east mezzanine (accessory store), first (fabric store), and second (waste storage room) floors were not separated by fire-rated construction.</p> <p>The entire basement area was dedicated to storage and discharged to all six (6) exit stairs that served the building.</p> | <p>Provide dedicated storage rooms separated by minimum 1-hr fire-rated construction.</p> <p>Provide a 2-hr fire-rated vestibule where a storage room discharges to an exit stair. Provide a 1.5-hr fire door on the exit stair side and a 1-hr fire door on the storage room side.</p> | Within 3 months |

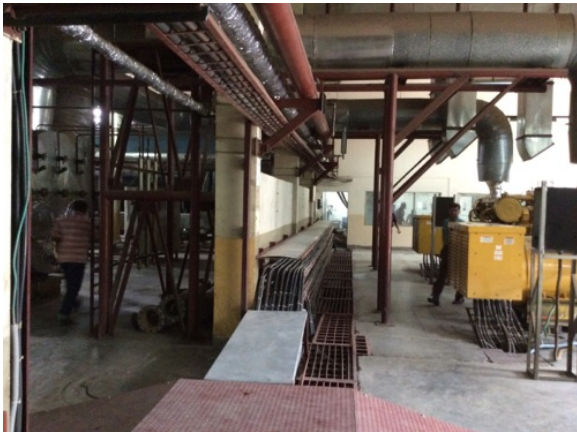
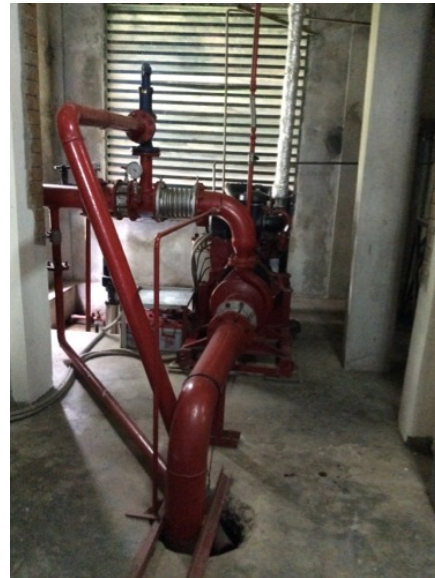
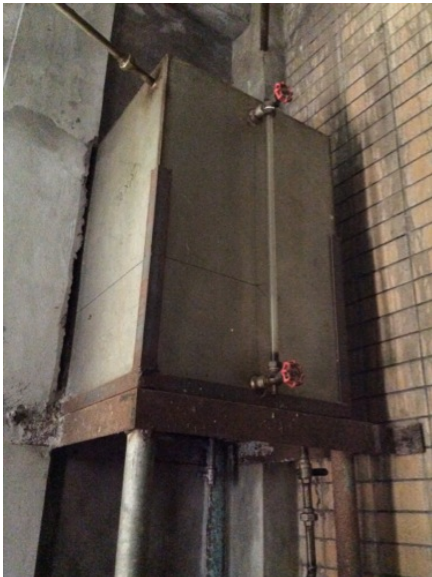
| F-5 | Fire Rated Construction | <p>The boilers and generators located in the separate Building 2 structure and in Building 4 were not separated from each other by fire-rated construction due to openings.</p> <p>Also, the diesel fire pump in Building 4 was not separated from the boilers/generators or the adjacent 1000 L. diesel storage tank.</p> | <p>Separate the boilers, generator, diesel fore pump, and diesel storage tank from each other by a minimum 2-hr fire-rated construction. Seal and/or protected all openings to maintain the required fire separations</p> | Within 3 months |

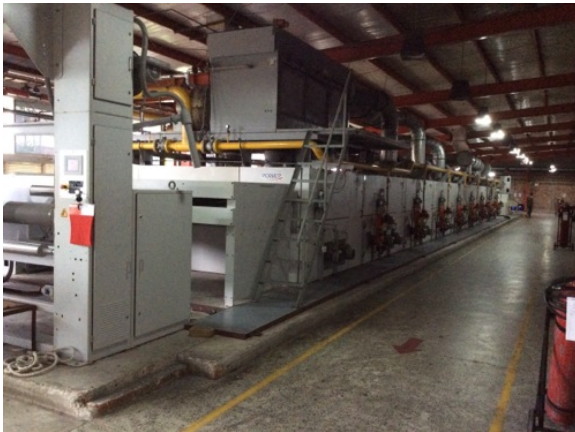
| F-6 | Fire Rated Construction | The two (2) stentor machines on the ground floor in the east shed extension are not separated by fire-rated construction and open to the surrounding factory areas. | Separate the stentor machines by a minimum 2-hr fire-rated construction. Seal and/or protected all openings to maintain the required fire separations | Within 3 months |

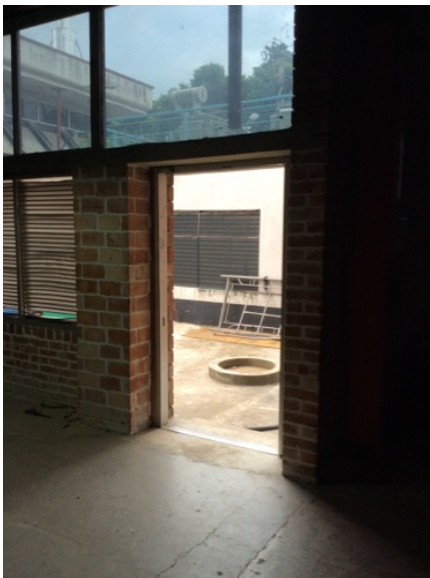
| F-7 | Fire Rated Construction | The exit discharge path serving a north door on the ground floor is less than 10 ft wide and is not separated from the sub station building interior. | Seal all penetrations and openings to the interior of the building along the discharge path, up to a height of 10 ft., to provide a minimum 1-hr fire separation. | Within 6 months |

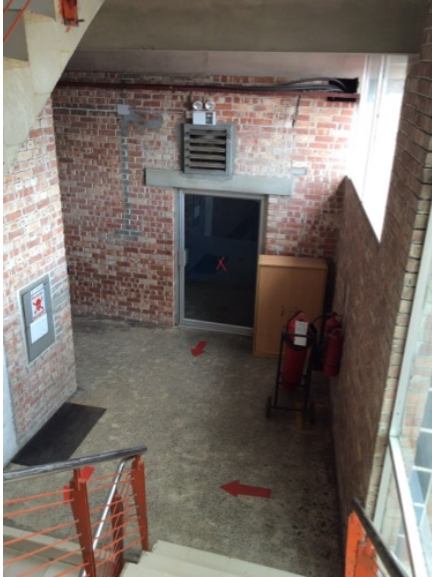
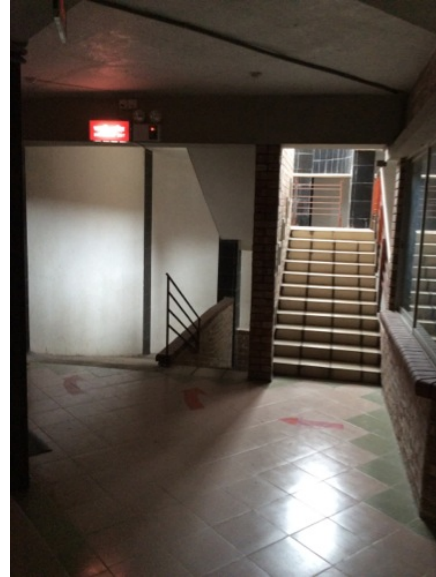
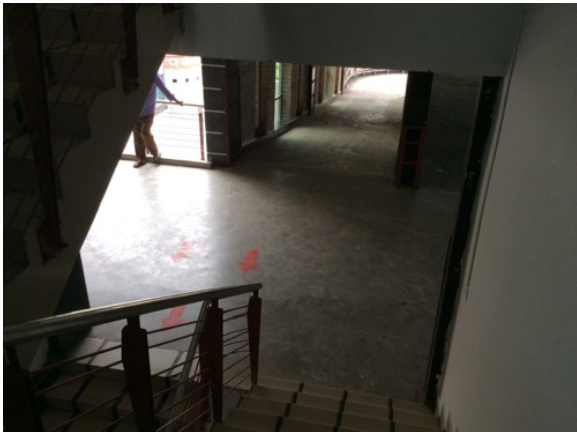
| F-8 | Fire Rated Construction | All exit stairs, excluding the west exit stair, were unenclosed in fire-rated construction on several/all floors | Enclose all exit stairs in 2-hr fire rated construction on all floors. | Within 6 months |

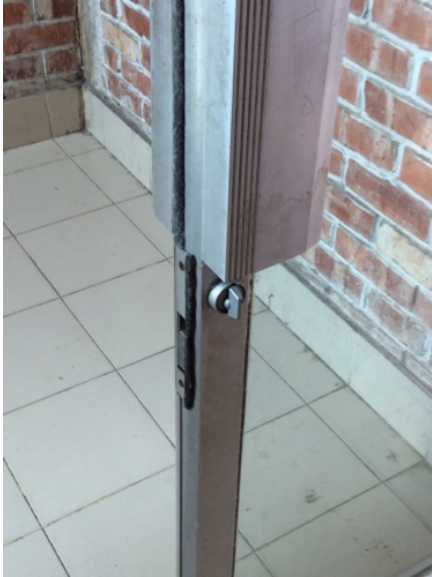
| F-9 | Egress | Egress doors with locking features are provided at building exits and exit stairs. All doors were open and unlocked during the inspection. | Remove locking features from all egress doors.<br><br>If locks are required for security reasons, utilize special door locking features complying with NFPA 101. | Immediate |

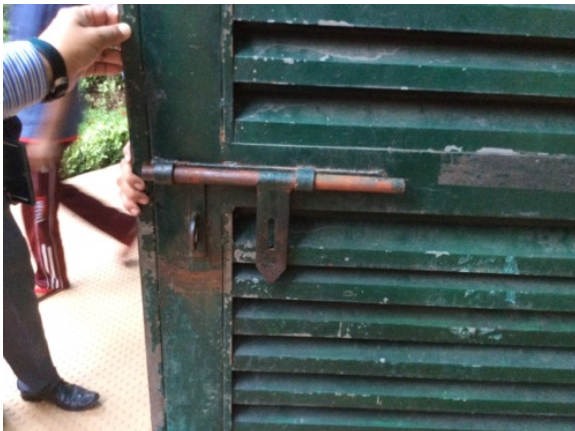
| No. | Category | Finding | Recommendation | Remediation Timeframe |
|---|---|---|---|---|
| F-2 | Egress | Egress doors with locking features are provided at building exits. All doors were open and unlocked during the inspection. | Remove locking features from all egress doors.<br><br>If locks are required for security reasons, utilize special door locking features complying with NFPA 101. | Immediate |

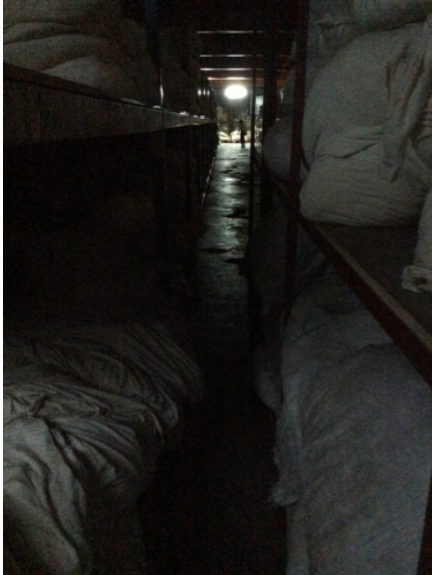
| F-5 | Egress | The width of egress aisles was less than 36-in. in several locations on the first floor. | Provide minimum aisle widths of 36-in. | Within 3 months |

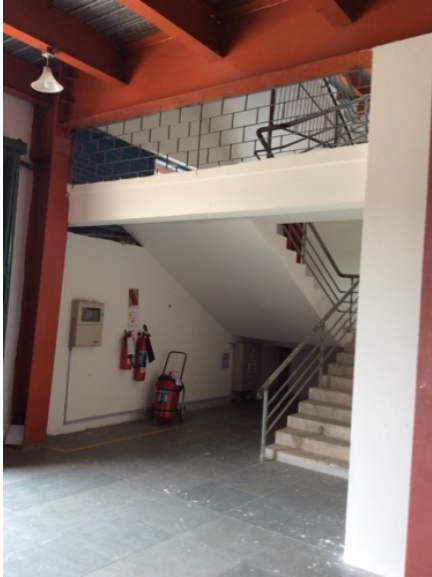
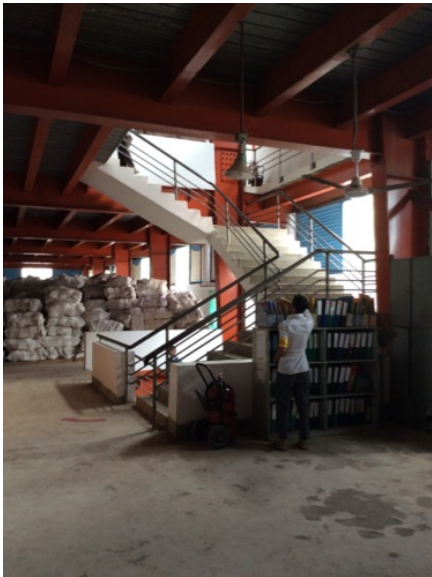
| F-2 | Fire Rated Construction | The interior exit stairs were not enclosed in fire-rated construction on any floor. | Enclose the interior exit stairs in 2-hr fire-rated construction on all floors. | Within 3 months |

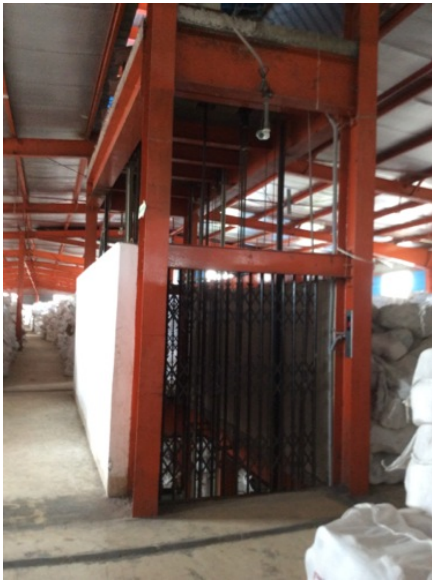
| F-3 | Fire Rated Construction | The elevator serving the ground to second floor was not enclosed in fire-rated construction on any floor. | Enclose the elevator in 2-hr fire rated construction on all floors. | Within 3 months |

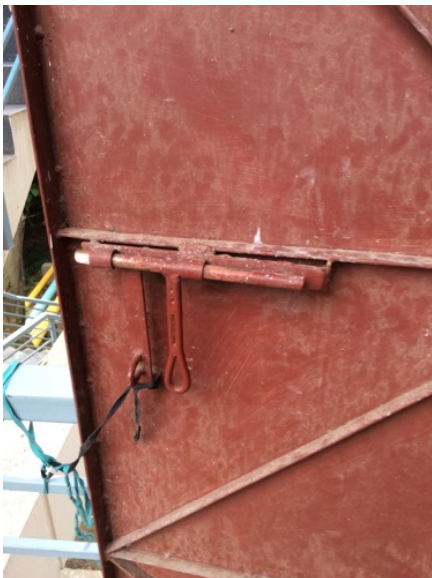
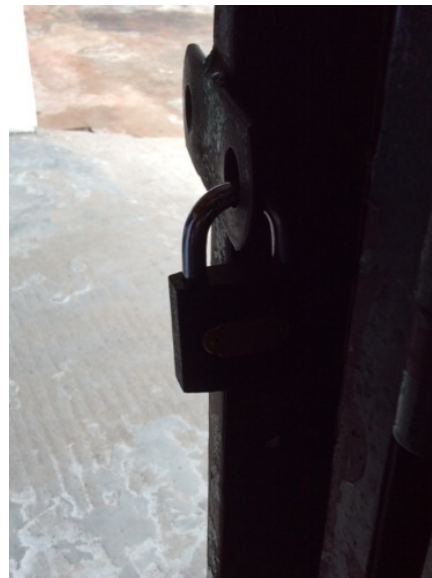
| F-4 | Egress | Egress doors with locking features are provided at building exits. All doors were open and unlocked during the inspection. | Remove locking features from all egress doors.<br><br>If locks are required for security reasons, utilize special door locking features complying with NFPA 101. | Immediate |

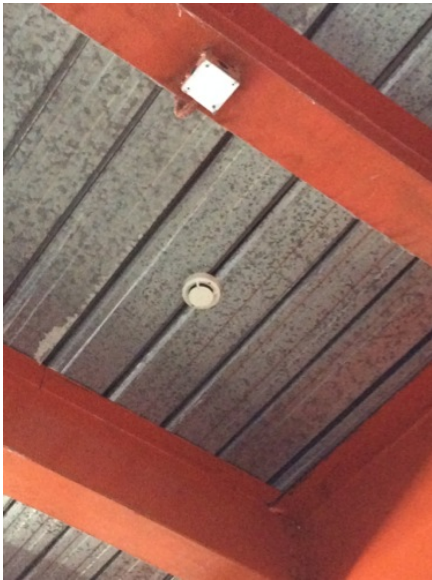
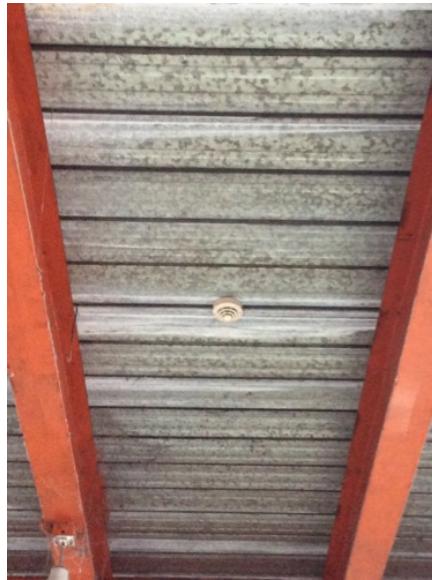
| F-8 | Fire Protection | Based off observations, the existing smoke/heat detectors tied to the fire alarm were not adequately provided. | Based on ceiling configuration, provide additional detectors where needed, and space them in accordance with NFPA 72. | Within 3 months |

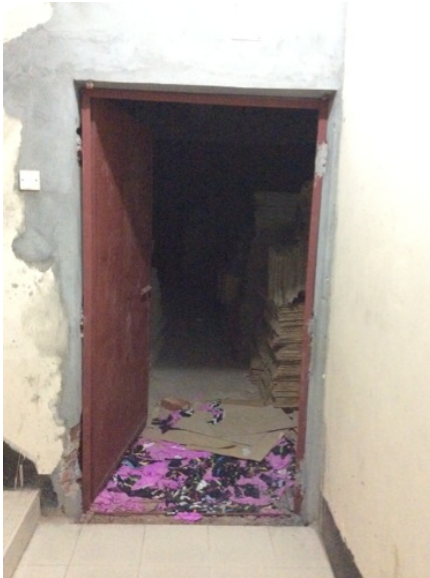
| F-2 | Fire Rated Construction | The Building 7 store room discharges to the west exit stair on the first floor. | Provide a 2-hr fire-rated vestibule from the store room to the west exit stair. Provide a 1.5-hr fire door on the exit stair side and a 1-hr fire door on the store room side.<br><br>Alternately, seal the door with 2-hr fire rated construction. | Within 3 months |

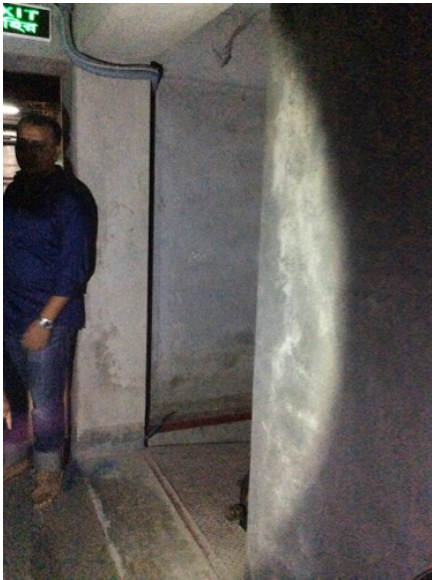
| F-3 | Fire Rated Construction | The exit discharge path serving the ground floor west building exit is less than 10 ft wide and is not separated from the Building 7 pump house. | Seal all penetrations and openings to the interior of Building 7 along the discharge path, up to a height of 10 ft., to provide a minimum 1-hr fire separation. Provide access to the pump house by an alternate means.<br><br>Alternately, provide a 1-hr fire door to the pump house. | Within 6 months |

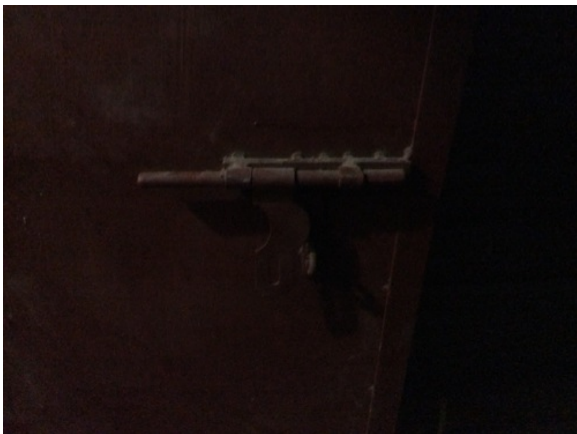
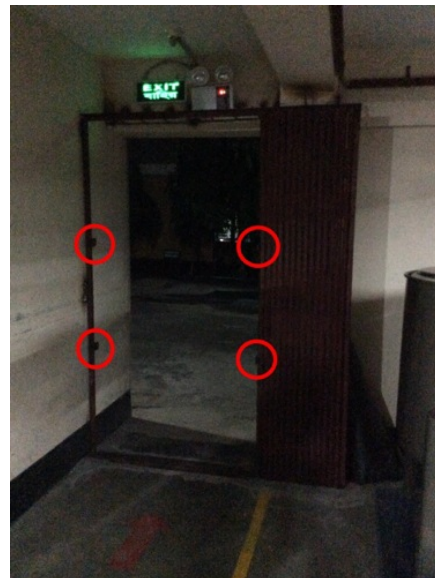
| F-4 | Egress | Egress doors with locking features are provided along egress routes and at building exits. All doors were open and unlocked during the inspection. | Remove locking features from all egress doors.<br><br>If locks are required for security reasons, utilize special door locking features complying with NFPA 101. | Immediate |

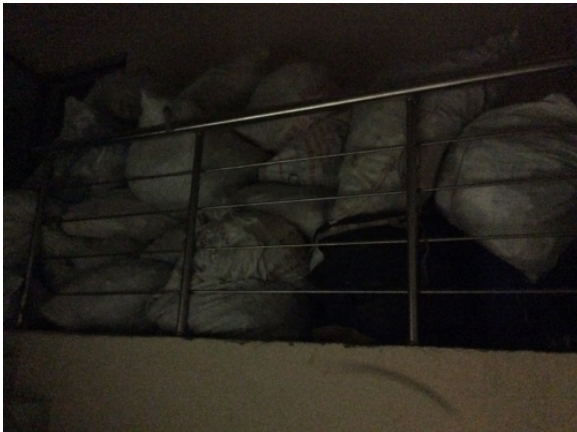
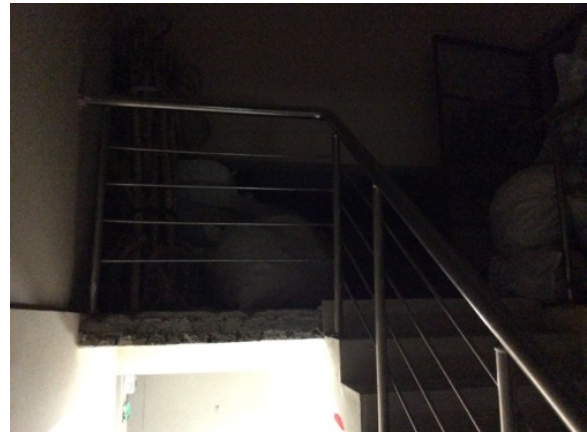
| F-5 | Egress | Storage was located in the east exit stair at roof level. | Remove all storage from exit stairs and egress paths. | Immediate |

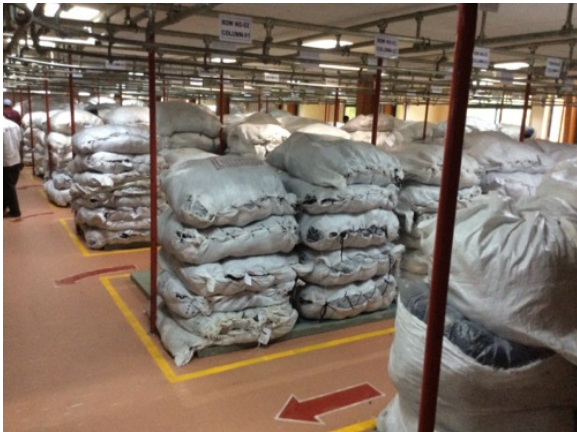
| No. | Category | Finding | Recommendation | Remediation Timeframe |
|---|---|---|---|---|
| F-1 | Fire Rated Construction | Areas used for combustible storage, open to the factory floor, were not separated by fire-rated construction. | <p>Provide dedicated storage rooms separated by minimum 1-hr fire-rated construction.</p> <p>Where separate storage rooms are not feasible, provide defined storage areas and limit the storage arrangement as follows:</p> <ul style="list-style-type: none"> <li>- Maximum height of 2.4m and maximum area of 23m<sup>2</sup></li> <li>- If sprinkler protected: maximum height of 3.66m and maximum area of 93m<sup>2</sup></li> </ul> <p>Separate areas of unenclosed combustible storage by a minimum clear distance of 3m.</p> | Within 3 months |

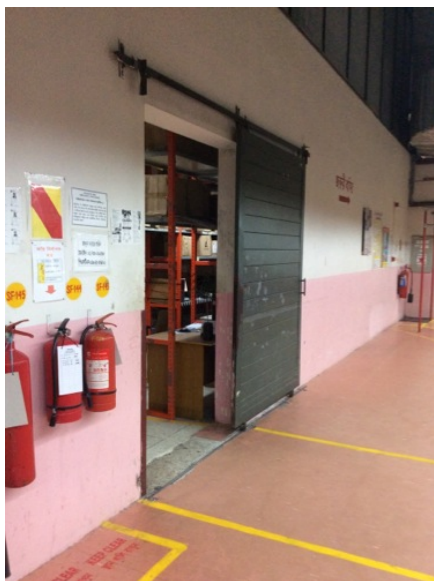
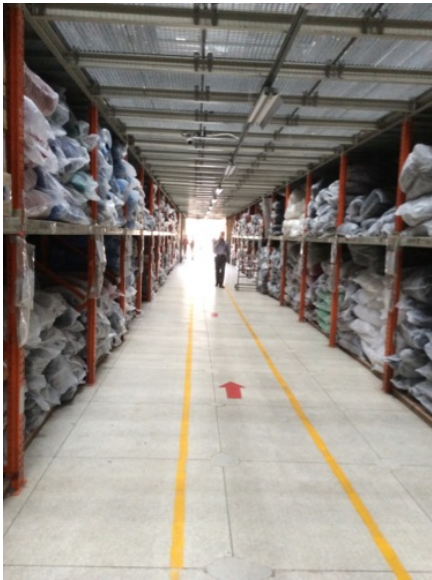
| F-2 | Fire Rated Construction | The entire finished fabrics and accessory store (ground and top two (2) mezzanines) was a room used for combustible storage and was not separated by fire-rated construction. | Provide dedicated storage rooms separated by minimum 1-hr fire-rated construction. | Within 3 months |

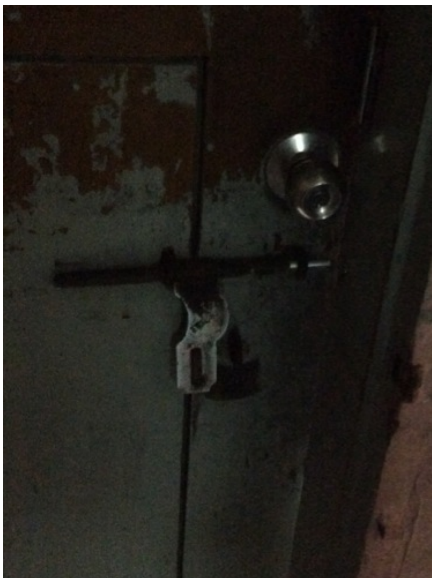
| F-3 | Egress | Egress doors with locking features are provided at building exits and along egress routes. All doors were open and unlocked during the inspection. | Remove locking features from all egress doors.<br><br>If locks are required for security reasons, utilize special door locking features complying with NFPA 101. | Immediate |

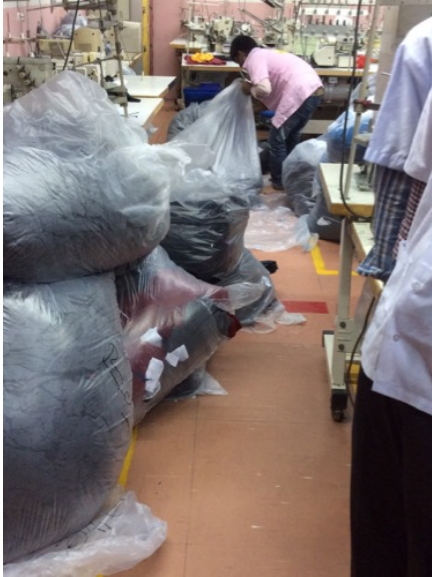
| F-4 | Egress | Storage was located in a egress path on the ground floor. | Keep egress paths and stairs clear of storage. | Immediate |

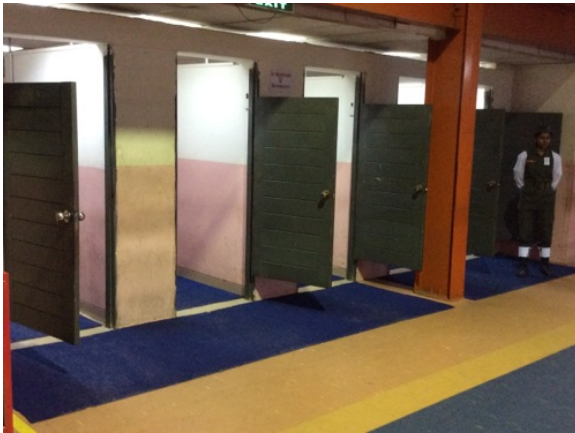
| F-7 | Egress | Both male and female general entrance doors (5 per each entrance) do not swing in the direction of egress travel. | Modify the egress door to swing in the direction of egress travel. | Within 3 months |

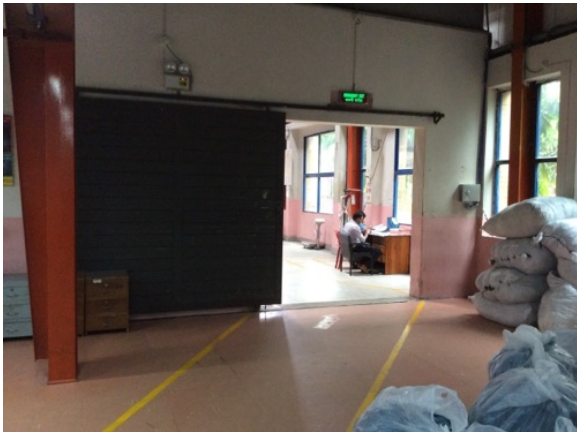
| F-8 | Egress | A required exit from the cutting room passes through the finished fabrics and accessory store. | Provide an 2-hr fire-rated exit passageway through to finished fabrics and accessory store to the exterior building discharge.<br><br>Alternately, provide a separate remote exit from the cutting room. | Within 3 months |

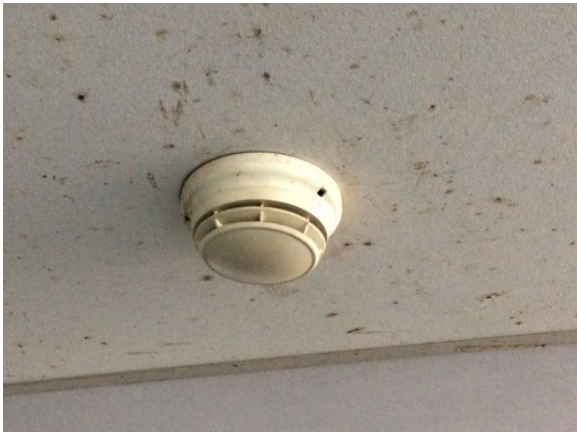
| F-10 | Fire Protection | Based off observations, the existing smoke detectors tied to the fire alarm were not adequately provided. Only single station smoke alarms were provided on the main factory floor. | Based on ceiling configuration, provide additional detectors where needed, and space them in accordance with NFPA 72. | Within 3 months |

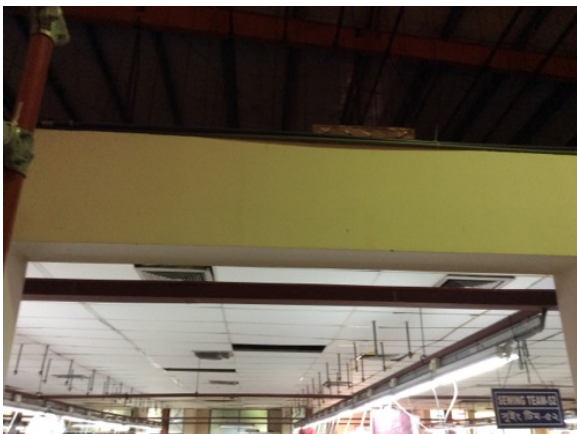
| F-12 | Egress Lighting | A lighted exit sign to the sewing floor line 50-55 was not provided. | Provide exit signs above all exits to the exterior and all doors to the exit stairs. | Within 1 month |

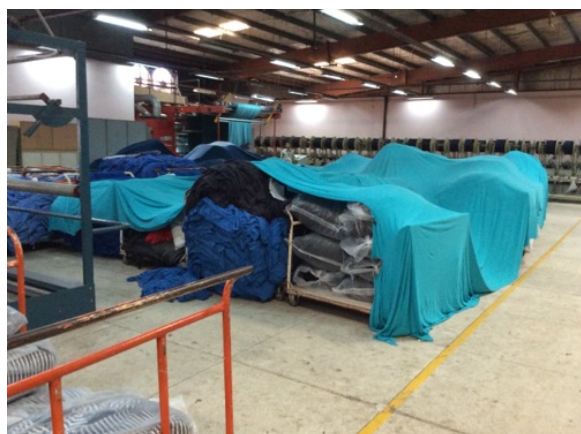
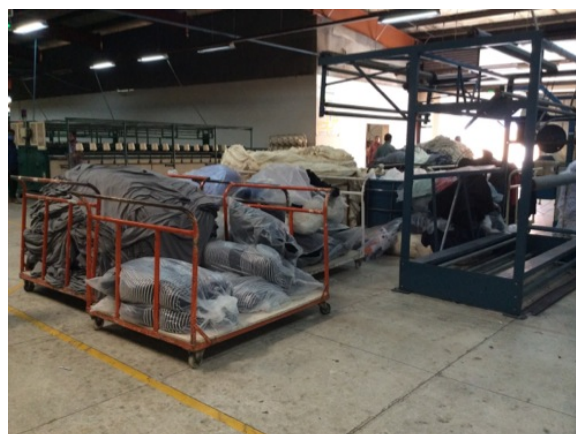
| No. | Category | Finding | Recommendation | Remediation Timeframe |
|---|---|---|---|---|
| F-1 | Fire Rated Construction | Areas used for combustible storage, open to the factory on the ground floor, were not separated by fire-rated construction. | <p>Provide dedicated storage rooms separated by minimum 1-hr fire-rated construction.</p> <p>Where separate storage rooms are not feasible, provide defined storage areas and limit the storage arrangement as follows:</p> <ul style="list-style-type: none"> <li>- Maximum height of 2.4m and maximum area of 23m<sup>2</sup></li> <li>- If sprinkler protected: maximum height of 3.66m and maximum area of 93m<sup>2</sup></li> </ul> <p>Separate areas of unenclosed combustible storage by a minimum clear distance of 3m.</p> | Within 3 months |

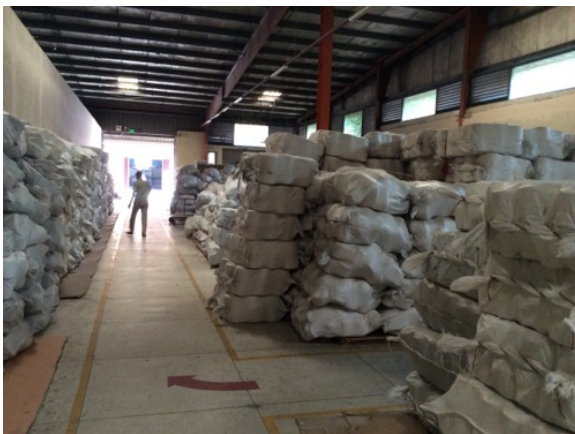
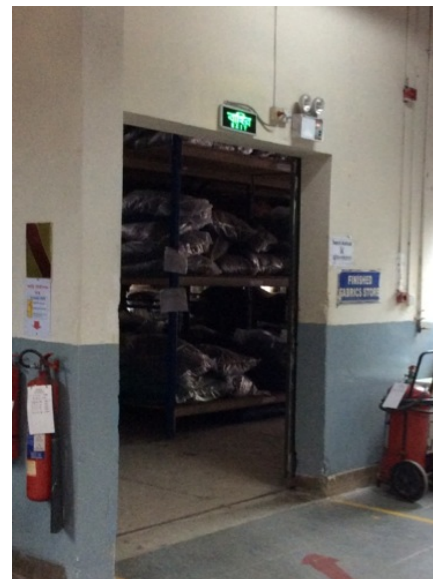
| F-2 | Fire Rated Construction | Rooms used for combustible storage on the ground floor (finished fabrics store, yarn store/chemical store) were not separated by fire-rated construction. | Provide dedicated storage rooms separated by minimum 1-hr fire-rated construction.<br><br>The chemical store does not need to be separated since access to the room is through the yarn store. | Within 3 months |

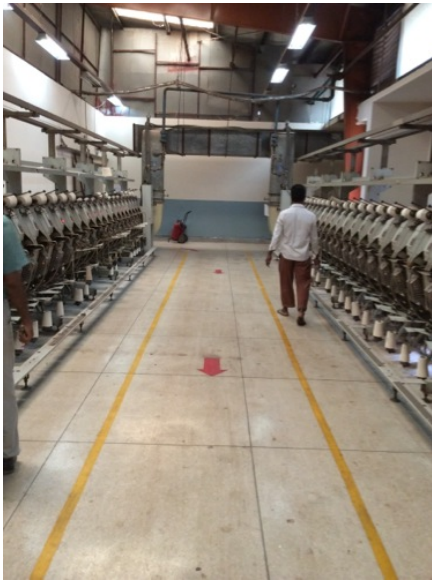
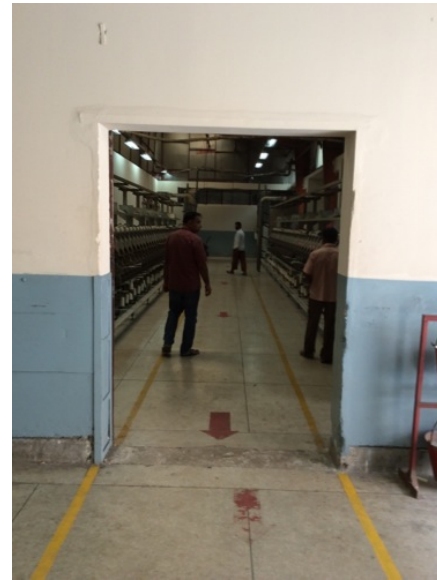
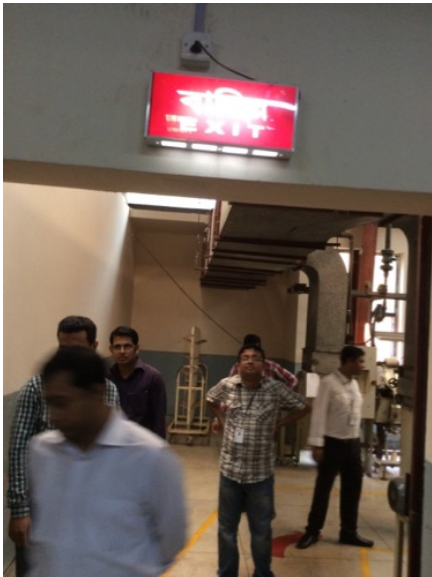
| F-3 | Fire Rated Construction | The yarn singeing operation room is not separated by fire-rated construction due to unprotected openings. The room is also provided with an exit sign above one of the two (2) doors that provide access to the room. | Separate the yarn singeing operation room by a minimum 2-hr fire-rated construction. Seal and/or protected all openings to maintain the required fire separations.<br><br>Remove the exit sign above the entrance to the yarn singeing operation room. | Within 3 months |

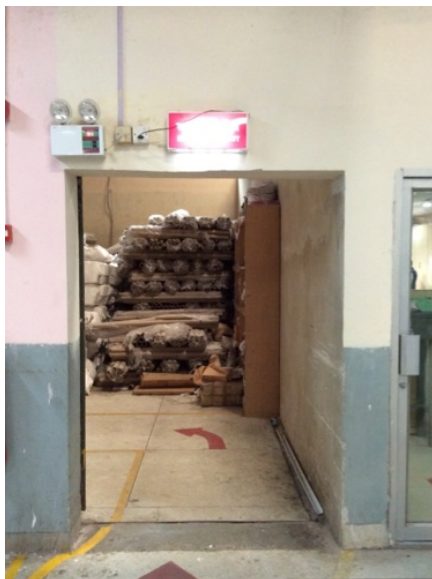
| F-7 | Egress | Exit signs were provided above the entrances to the finished fabrics store and the yarn store. Both of these rooms were dedicated storage rooms. | <p>Provide 2-hr fire-rated exit passageways through the storage rooms to the exterior exit discharge.</p> <p>Alternately, remove the exit signs above the entrances to the storage rooms. Ensure that the exit capacity for the building is still adequate and that travel distance is not exceeded.</p> | Within 3 months |

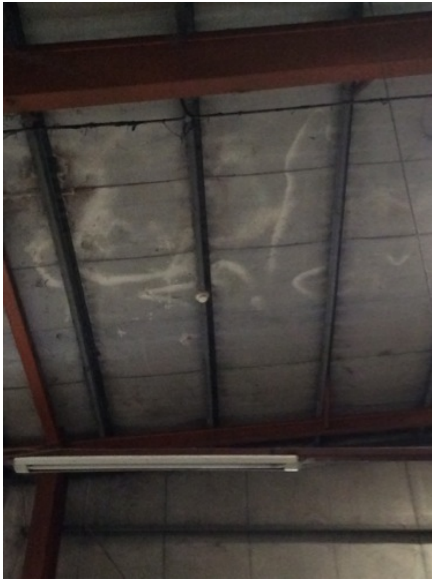
| F-9 | Fire Protection | Based off observations, the existing smoke detectors tied to the fire alarm were not adequately provided. | Based on ceiling configuration, provide additional detectors where needed, and space them in accordance with NFPA 72. | Within 3 months |

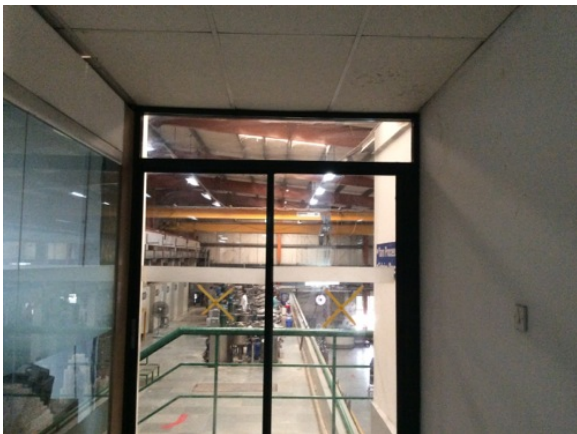
| F-10 | Egress Lighting | A lighted exit sign was not provided from the west mezzanine office area. | Provide exit signs above all exits to the exterior and all doors to the exit stairs. | Within 1 month |

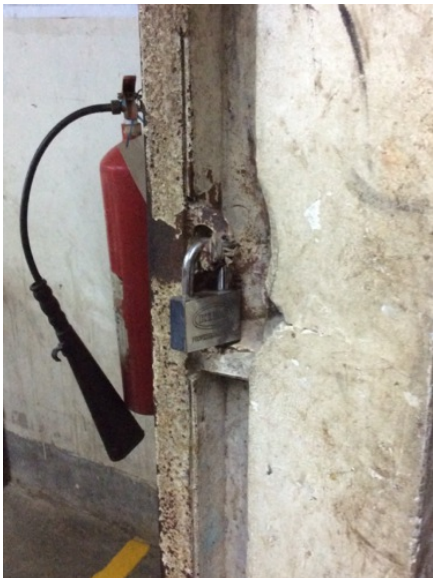
| No. | Category | Finding | Recommendation | Remediation Timeframe |
|---|---|---|---|---|
| F-1 | Egress | Egress doors with locking features are provided at building exits. | <p>Remove locking features from all egress doors.</p> <p>If locks are required for security reasons, utilize special door locking features complying with NFPA 101.</p> | Immediate |

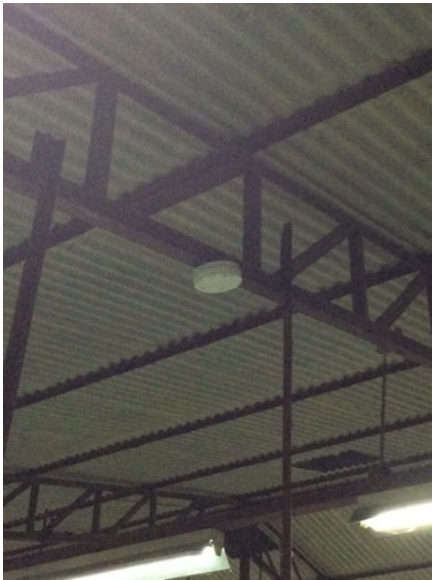
| F-4 | Fire Protection | The building is equipped with single-station smoke alarms. Smoke alarm activation sounds only a local alarm and does not provide automatic fire alarm notification of occupants. | Remove single-station smoke alarms. Provide automatic smoke detection throughout the building, tied into the fire alarm system, in accordance with NFPA 72. | Within 6 months |

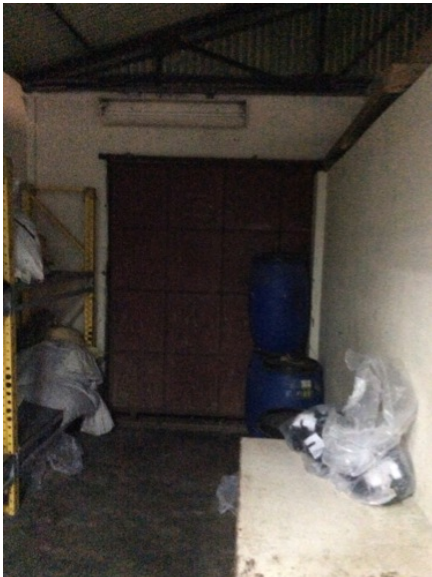
| F-5 | Egress Lighting | A lighted exit sign was not provided to the north building exit. | Provide exit signs above all exits to the exterior and all doors to the exit stairs. | Within 1 month |
