Muazuddin Textile Ltd. (9998)

Plot # 235/236, East Chandura, Shafipur, Kaliakor, Gazipur

12.APRIL.2014

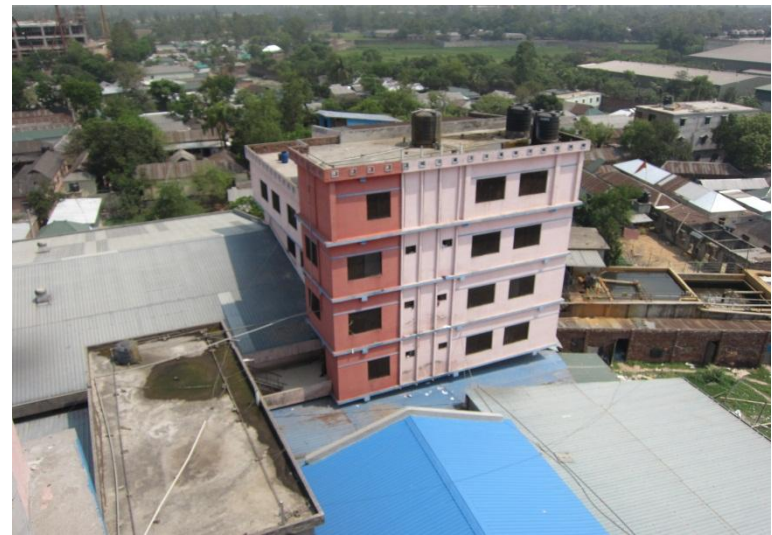
Water ingress

Evidence of water ingress was found. Some areas have mould. These may lead to deterioration and/or spalling of concrete in the future.

- For both serviceability and durability, it's recommended to repair the ingresses found with suitable methods.
- After repairing, suitable waterproofing material should be applied.
