Silken Sewing Ltd - New building

Baniar Chala (Member Bari), Vobanipur, Gazipur

13th February, 2017

Observations

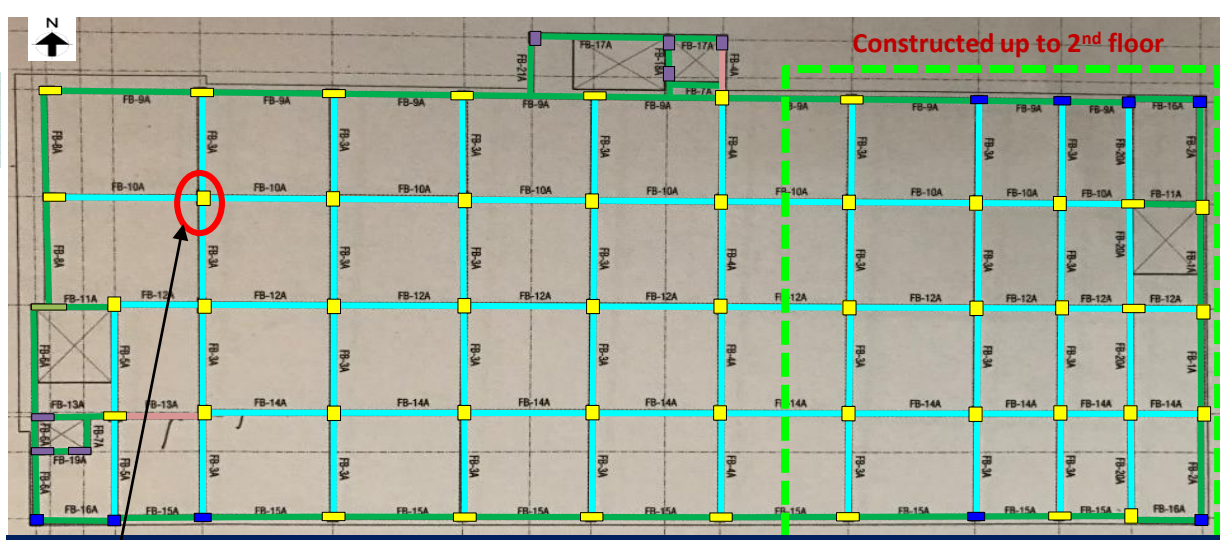
Typical Beam Column Layout

Found 12-20mm dia rebar in C-16 column on roof top but in column schedule, the rebar was different

Found 7 nos. and 8 nos. re-bars on first floor instead of 9 bars in column schedule of C-16 on long direction of column

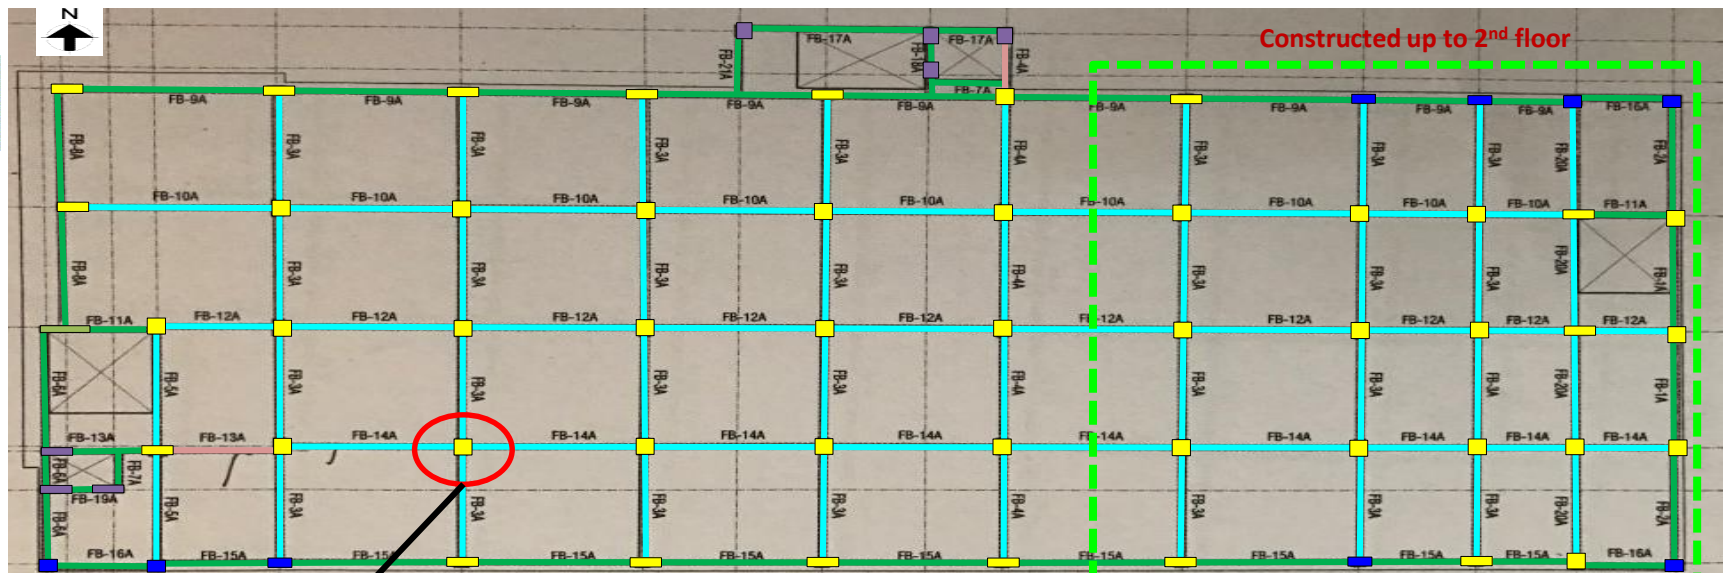
Typical Beam Column Layout

Found 6nos. rebar in C-15 column at one face on 1st floor but in column schedule, the rebar was shown 7nos.

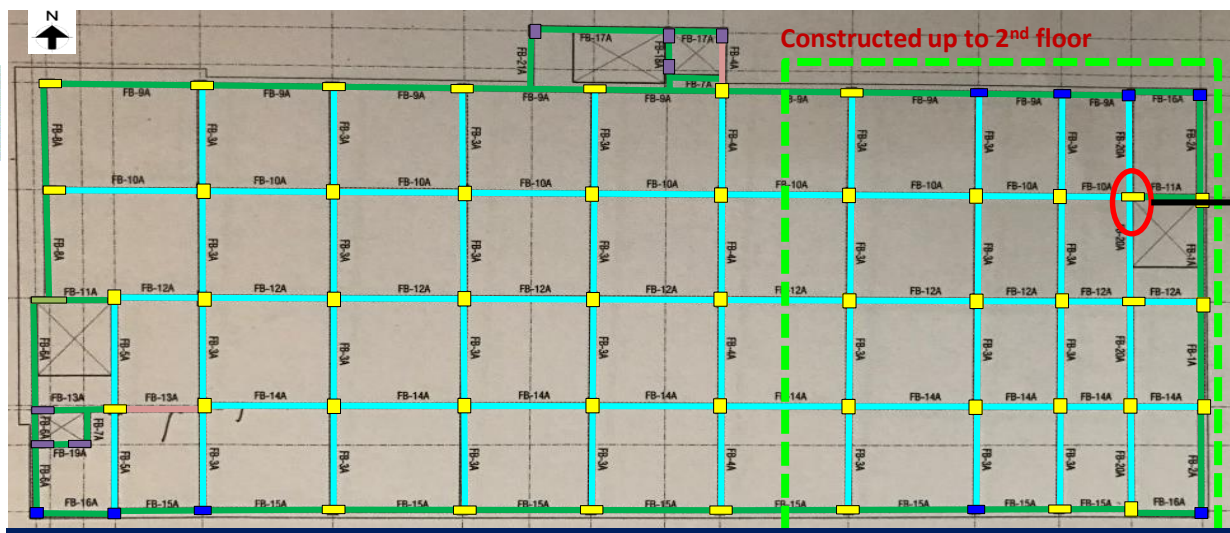
Typical Beam Column Layout

C-12 column at 1st floor on stair case

C-12 column size found different in stair case but according to provided column schedule, the size of column was shown same on Ground floor to roof top.

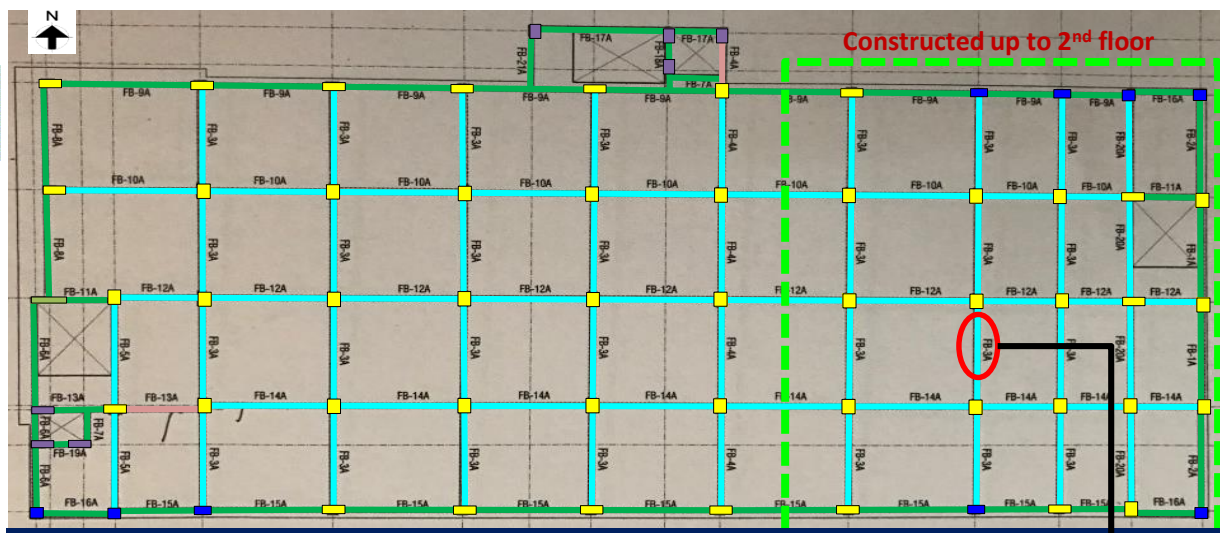
Typical Beam Column Layout

The reinforcements in FB-3A was found less than in provided drawing

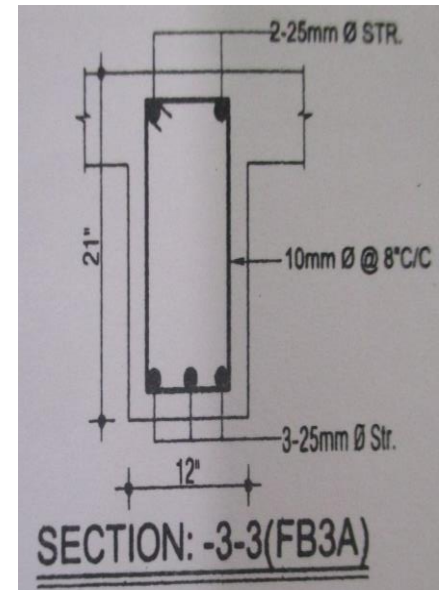
In provided drawing, the FB-3A beam has 6-25mm rebar as top bar and 3-25mm rebar as bottom bar

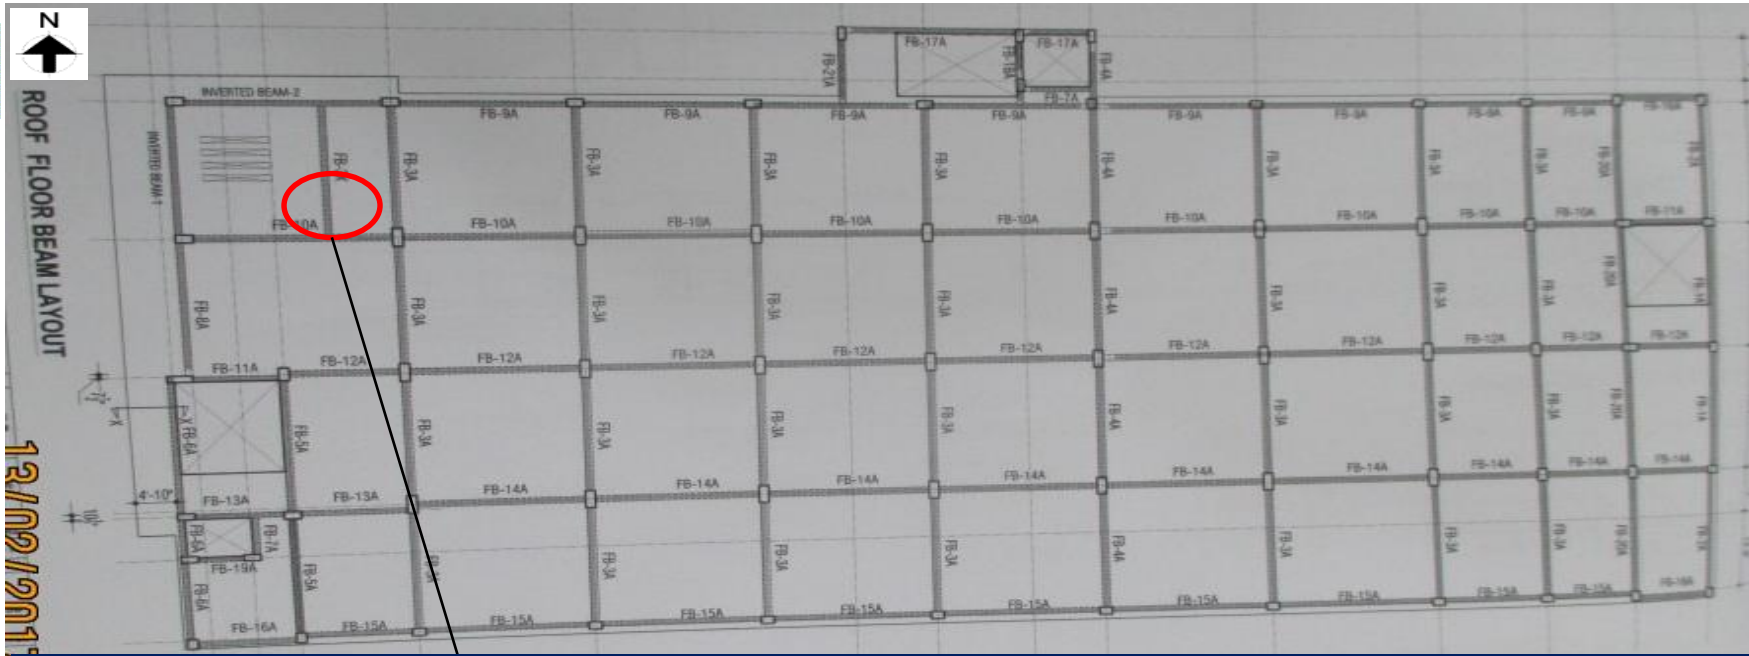
5th floor Beam Column Layout

Crack observed on the joint of two beam

Item No.	Observation	Recommended Action Plan	Recommended Timeline
1	Inconsistent and missing documents	Engage a Building Engineer to survey the structure and update a full set of “as-constructed” drawings	6-weeks
2	Appearance Hairline crack observed on beams	Engage a Building Engineer to investigate if cracks penetrate the building structure.	6-weeks
3	Appearance Hairline crack observed on beams	Building Engineer to carry out design check on beam to confirm that these cracks are non-structural.	6-weeks
4	Appearance Hairline crack observed on beams	Carry out remedial works resulting from engineering assessment if necessary.	6-months
