# Tusuka Jeans Ltd. (Unit-2)

Konabari, Neelnagar, Gazipur  
(24.0108529N,90.3245044E)

18<sup>th</sup> January 2017

# Observation

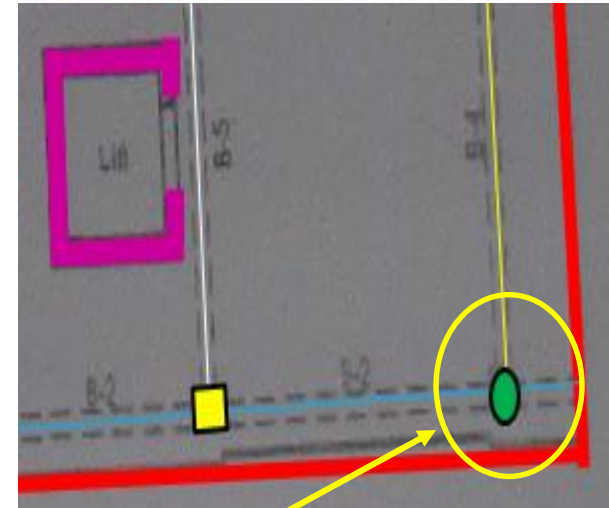
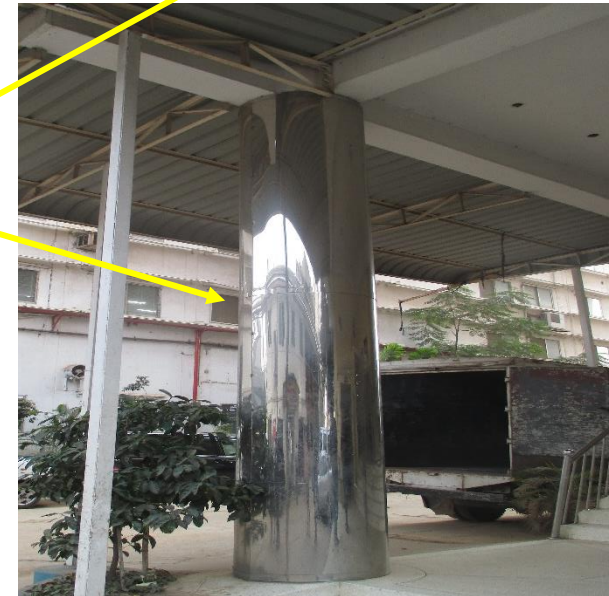
**Discrepancy between provided drawing and as constructed condition**

Grid dimension varies at north most bay. The dimension didn't match with the provided drawing. The length of the grid decreases from west to east direction.

| Item No. | Observation | Recommended Action Plan | Recommended Timeline |
|---|---|---|---|
| 1 | Discrepancy between provided drawing and as constructed condition | Produce accurate as built documentation reflecting existing condition | 6-weeks |
