# Hams Garments Ltd (extension)

South Vangnahati, Chapilapara, Sreepur  
(24.194313N, 90.452568E)

11<sup>th</sup> January, 2017

# **Discrepancy between drawing and as-built condition**

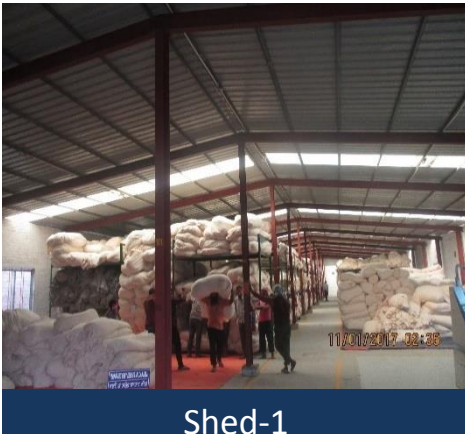
Shed-1

**Sheds appeared to be non engineered**

Connection in column-rafter joint and bracing-column joint appeared to be inadequate. Lateral stability in the long direction is provided by vertical bracing in the two end bay (red circle in the layout) which is appeared to be inadequate. Moreover, no horizontal bracing was observed in roof. Factory engineer has to check the lateral stability and adequacy of the connections.
