Life Textile (Pvt) Ltd. (10140)

69,70,71 Bscic Industrial Estate, Konabari, Gazipur

15.APRIL.2014

ACCORD
on Fire and Building Safety in Bangladesh

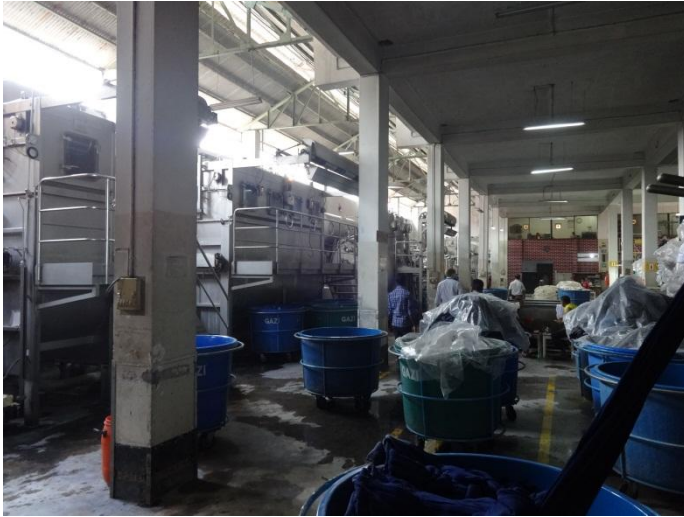
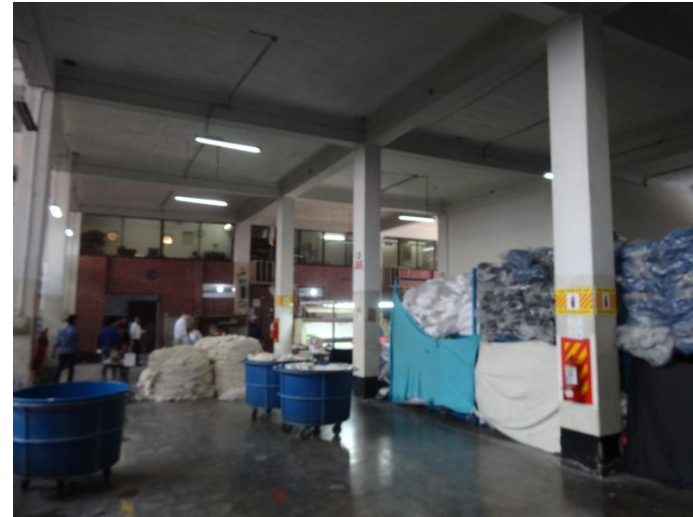
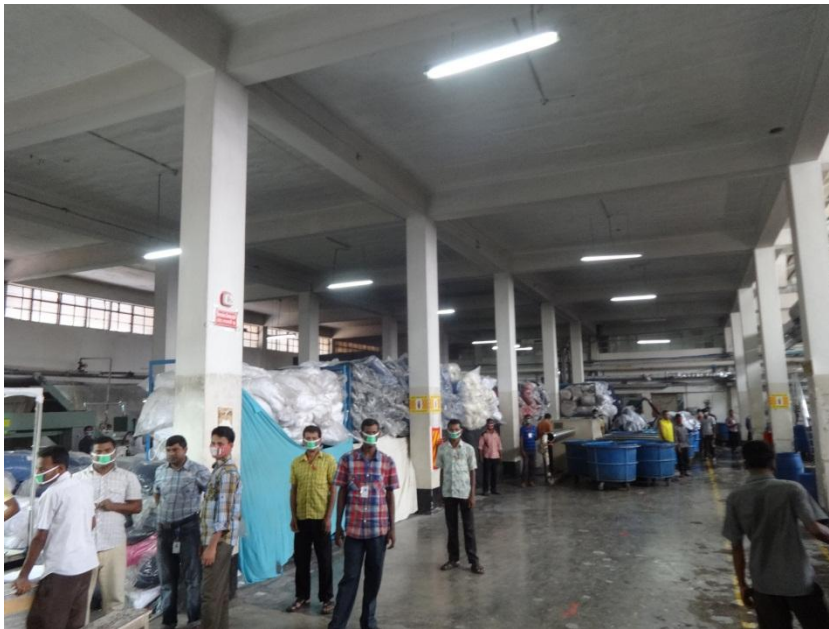
Priority 1 Concern

The central columns are significantly overloaded and have a factor of safety less than 1.25.

- ITEM 1: The interior columns are overloaded.**
- ITEM 2: The existing structural drawings do not match the building.**
- ITEM 3: Toilet block at SE corner showed signs of excessive slab deflection and seems inadequately designed (additionally type of construction was not shown on the structural drawings).**
- ITEM 4: Cracks observed in the beams and slabs.**
- ITEM 5: Materials lift is in a deteriorated condition and is inadequately designed and detailed.**
- ITEM 6: New steel staircase at roof improperly anchored to slab.**
- ITEM 7: A large concrete up-stand at the 1st floor not shown on structural drawings.**

- The interior columns are overloaded and therefore we recommend the 4th, 5th, 6th, and roof slabs be evacuated and all imposed loading is removed down to 0 kPa.
