# K.C Bottom & Shirt Wear Company

K. C. Industrial Park, Ratuti, Katchkura, Uttarkhan, Uttara, Dhaka District.  
(23.859153N, 90.465239E)  
12<sup>th</sup> February 2017

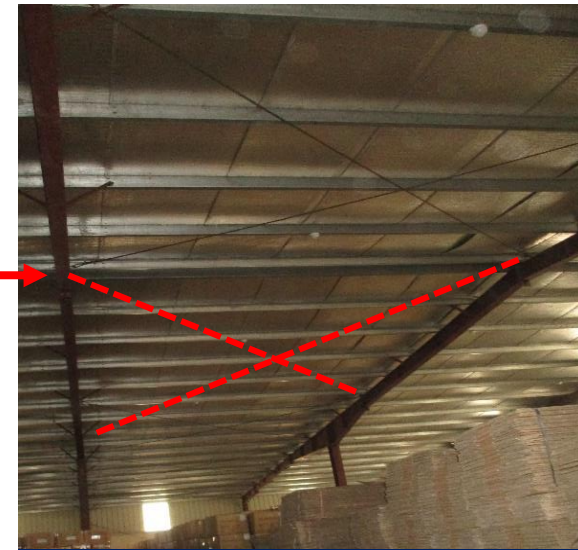
Steel roof

# loose and missing bracings

Vertical bracing are missing in highlighted area and some of the horizontal bracings are appeared to be loosely installed. Sagging of bracings was also observed in the horizontal bracing. Factory to install missing bracing and tighten all loose bracing according to the suggestion by the factory engineer.

| Item No. | Observation | Recommended Action Plan | Recommended Timeline |
|---|---|---|---|
| 2 | loose and missing bracings | Factory to install missing bracing and tighten all loose bracing according to the suggestion by the factory engineer. | 6-weeks |
