**Sumi Apparels (Pvt) Ltd. #9920**  
**Disari Poly Print & Packaging Ind. Ltd.**  
**Disari Washing Plant**

A-112, 113, (West side) BSCIC, Tongi, Gazipur  
(+23.895039N, 90.414413E)

17.APRIL.2014

## Identified Priority 1 Concerns

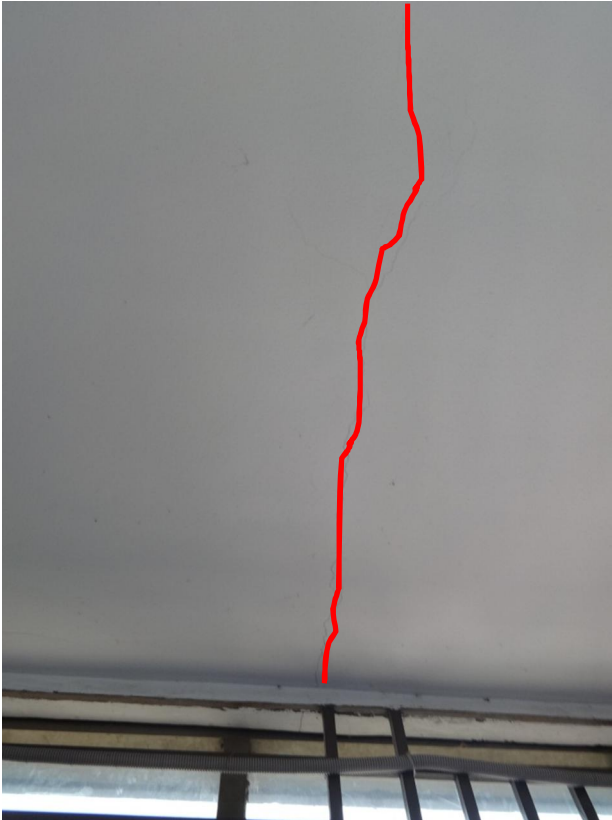
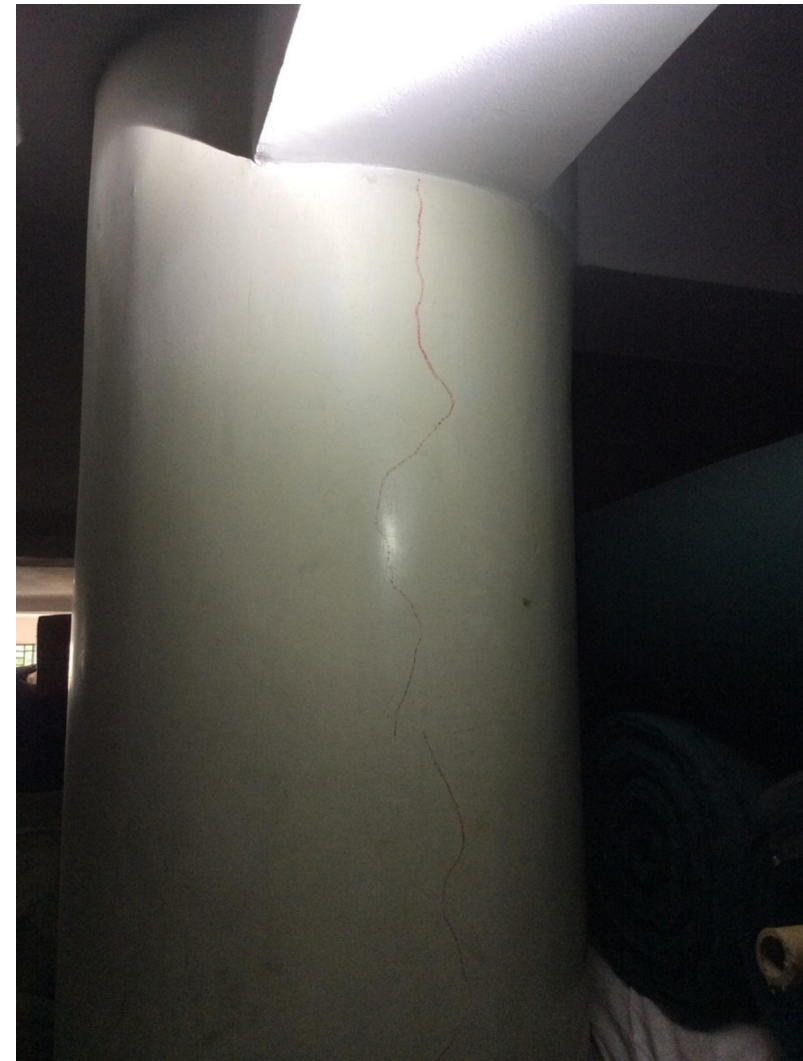
3<sup>rd</sup> Priority 1 Concern

Cracking in beams, slabs and one isolated crack in column. Cracks are shown in red for clarity

Hairline to small cracking was observed in the slabs and beams on several floors. One isolated vertical hairline crack was observed on a 1<sup>st</sup> storey mezzanine column extending from slab to slab.

- Engineering assessment be carried out to determine the cause of the cracks.

- Remedial work be carried as required to repair cracking.
