INTERFAB SHIRT MFG CO. (10041)

302/547, Gasa Union Road, Gazipur
(+23.933525N, 90.387314E)
25 March 2014

Site Observations

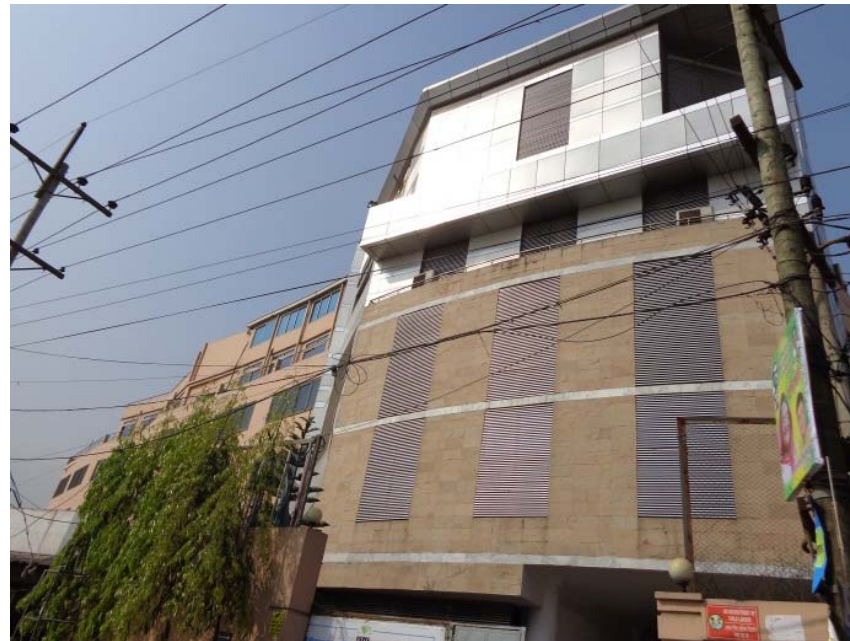
No apparent water proofing on roof

Priority 3 Concern

No waterproofing membrane was visible on the roof of the building. This means that any cracks in the surface finishes on the roof will allow water to seep into the concrete slab beneath the finishes, and cause long-term soaking of the slab.

Roof Floor does not appear to have any waterproof membrane to protect lower floor from water damage
