# Jerat Shirt Limited

Plot - 188/189, Nasirabad I/A, Baizid, Chittagong.  
(22.387914N, 91.812415E)  
9<sup>th</sup> March 2017

# Observations

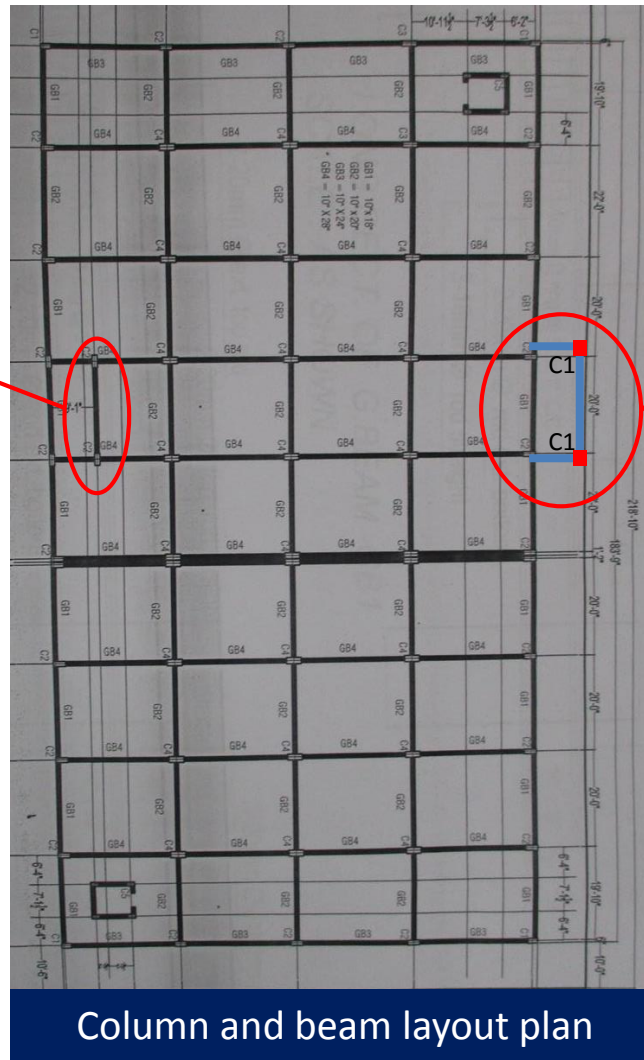
Column and beam layout plan

Additional stair columns

Two number of columns with beam at south side stair were not shown in drawing. Again, two additional columns with a beam were shown in drawings but not found on site. factory engineer to survey the structure and update the as-built drawings.

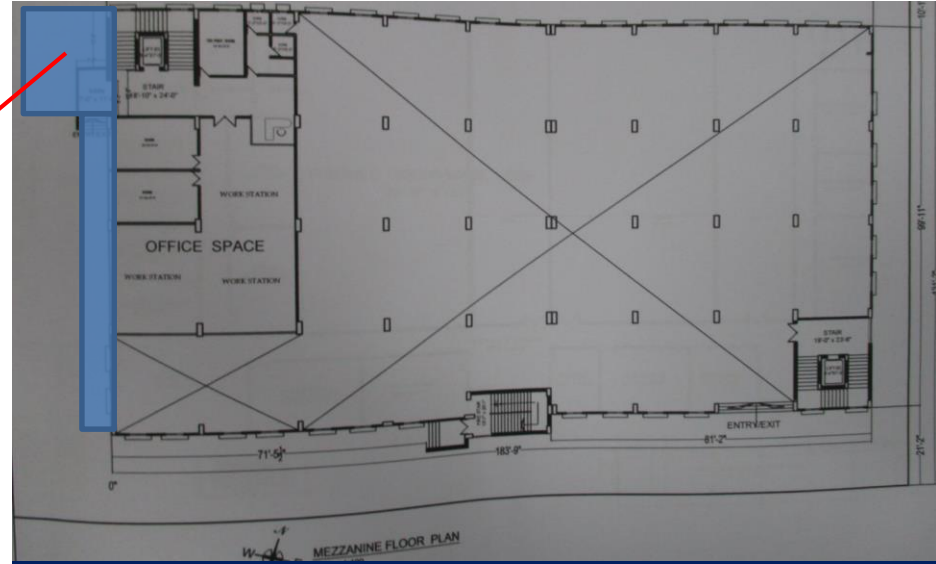
Floor layout plan

The porch and the cantilever beam and slab not shown in as-built drawings.

Provided as-built drawing does not matched with as-built conditions. Floor built-up, roof top water tanks, cantilever slab, porch and some internal partition walls were not mentioned in as-built drawings. Factory engineer to update the as-built drawings as per actual scenario.

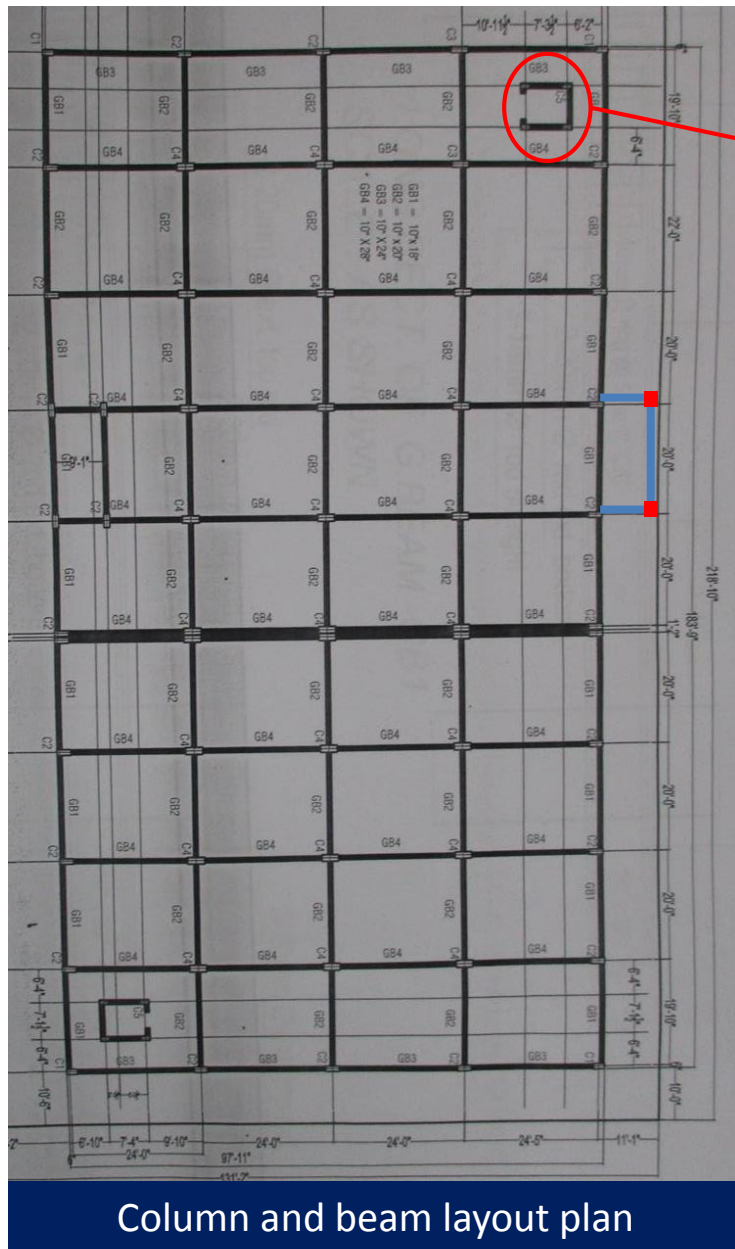
Column and beam layout plan

10 numbers of rebar were found inside for the column C5 where drawing shows 12 numbers.

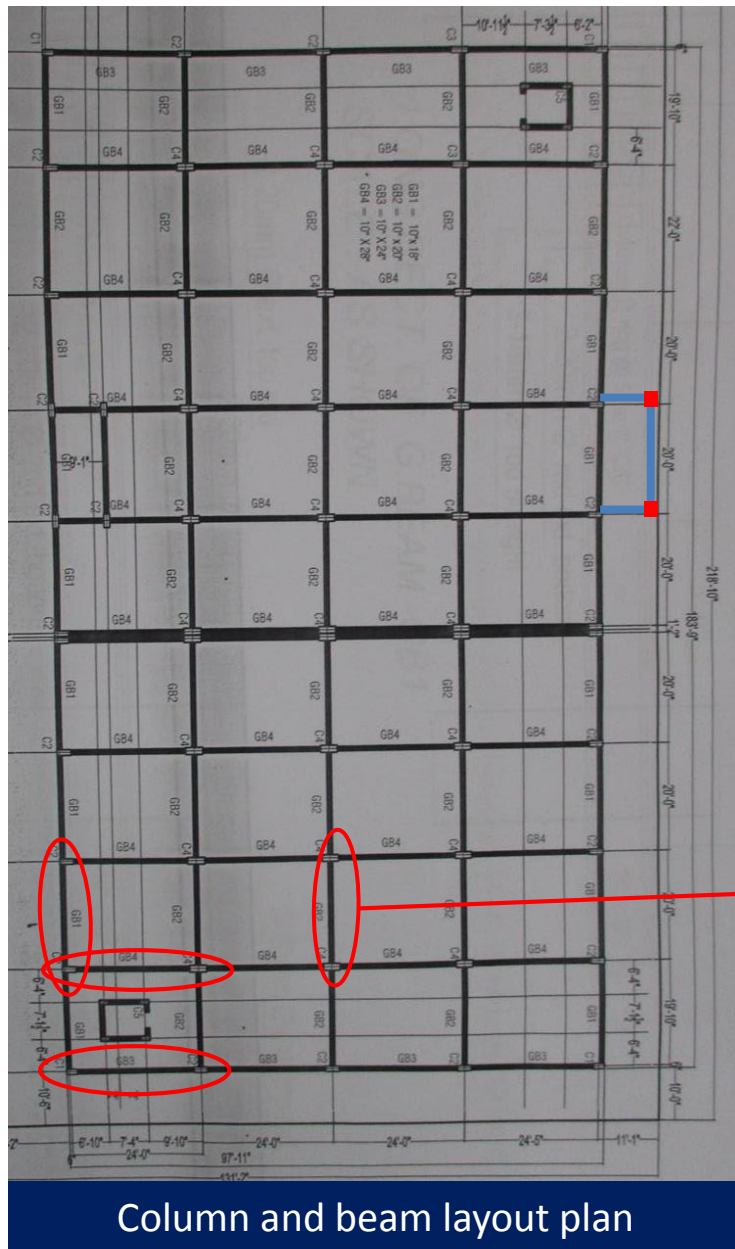
LONG SECT. OF R.BEAM-RB3  
SCALE : AS SHOWN

The dimension of floor beams for RB2, RB3 and RB4 does not matched with as-built conditions.
