FIRE SAFETY INSPECTION REPORT

FACTORY: Epyllion Style Limited (Extension Project)

ACCORD ID: 12768

Date: 23/04/2017

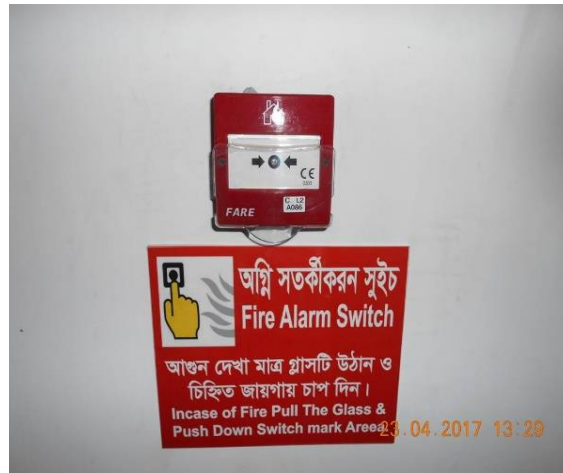
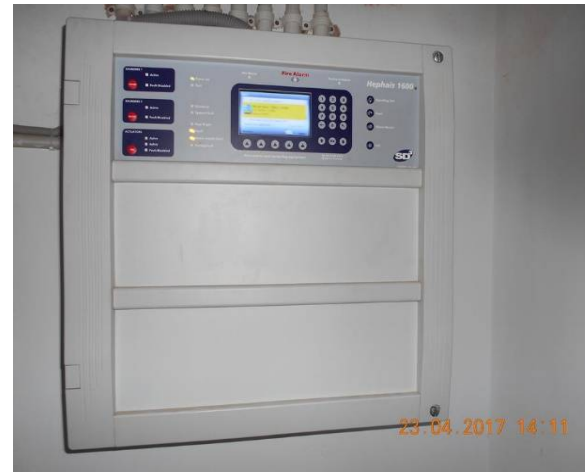
Fire Detection System

Type of Detector	Addressable	
Smoke Detection Per NFPA 72	Yes

SI No.	Category	Findings	Required Action	Remediation Time Frame	Pictorial Evidence
8	Fire Alarm & Detection System	The addressable fire alarm system installation is going on without design approval from AHJ.	Submit As-Built drawing to AHJ for approval and replace or modify the fire alarm system in accordance with NFPA 72.	Within 2 months (Design submission) & 6 months (Installation)

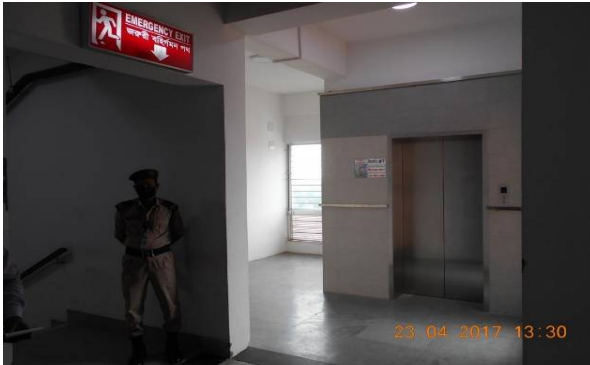
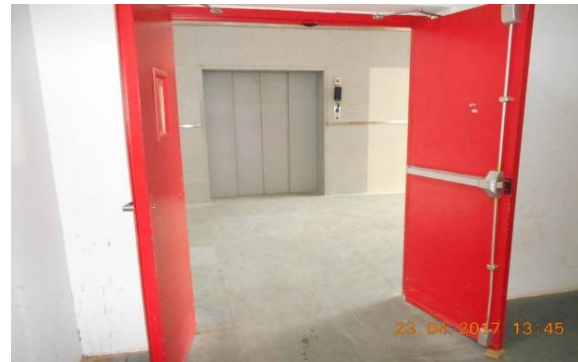
Compressor Equipment

6 nos. compressors were found inside utility building.

Location(s)	Utility Building	
Fire Rated Separation	No

Generator and Compressor room is not properly separated by fire rated construction. Fire doors were found open during working hour but those are not tied with fire alarm system by automatic closing devices.
