Fuji Knitwears Ltd.

Hossain Ahmed Road Opposite Police Line , Fatullah
(23.633595, 90.482869)

12th March 2017

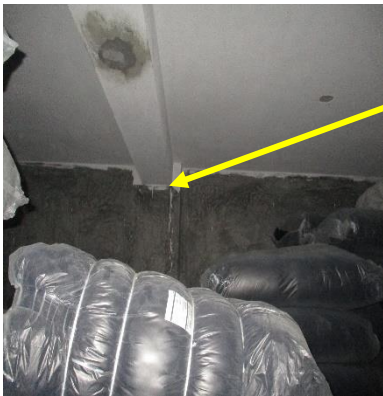
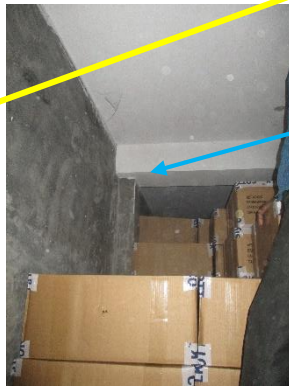
Beam Layout of Basement

Discrepancies between provided drawings and on site condition

Beam layout for basement wasn't matched with site condition. On grid-03 floor beam was found continuous and rest on brick wall shown as red mark on drawing. Floor beams were missing at Ground floor level marked as yellow in layout drawing.

Item No.	Observation	Recommended Action Plan	Recommended Timeline
1	Discrepancies between provided drawings and on site condition	Building Engineer is required to survey the as-built structure and prepare the accurate as-built drawings.	6-weeks
2	Falling hazards and exposed rebar at the roof	Secure constructed area from any possible falling hazard.	Immediate - Now
3	Falling hazards and exposed rebar at the roof	All exposed reinforcement is required to protect from corrosion which may cause degradation of the concrete.	6-weeks
4	Columns suspected to vehicle impact	Install a barrier to prevent vehicle impact in column.	6-weeks
