# Pentagon Knit Com Ltd. Global Apparel Park Ltd.

17<sup>th</sup> January, 2017

# Observations

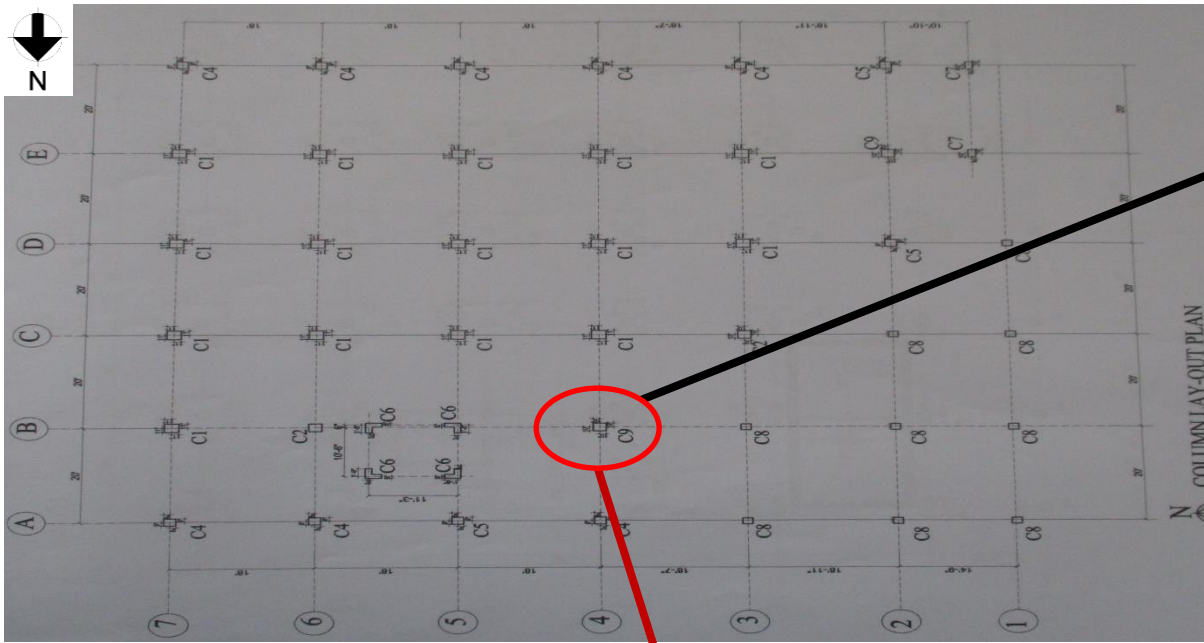
Column layout plan

The number of reinforcement does not match with column schedule . 16 number of rebar was found where column schedule shown 20 rebar. Factory engineer is required to be checked and update as built drawing.
