Oeko-Tex Limited

Yasin Knittex Ind. Ltd

16 April 2014

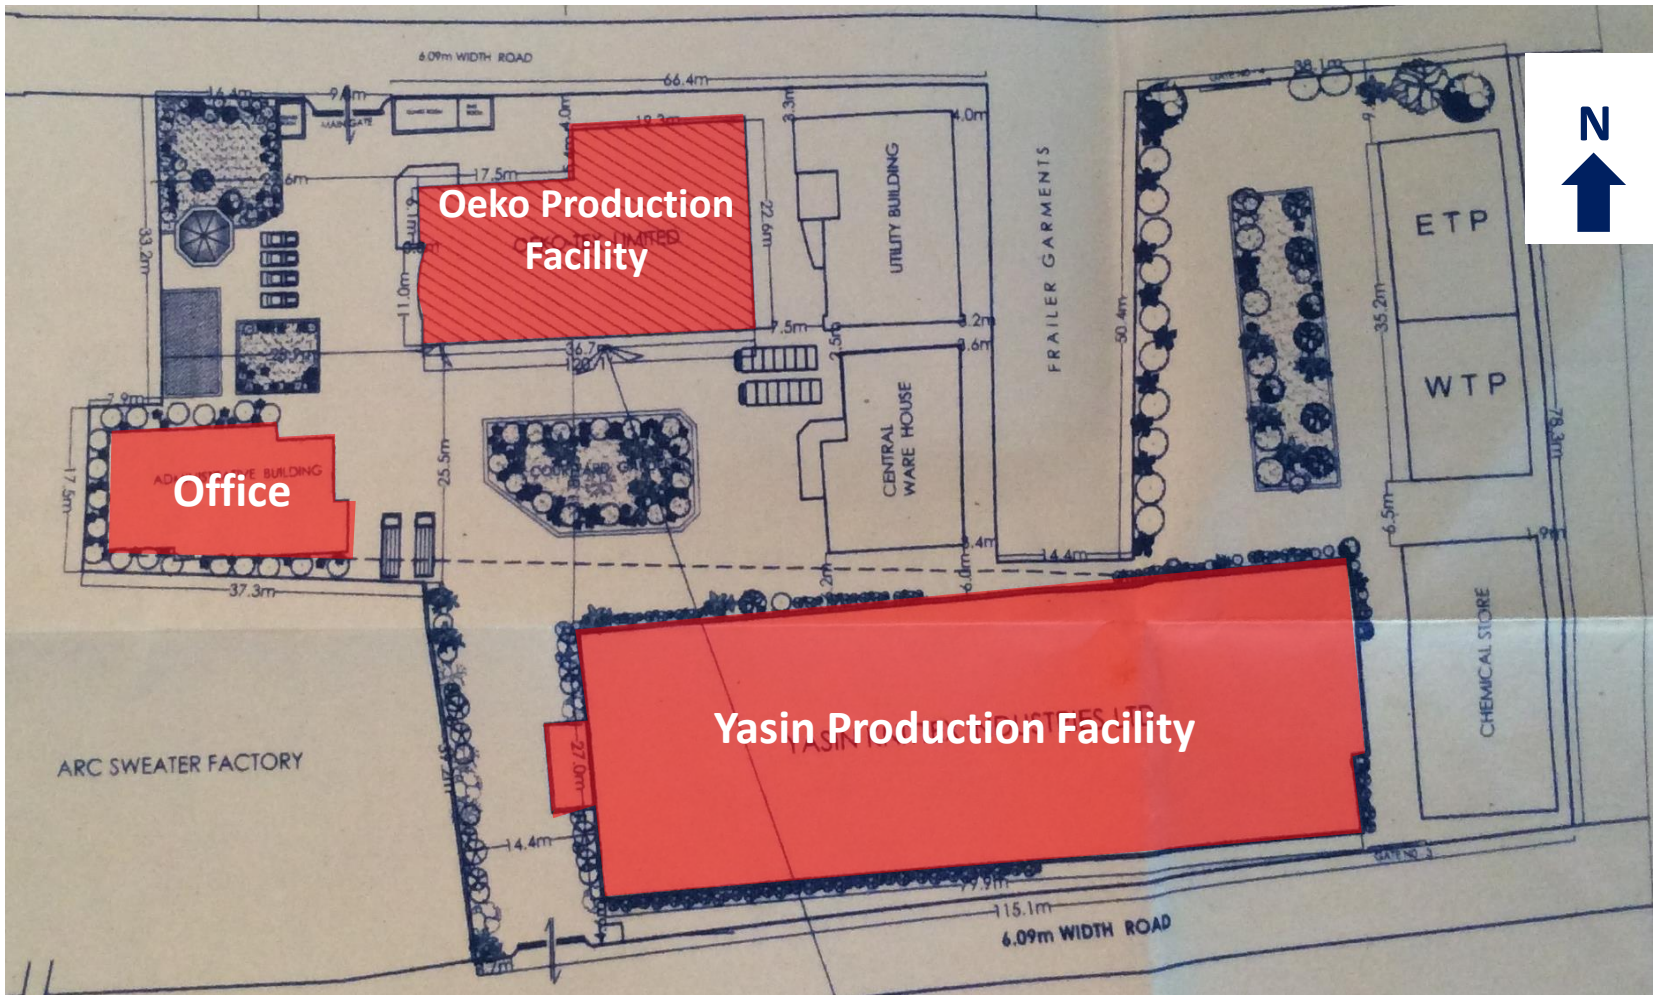
Factory Layout Plan

Stress in columns at ground level in these three facilities is sufficiently high to require confirmation of the in-situ concrete strength.

High stress in columns

Buildings requiring confirmation of their in-situ concrete strength

Item No.	Observation	Recommended Action Plan	Recommended Timeline
1	High stress in columns in Okeo Tex production building, Yasin Knittex Industries production building and Office building	Factory Engineer to review columns stresses in buildings identified above.	6-weeks
2	High stress in columns in Okeo Tex production building, Yasin Knittex Industries production building and Office building	Verify in-situ concrete strength either by cores or existing cylinder strength data for the columns in the buildings noted above	6-weeks
3	High stress in columns in Okeo Tex production building, Yasin Knittex Industries production building and Office building	Continue to actively manage the loading plans for all floor plates within the factory giving consideration to floor capacity and column capacity.	6-months
4	Cracking to beams in Yasin Knittex Industries production building and slab in the utility building	A Building Engineer should investigate if cracks are in the structure or only in the plastering.	6-weeks
