# Pakiza Knit Composite Ltd.

A-1/5, Mojidpur (Borobolimeher), Savar, Dhaka, Bangladesh  
(23.841370N, 90.258353E)

30th March 2017

# Observation

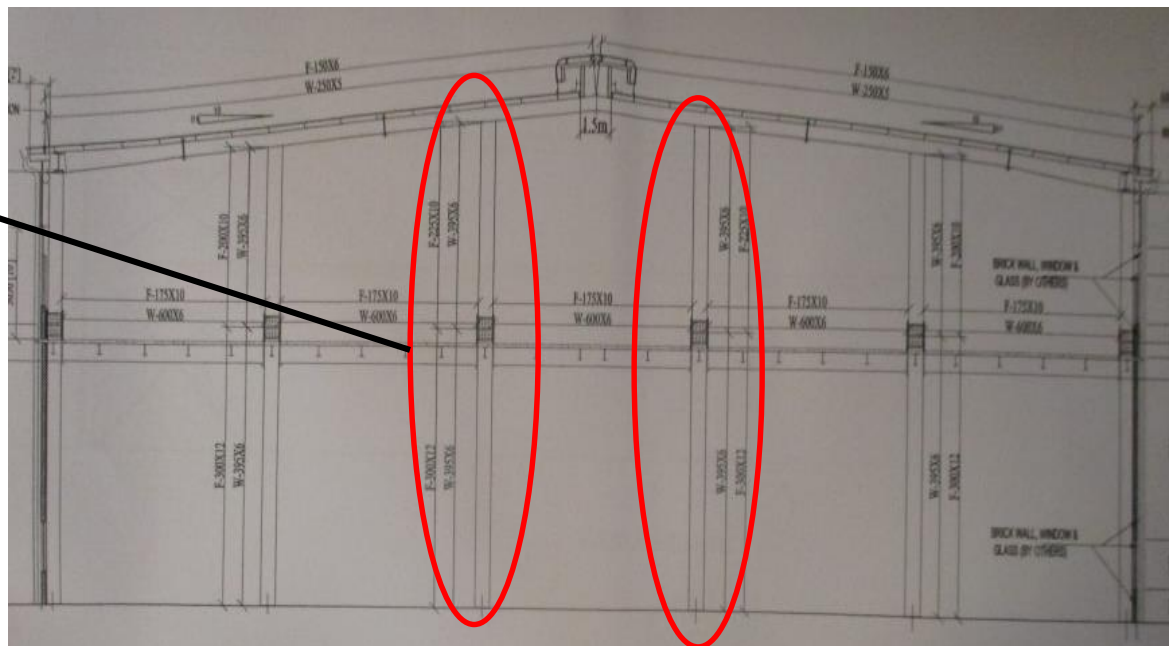
Section of end bay of steel building

Width of flange was found  
200mm instead of 225 mm on  
1<sup>st</sup> floor

200mm width was measured on 1<sup>st</sup> floor

| Item No. | Observation | Recommended Action Plan | Recommended Timeline |
|---|---|---|---|
| 1 | Knitting Building<br>Discrepancies between site observations and provided drawings | Building engineer to survey the whole building and produce as-built documentation reflecting the as constructed condition. | 6-weeks |

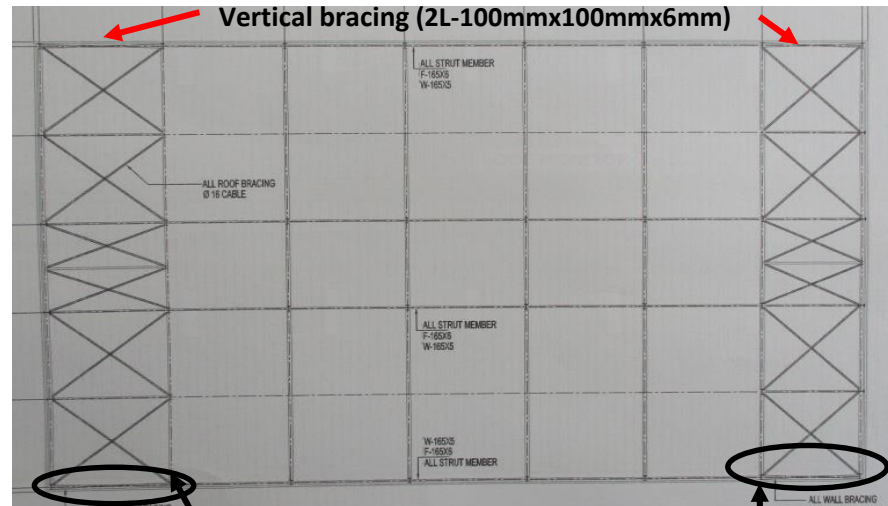
Bracing layout plan in provided drawing

Single angle bracing was found instead of double angle bracing on south-west corner of 1<sup>st</sup> floor

No vertical bracing was found at south-east corner of 1<sup>st</sup> floor

| Item No. | Observation | Recommended Action Plan | Recommended Timeline |
|---|---|---|---|
| 3 | Knitting Building:<br>Missing bolts and bracings | Reinstate disconnected bracing in braced bays | 6-weeks |
| 4 | Knitting Building:<br>Missing bolts and bracings | Building engineer to check the capacity of the steel building under lateral and vertical loading. | 6-weeks |

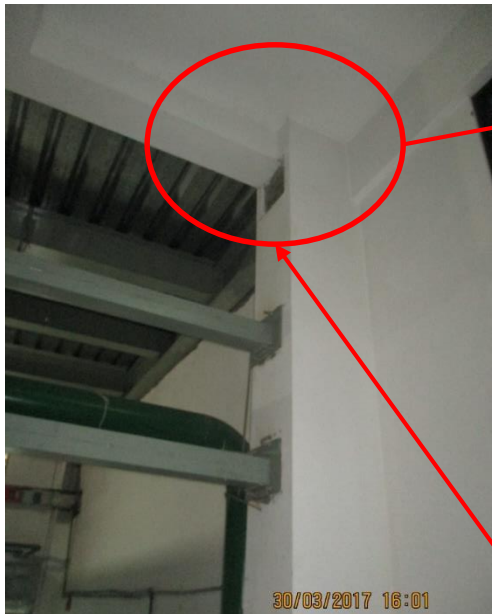
RC beam column system of  
South side Stair

Crack on beam and landing slab

Crack was found on south side stair's beam and adjacent slab. This crack is required to be investigated and repair with appropriate method

| Item No. | Observation | Recommended Action Plan | Recommended Timeline |
|---|---|---|---|
| 9 | Dyeing Building:<br>Crack on Beam and Slab | Sections of plaster finish to be removed to investigate if cracks penetrate the building structure. | 6-weeks |
| 10 | Dyeing Building:<br>Crack on Beam and Slab | Factory Engineer to prepare the investigation report as part of the Engineering Assessment. | 6-weeks |
| 11 | Dyeing Building:<br>Crack on Beam and Slab | Carry out remedial works resulting from engineering assessment if necessary. | 6-months |

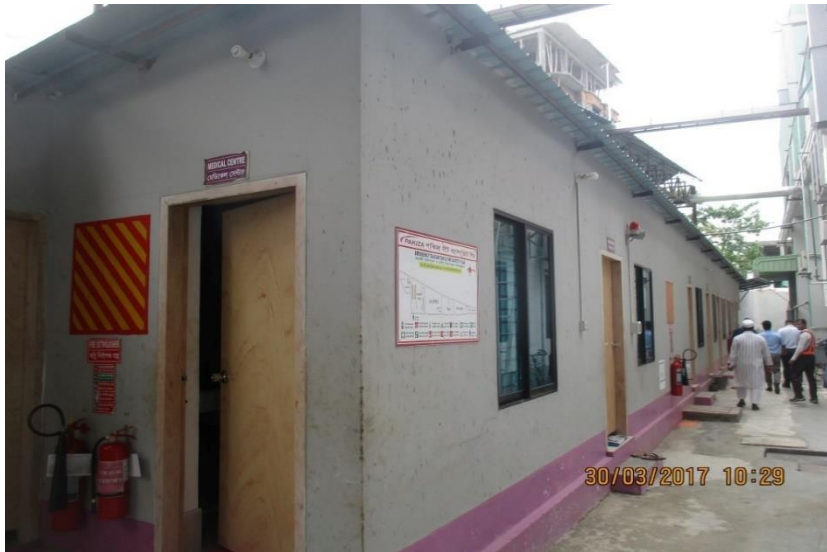
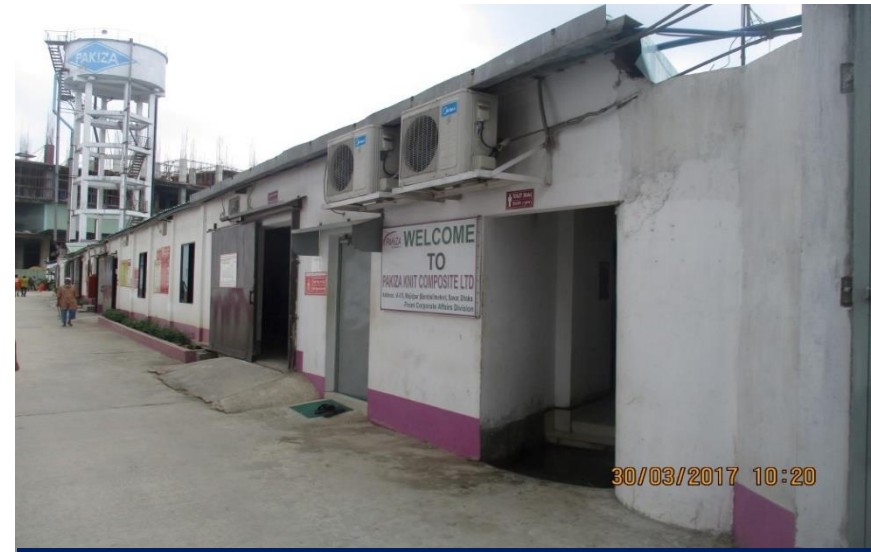
Medical & Day care shed

The support condition of those steel sheds were vulnerable and non engineered due to poor detailing of connection between members
