INITIAL FIRE SAFETY INSPECTION REPORT

South East Textiles (Pvt.) Ltd. (Extension 2)

RSC ID: 26548

Date: 17-February-2026

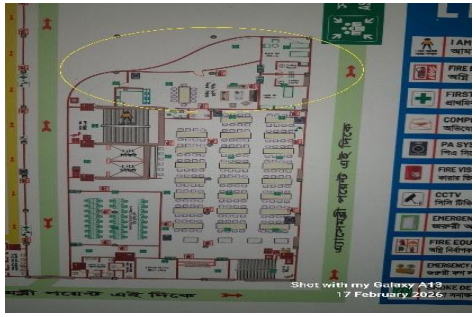
F-08	Means of Egress	A single means of exit has been provided on the 5th floor. **Location(s): Part B- Factory Building.**	The number of means of egress from any floor, story or portion thereof shall not be less than 2 except where a single exit is permitted by RSC Technical Guideline (Standard), section 6.6.2. Provide additional exit and ensure that the exit doors or means of egress openings are located a distance apart as per RSC Technical Guideline (Standard) section 6.6.6	Within 3 Months

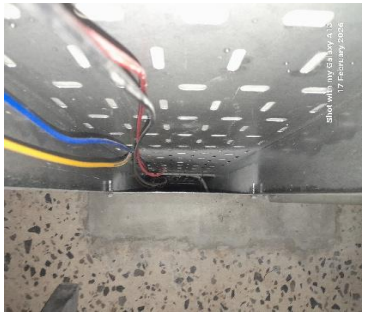
F-22	Fire Rated Construction	Bus bar penetrations through floor/ceiling assemblies are found unsealed due to the installed fire door non-functionality and unsealed penetrations. **Location(s): All floors (Factory Building).** **Non-functionality: Penetration opening more than 144 sq. inches, Unprotected opening, etc.**	Seal all penetrations and openings in floor/ceiling assemblies by a listed through-penetration fire stop system tested in accordance with ASTM E814 or approved alternative standard to maintain minimum 3-hr. fire resistance rating. Installation shall be as per manufacturer's published installation guidelines and the certification authority guideline to ensure the fire-rating in accordance with section 4.7 of RSC Technical Guideline (Standard) Or, Provide a minimum 2-hr fire rated shaft to separate the penetration from each floor if required. Keep proper datasheet & certifications for installed fire doors & accessories on-site for verification.	Within 3 Months

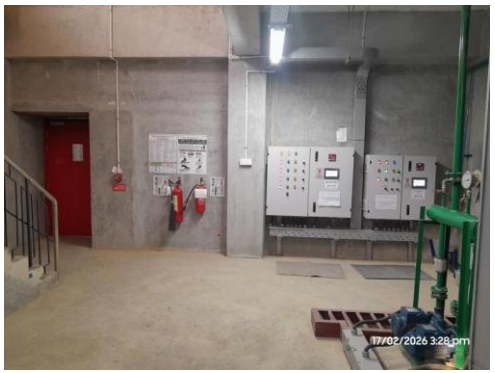
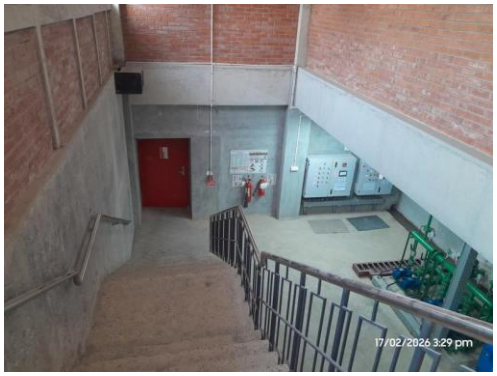
F-39	Fire Rated Construction	Fire pump room was not directly accessible from the outside or not provided with an enclosed passageway. **Location(s): Boiler Building (UG Fire Pimp Room).**	Provide direct access from the outside or provide a 2-hr enclosed passageway from an enclosed stairway or exterior exit.	Within 3 Months
