# INITIAL FIRE ASSESSMENT REPORT (FAR)

Factory Name: **Garment Export Village Ltd**

Assessor: **Bureau Veritas**

Date: **11 Jun 2014**

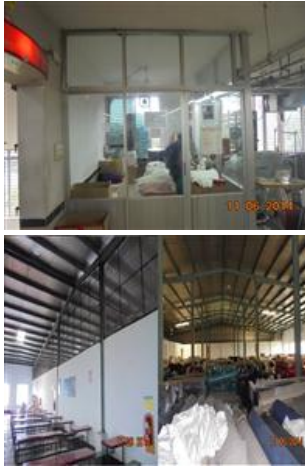
| Description: | On 1st floor of Ten story RCC main production building, bonded ware house (H2) is separated from printing section (G2) by steel grill, which is not capable of providing 1 hour fire separation as demanded in Section 3.4.2.1.5 of Alliance Standard. Spot removing room on 3rd floor of main building is separated from production area by glass and aluminum partitions. The room needs to be fire separated with 1.0 hour construction barrier along with 0.75 hour rated doors. Dining area (E4) on 9th floor of main building is separated from fabric & accessories store (H2) by wire mesh on top of brick wall, where 3.0 hour fire separation is required as per Table 3.2.1 of BNBC. | |
| Source of Findings: | Visual Assessment: Non rated separations were observed at noted locations. | |
| Suggested Plan of Action: | Provide fire-resistive rated construction barriers between hazard types in accordance with Alliance Standard Sections 3.4 and 4.5. Consult a qualified fire protection engineer to design the required rated construction barrier. | |
