# INITIAL ELECTRICAL ASSESSMENT REPORT (EAR)

Factory Name: **ODESSA FASHION LTD**

Assessor: **Sumerra**

Date: **18 May 2014**

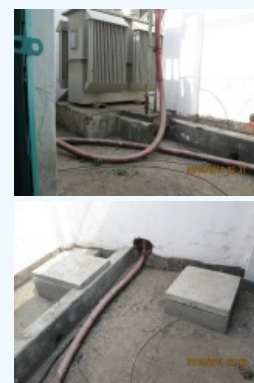
| Suggested Plan of Action: | The generator frame shall be earthed by two separate and distinct connections to earth. |
