INITIAL STRUCTURAL INTEGRITY ASSESSMENT REPORT (SIAR)

Factory Name: **Peninsula Garments Ltd. (Sunman)**
Address: **Sector #1, Plot #46-48 CEPZ, Chittagong Chittagong
Chittagong Bangladesh**
Assessor: **Bureau Veritas**
Date: **12 Feb 2015**

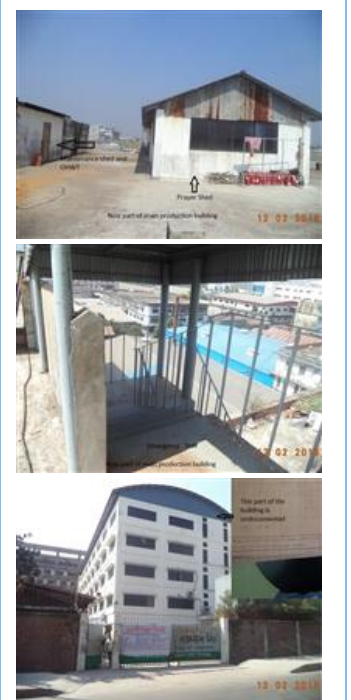
Question:	If the structure has been previously expanded, was the structural impact on the entire structure analytically evaluated and confirmed by a qualified structural engineer.
Priority Level:	Medium
Non-Compliance Level:	3
Description:	Main Production Building: Old Part: Presently the building is five storied (G+4) but structural document is available for four storied building. No structural document is available for the top most story which is a truss shed. New Part: There are three undocumented roof top constructions on new part of the main building: 1) Prayer shed, 2) RCC water tank and 3) Maintenance shed. Also, an undocumented emergency steel stair is attached to north east corner of this part. For these undocumented constructions load impacts on existing structure were not evaluated and confirmed by a qualified structural engineer.
Source of Findings:	Document Review: Documents unavailable for these expansions., Visual Assessment: Visually confirmed.
