# Progress Apparels (Bangladesh) Limited

M.S-S.F.B# 01 & 02, Adamjee EPZ, Siddhirganj  
(23.677097, 90.525516)  
9<sup>th</sup> April 2017

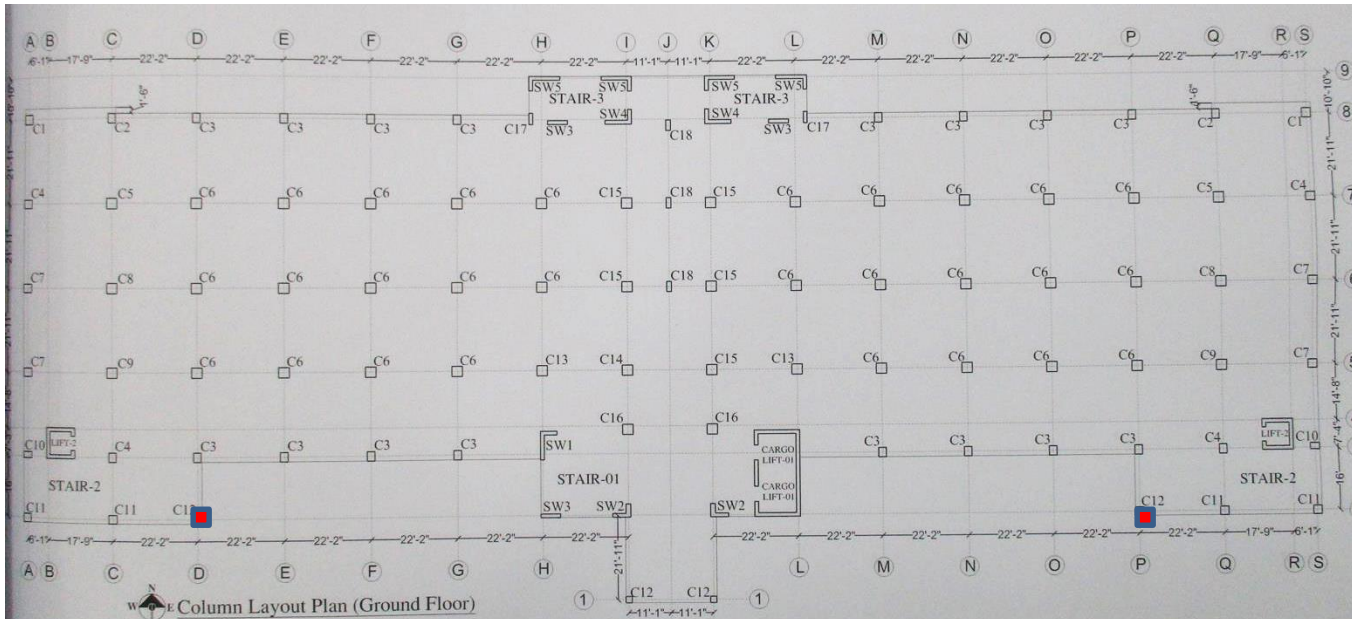
Column layout plan-2<sup>nd</sup> floor

**Structural column layout to be verified**

| Item No. | Observation | Recommended Action Plan | Recommended Timeline |
|---|---|---|---|
| 1 | Structural column layout to be verified | Building Engineer is required to investigate the structural column layout. | 6-weeks |
| 2 | Structural column layout to be verified | Update the as-built drawings to the as-constructed status. | 6-weeks |

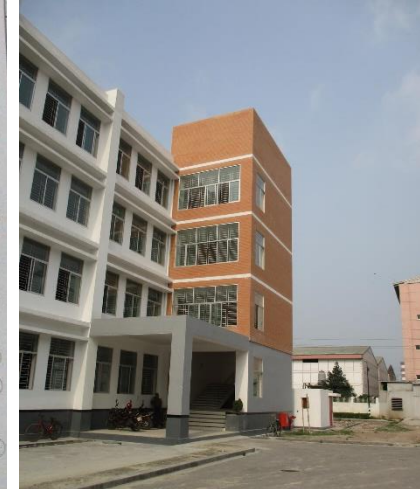
Additional Column

Marked column was not observed on site. The structural column layout to be updated by the factory engineer.
