# **FIRE SAFETY INSPECTION REPORT**

## **NEWAGE GARMENTS LTD.**

**NISCHINTOPUR, PURBO NARSINGHAPUR, ASHULIA,  
SAVAR DHAKA.**

April 17, 2014

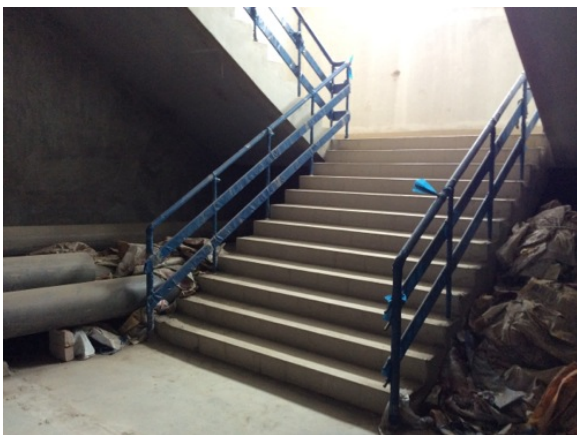
| No. | Category | Finding | Recommendation | Remediation<br>Timeframe |
|---|---|---|---|---|
| F-1 | Fire Rated<br>Construction | The exit stairs are not separated from work areas, other spaces on each floor by fire-rated construction. | <p>Provide minimum 1.5-hr fire rated doors and seal all unprotected openings to separate the exit stairs from work areas and other building spaces on all floor levels. Ensure that the fire doors are self-closing and positive latching and that they are provided with fire exit (panic) hardware where serving production floors.</p> <p>If fire doors are required to be held open for functional reasons, provide automatic-closing devices tied to the fire alarm system.</p> | Within 3 months |

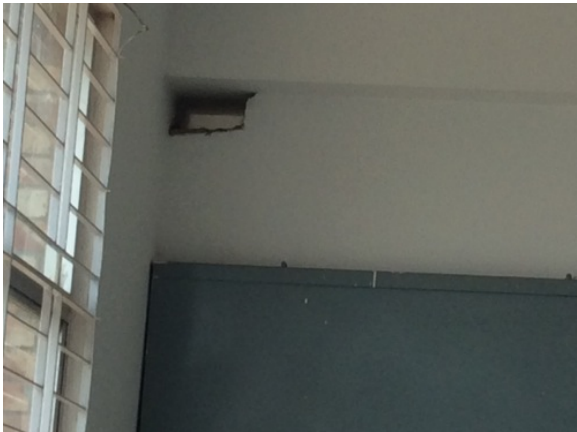
| F-2 | Fire Rated Construction | Unsealed penetrations and openings are located in exit stair enclosures. | Seal all penetrations and openings in exit stair enclosure walls to maintain the fire separation. | Within 3 months |

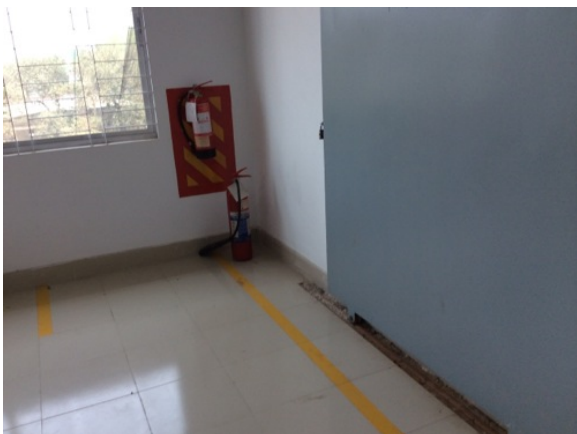
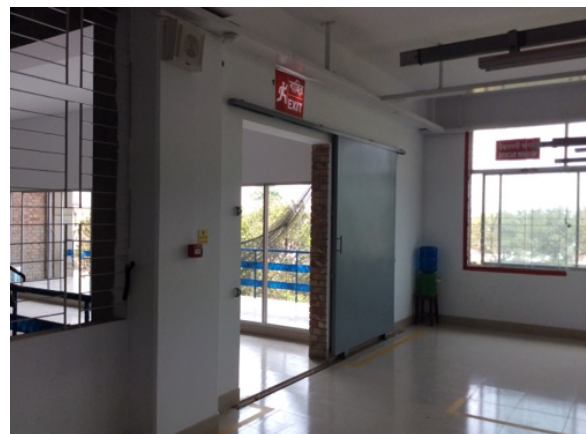
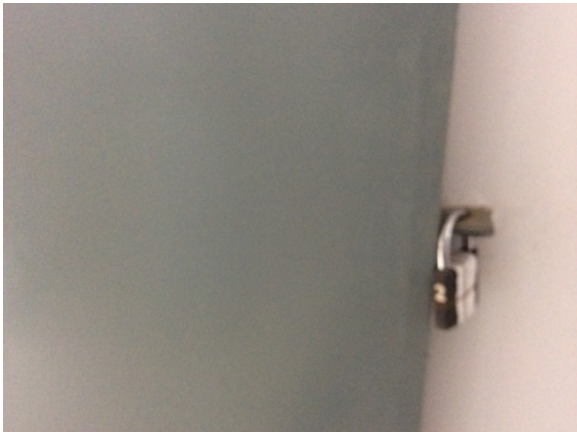
| F-3 | Egress | Egress doors and gates with locking features are provided at building exits and exit stairs. | Remove locking features from all egress doors and gates.<br><br>If locks are required for security reasons, utilize special door locking features complying with NFPA 101. | Immediate |

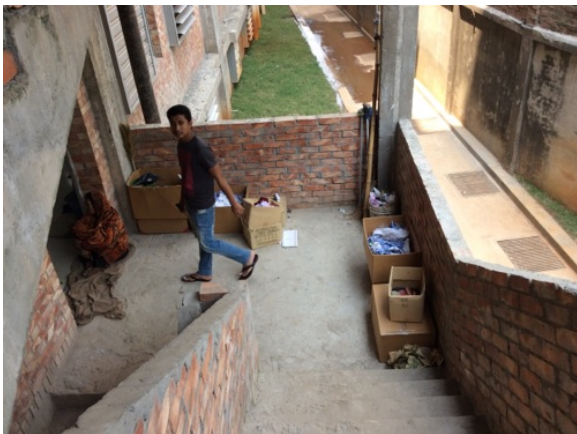
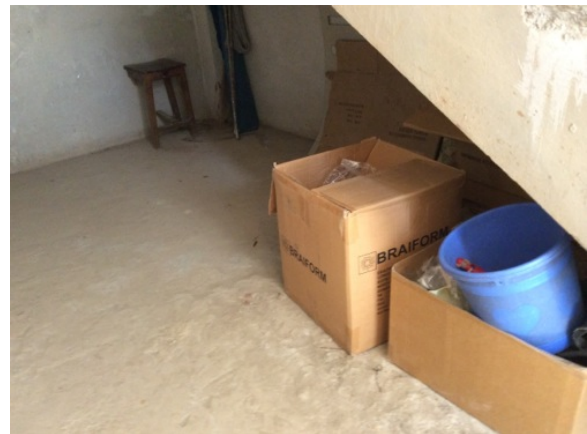
| F-4 | Egress | Storage was located on the ground floor of north eastern stair and north western stair. | Remove all storage from exit stairs and egress paths. | Immediate |

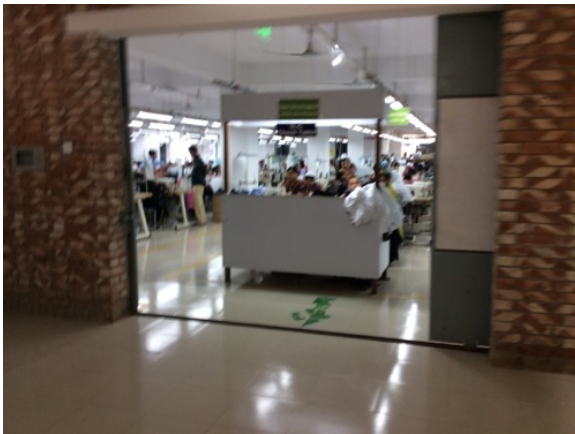
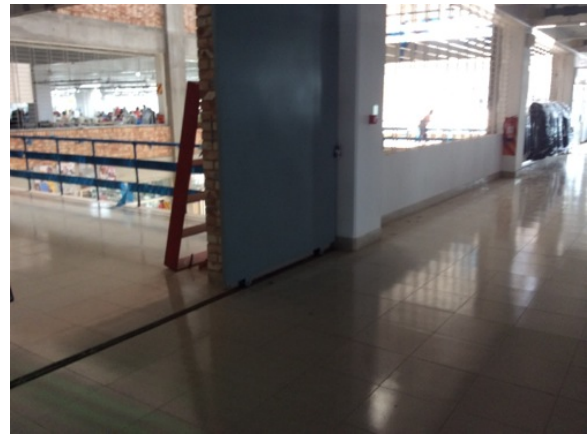
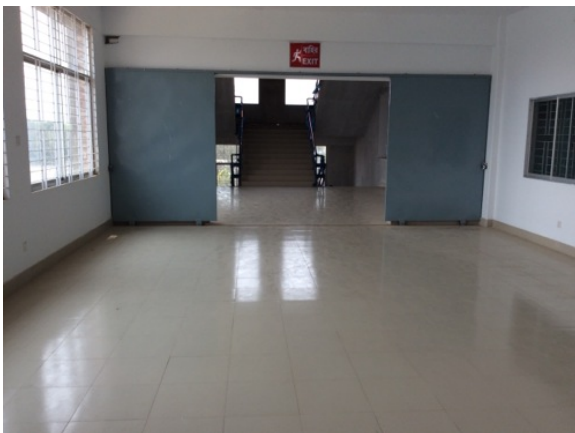
| F-5 | Egress | Collapsible gates and sliding doors are provided at building exits and exit stairs. | Replace all gates and sliding doors along the means of egress with side-hinged, swinging egress doors. | Within 1 month |

If locks are required for security reasons, utilize special door locking features complying with NFPA 101.

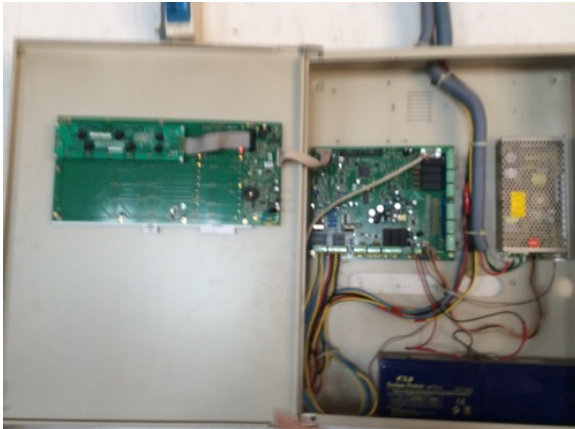
| F-6 | Fire Protection | The fire alarm system is conventional, not a listed system, and does not provide alarm and notification features consistent with acceptable standards. | Replace the fire alarm system with a new, listed addressable fire alarm system in accordance with NFPA 72. | Design within 4 months, install within 9 months |

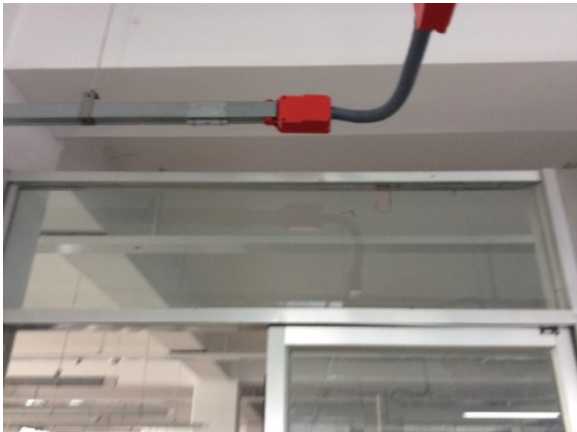
| F-8 | Egress Lighting | In multiple locations exit signs were not provided at exits. | Provide exit signs above all exits to the exterior and all doors to the exit stairs. | Within 1 month |
