FIRE SAFETY INSPECTION REPORT

Kimberly Design (new)

ACCORD ID: 12863

Date: 7 June, 2017

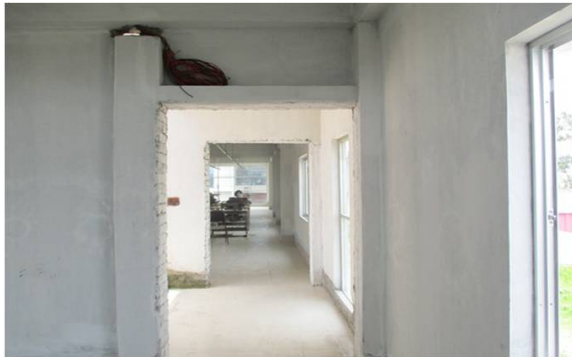
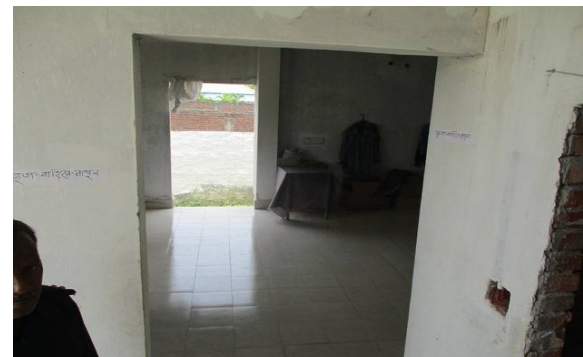
SI No.	Category	Findings	Required Action	Remediation Time Frame
1	Fire Rated Construction	The exit stairs enclosures are not separated from work areas and other spaces on each floor by fire-rated construction(Non rated doors, unsealed penetrations and openings etc.).	Provide minimum 1-hr rated doors for buildings with 3 or fewer stories and 1.5-hr fire rated doors for buildings that are 4 or more stories. Seal all unprotected openings to separate the exit stairs from work areas and other building spaces on all floor levels. Ensure that the fire doors are self-closing and positive latching and that they are provided with fire exit (panic) hardware where serving production floors. If fire doors are required to be held open for functional reasons, provide automatic closing devices tied to the fire alarm system. Once fire doors are installed, every door in a stair enclosure serving more than 5 stories shall be provided with re-entry unless it meets.	Within 3 months

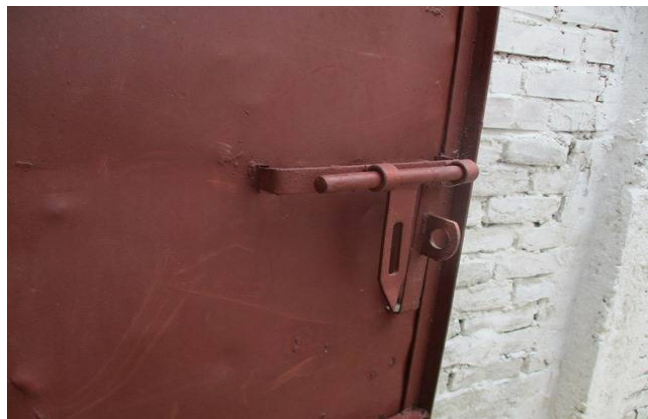
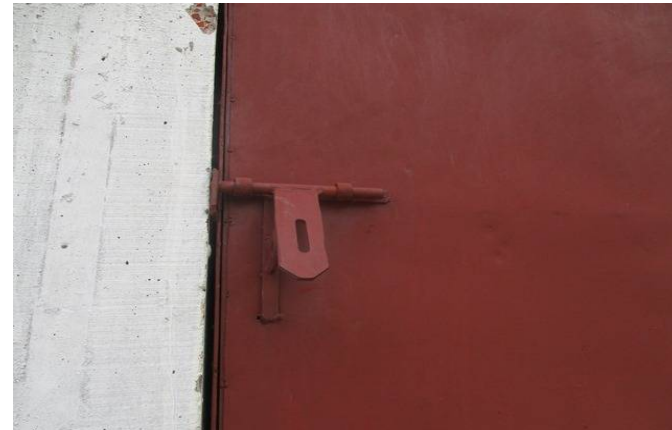
2	Egress	Egress doors/gates with locking features not complying with NFPA101 are provided at building.	Remove locking features from all egress doors/gates. If locks are required for security reasons, utilize specialized door locking features complying with NFPA101.	Immediate
---	--------	---	--	-----------

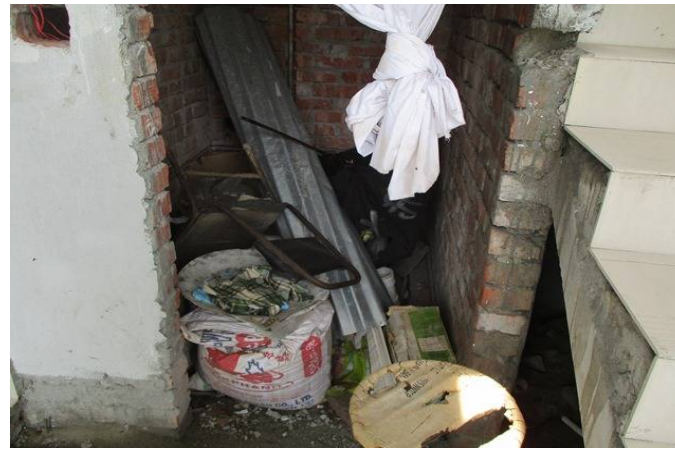
3	Egress	Storage was located in all exit stairs. Location: Ground floor.	Remove storage from the exit stairs and egress path.	Immediate
---	--------	--	--	-----------

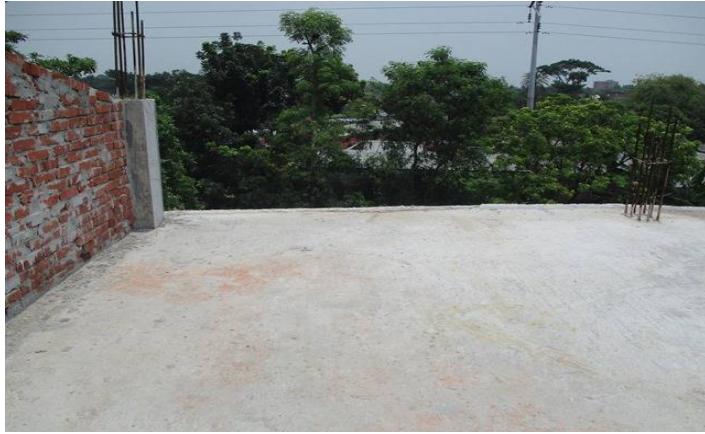
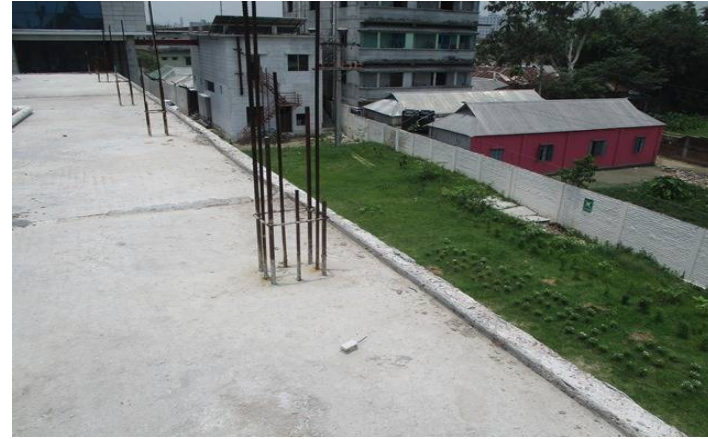
4	Guard rail	The occupiable roof was not provided with an adequate guard rail.	All occupiable roofs shall be provided with parapets or guards with a minimum height of 1067 mm (42 in.)	Within 3 months
---	------------	---	--	-----------------

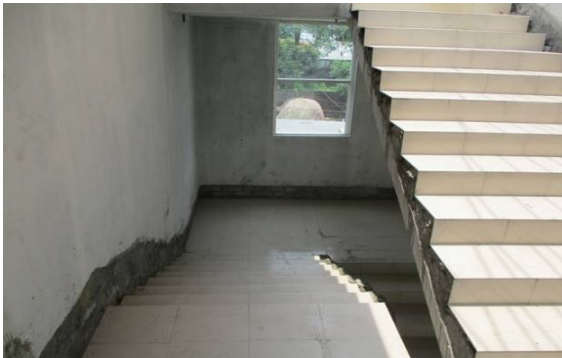
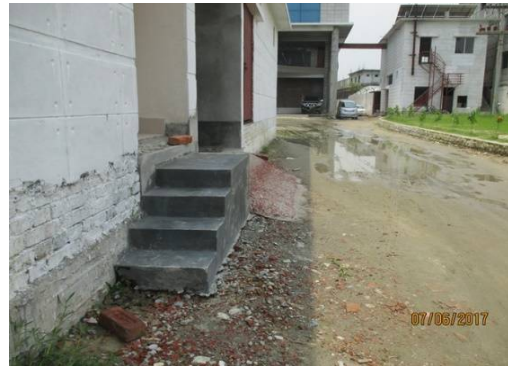
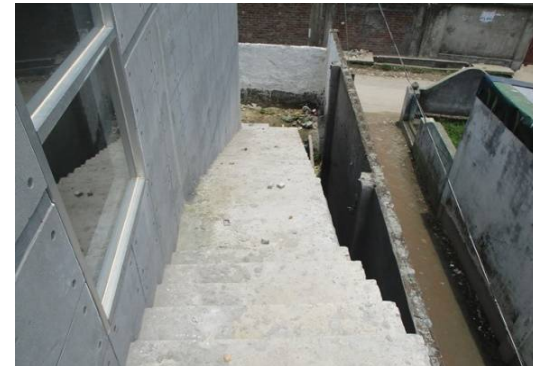
5	Handrail	<p>Handrails are not provided on both sides of each exit stairs on all floors. Having handrails on one side of said staircase, may pose as a falling hazard during evacuation.</p> <p>Or, Handrails are not provided at exit stairs.</p>	<p>Provide handrails on both sides of the exit stair. New handrails shall have a minimum height of 865 mm (34 in.) and a maximum height of 965 mm (38 in.) as measured from the leading edge of the tread.</p> <p>Intermediate handrails shall be provided when the stair width exceeds 2.2 m (87 in.)</p>	Within 3 months
---	----------	--	--	-----------------

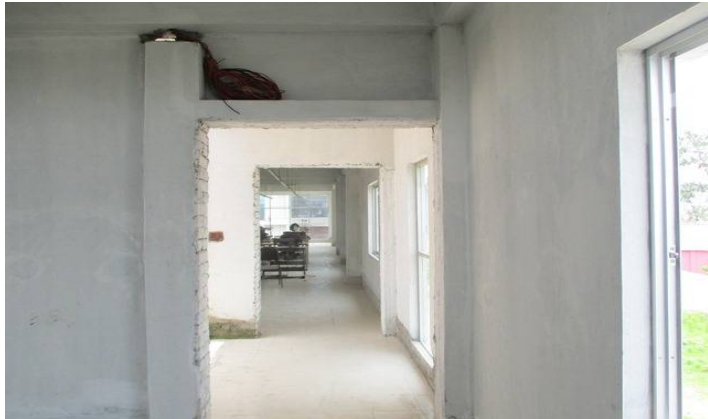
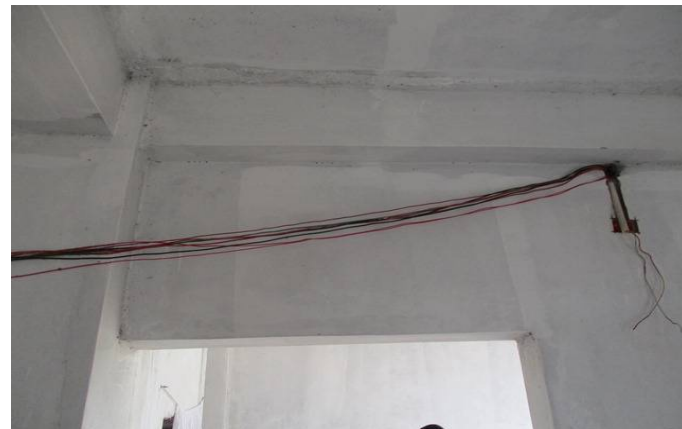
6	Egress Lighting	Exit sign not provided at exit. Location: All through the building.	Lighted exit signs shall be placed at entrance to an exit. Additional exit signs shall be placed throughout the facility anywhere the continuation of the egress is not obvious. Lighted exit signs shall be provided with either battery backup or uninterruptable power supply systems and shall be continuously illuminated.	Within 1 month
---	-----------------	--	---	----------------

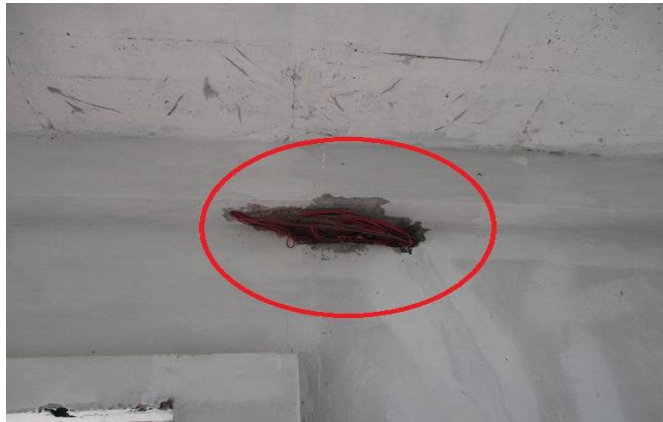
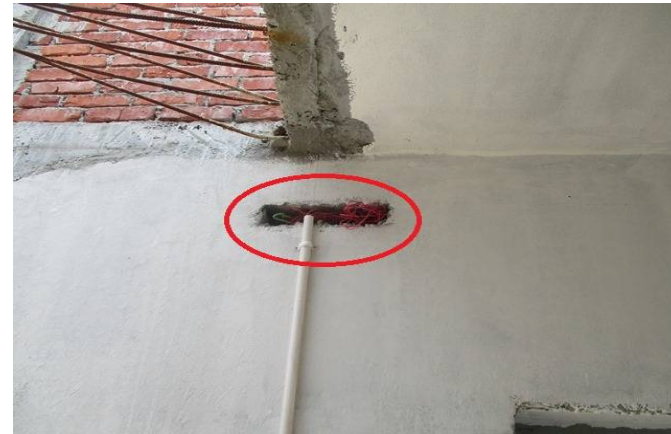
7	Opening/Penetration to Exit enclosure	Unsealed penetrations and openings are located in exit stair enclosures.	Seal all penetrations and openings in the wall of exit enclosure walls (full thickness of the wall) by fire rated materials to maintain the fire resistance rating.	Within 3 months
---	---------------------------------------	--	---	-----------------
