# FIRE SAFETY INSPECTION REPORT

## MG Niche Flair Limited (Unit-2)

ACCORD ID: 12774

Date: 18 May 2017

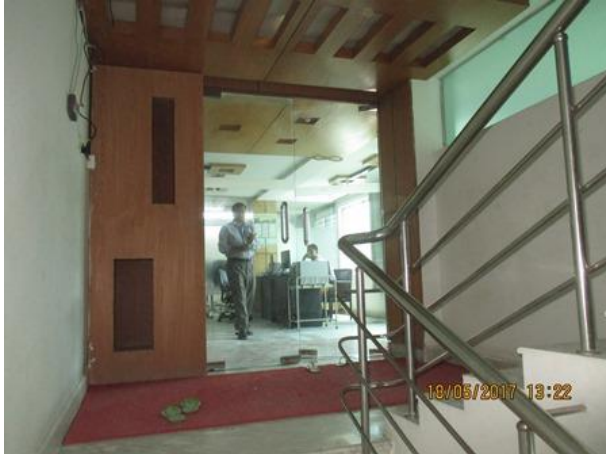
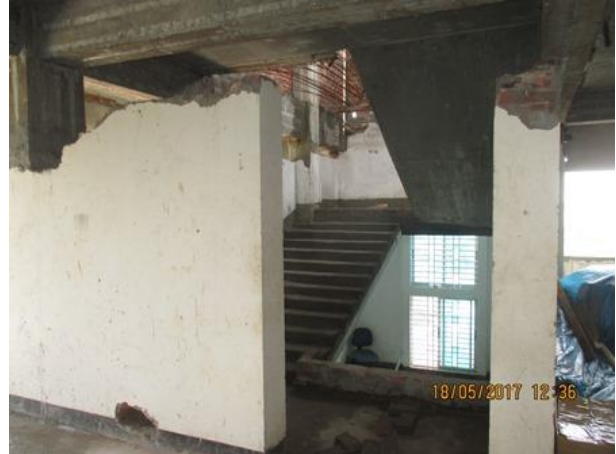
| No. | Category | Finding | Recommendation | Remediation<br>Timeframe |
|---|---|---|---|---|
| F-1 | Fire Rated<br>Construction | Exit stairs are not separated from work areas & other spaces on each floor by fire-rated construction due to unprotected openings and penetrations. | <p>Separate the exit stairs from work areas and other building spaces on all floor levels by minimum 2- hr fire-rated construction. Provide minimum 1.5- hr fire rated doors and seal all unprotected openings and penetrations to maintain the fire separation.</p> <p>Ensure that all fire doors are self-closing and positive latching, and are provided with fire exit (panic) hardware where serving production floors or assembly occupancies.</p> <p>If fire doors are required to be held open for functional reasons, provide automatic-closing devices tied to the fire alarm system.</p> <p>Once fire doors are installed, every door in a stair enclosure serving more than 5 stories shall be provided with re-entry unless it meets ACCORD standard 6.8.3.1.</p> | Within 3 months |

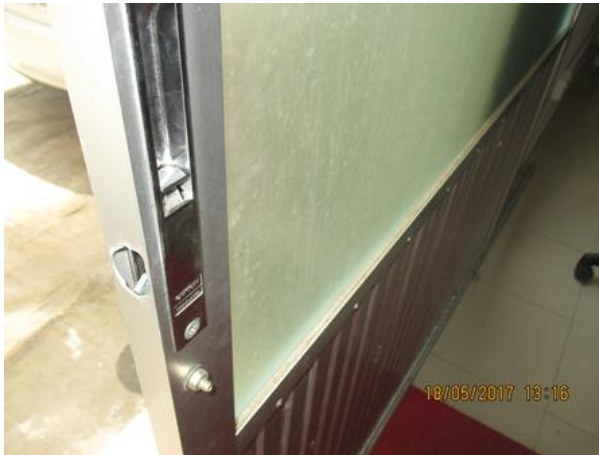
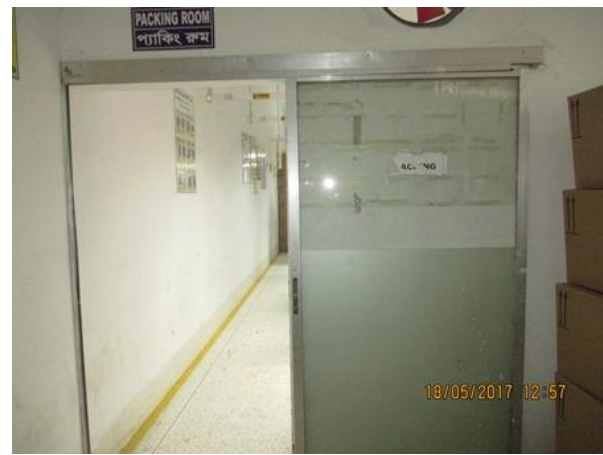
F-2 Egress

Egress gates are provided with non-compliant locking features at some exits such as finishing, packing section, sample section etc.

Remove locking features from all egress gates.

Immediately

If locks are required for security reasons, utilize special door locking features complying with ACCORD standard 6.8.2.

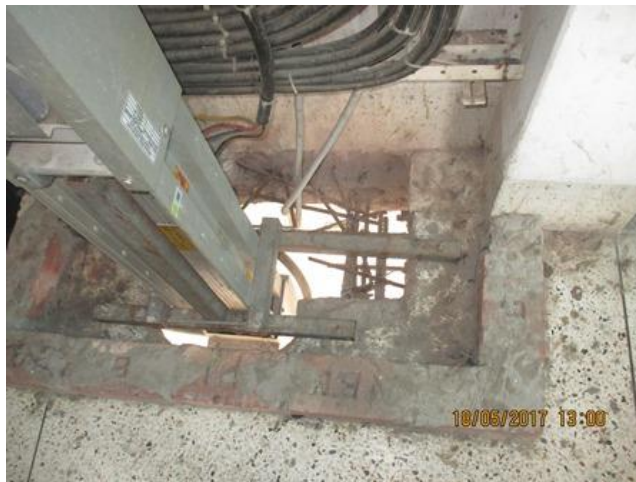
| F-3 | Fire Rated Construction | Unsealed electrical shaft is located in the fire-rated floor/ceiling assemblies. | Provide a minimum 2-hr fire-rated shaft to separate the utility risers from each floor level and seal all penetrations in floor/ceiling assemblies to maintain the fire separation. | Within 3 months |

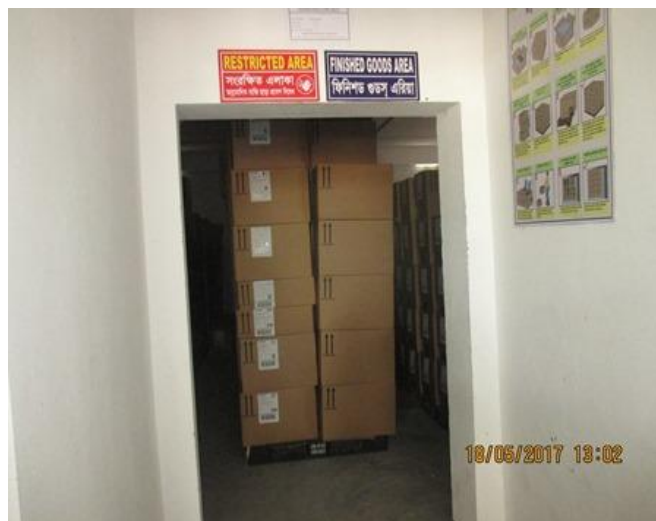
| F-4 | Fire Rated Construction | Storage room at ground floor is not separated from the exit stair and discharges directly into the exit stair discharge. | <p>Openings from exit enclosure to storage room shall be provided with a vestibule with fire rated construction and openings.</p> <p>Provide a 1.5 hr. fire rated door on the exit stair side and a 1-hr. fire rated door on the Store room side. Ensure that the fire rating of the vestibule construction matches that of the exit stair enclosure.</p> | Within 3 months |

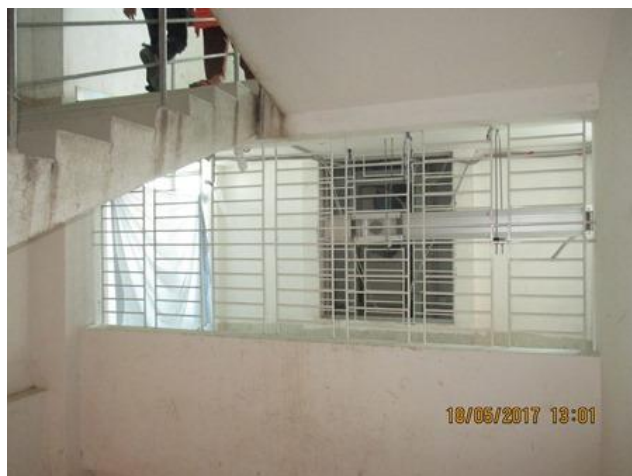
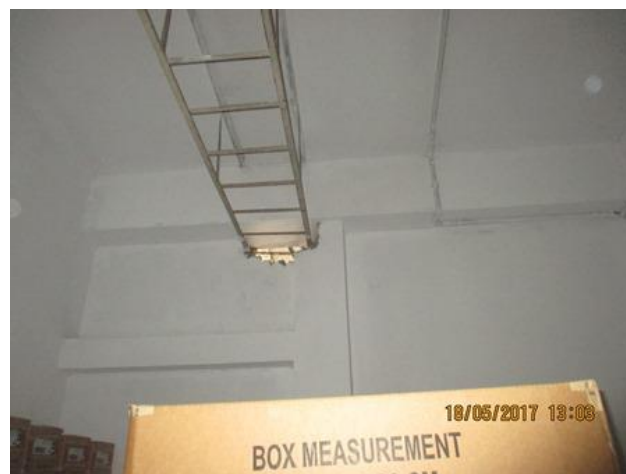
| F-5 | Fire Rated Construction | Unsealed penetrations and openings are located in exit stair enclosures. | Seal all penetrations and openings in exit stair enclosure walls to maintain the required fire separation. | Within 3 months |

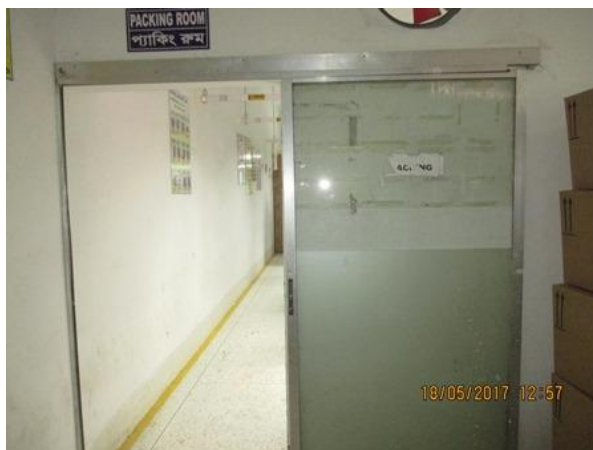
| F-6 | Egress | Sliding gate is provided at some exits such as finishing, packing, sample section etc. | Replace all gates, sliding doors and rolling shutters along the means of egress with side-hinged, swinging egress doors.<br><br>If locks are required for security reasons, utilize special door locking features complying with NFPA 101. | Within 1 month |

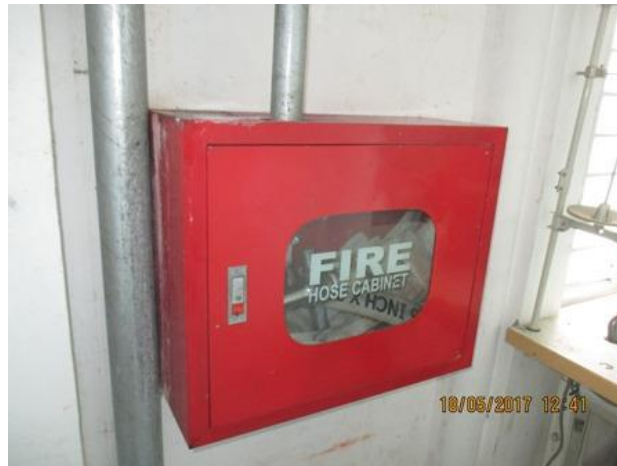
| F-10 | Fire Protection | The required standpipe system is not installed in accordance with the ACCORD standard and NFPA 14. | Install a new standpipe system in accordance with ACCORD standard 5.4 and NFPA 14.<br>A class III system shall be highest occupiable floor 10 m (33 ft.) above grade or more. | Design Within 3 months<br>Install within 6 months |

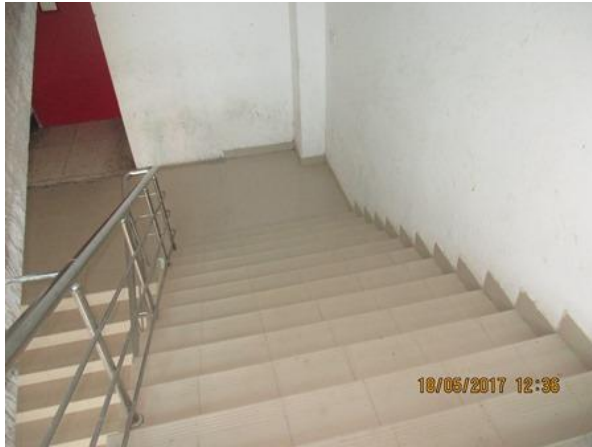
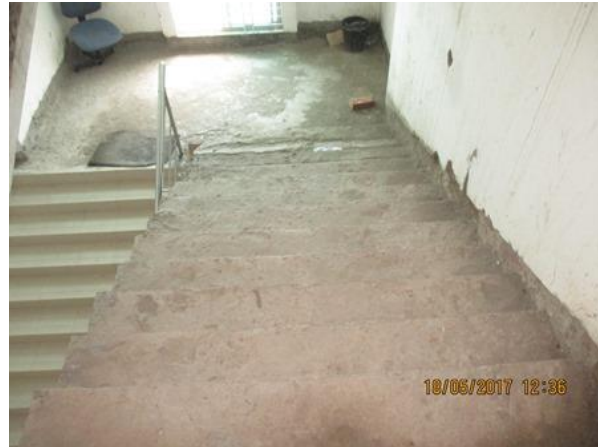
| F-12 | Egress | Handrails are not provided on both sides of both exit stairs. | Provide handrails on both sides of the exit stair. New handrails shall have a minimum height of 865 mm (34 in.) and a maximum height of 965 mm (38 in.) as measured from the leading edge of the tread. Intermediate handrails shall be provided when the stair width exceeds 2.2 m (87 in.) | Within 3 months |

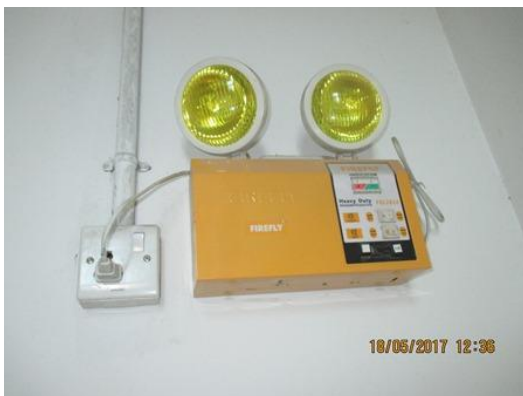
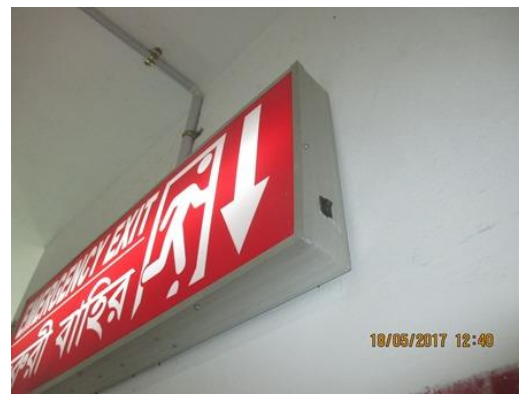
| F-14 | Egress Lighting | Manual on-off switch is provided for emergency lighting and exit signage units. | Remove manual on/off switches from emergency Lighting & exit signage units to prevent them from being | Within 1 month |

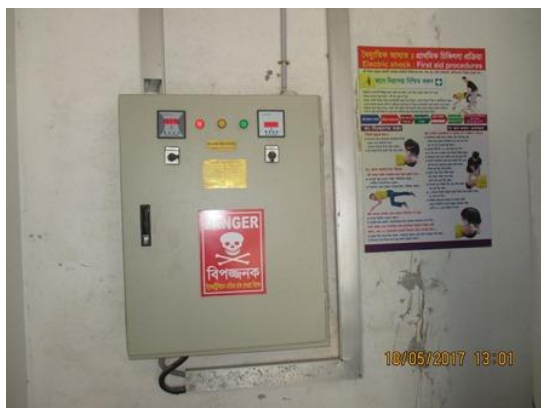
| F-16 | Fire Rated Construction | Electrical panels were located in the S-E exit stair enclosure.<br><br>At ground floor. | Remove and re-locate all electrical panels from exit stair enclosures. | Within 3 months |

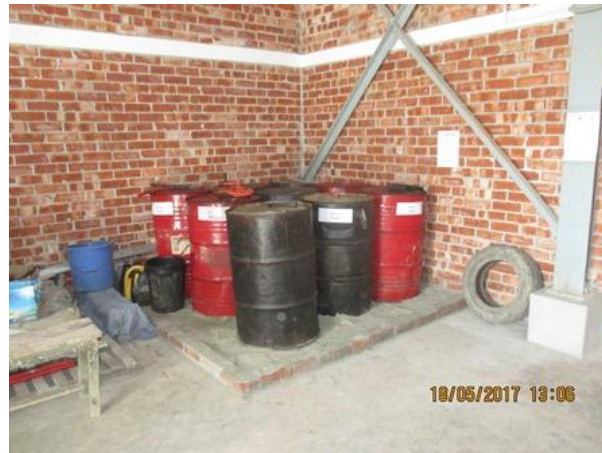
| F-17 | Fire Rated Construction | Diesel fuel storage was located inside the generator room. | Remove all diesel fuel storage from the generator room and relocate to the exterior such that the diesel fuel storage is at least 10 ft from required egress paths. If located along egress paths or in utility building, separate the diesel fuel storage with 2-hr fire rated construction. There shall be no diesel fuel storage in a factory production building. | Immediately |

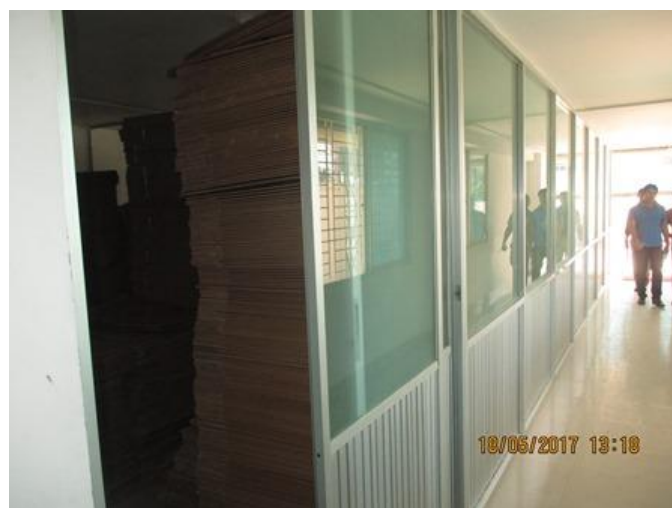
| F-18 | Fire Rated Construction | N-W exit stair do not discharge the occupant directly to the outside. | Modify stair to discharge directly outside.<br>Or<br>Provide 2-hr fire-rated exit passageway leading directly outside (vestibules to separate any storage areas).<br>Or<br>Provide sprinkler protection for discharge floor in accordance with NFPA 13. | Within 6 months |
