# **FIRE SAFETY INSPECTION REPORT**

**LIBERTY KNITWEAR LTD. UNIT 2**  
**HOLDING # G-88/1, CHANDRA (POLLI BIDDUT),**  
**KALIAKOIR**

May 18, 2014

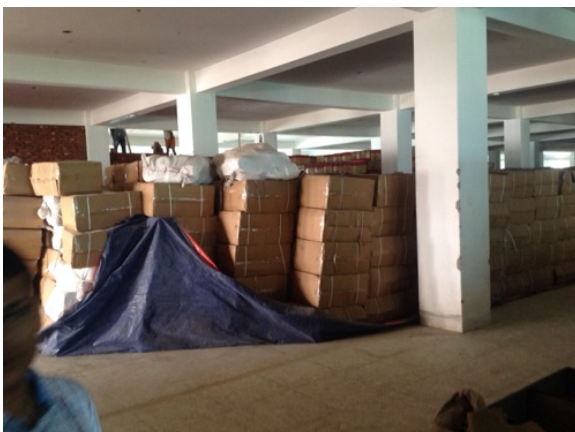
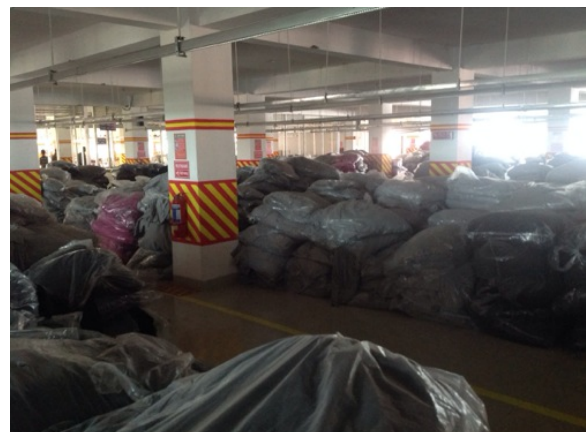
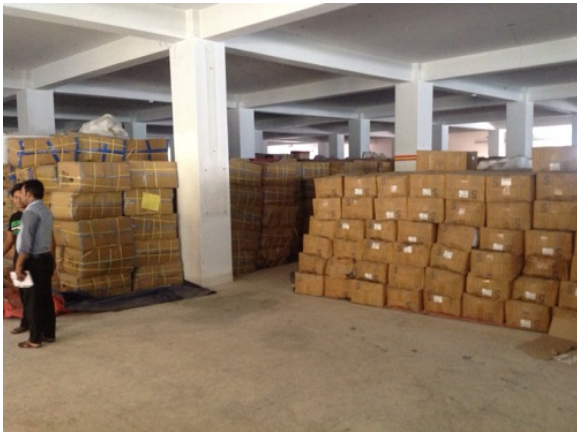
| No. | Category | Finding | Recommendation | Remediation Timeframe |
|---|---|---|---|---|
| F-1 | Fire Rated Construction | Areas used for storage on the ground floor and second floor are not separated by fire-rated construction. | <p>Provide dedicated storage rooms separated by minimum 1-hr fire-rated construction on the ground floor including fire rated doors and a corridor at the exit access.</p> <p>On the second floor where separate storage rooms may not be feasible, provide defined storage areas and limit the storage arrangement as follows:</p> <ul style="list-style-type: none"> <li>- Maximum height of 2.4m and maximum area of 23m<sup>2</sup></li> <li>- If sprinkler protected: maximum height of 3.66m and maximum area of 93m<sup>2</sup>.</li> </ul> | Within 3 months |

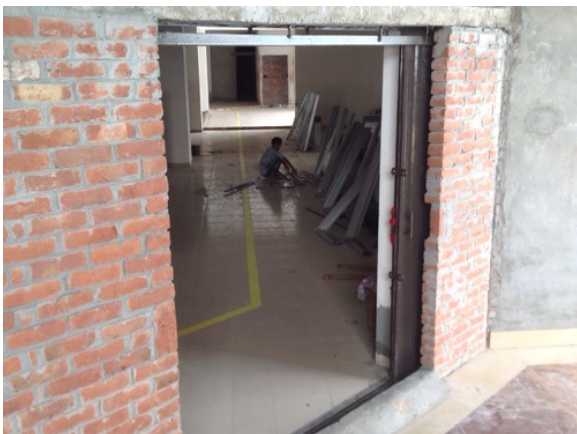
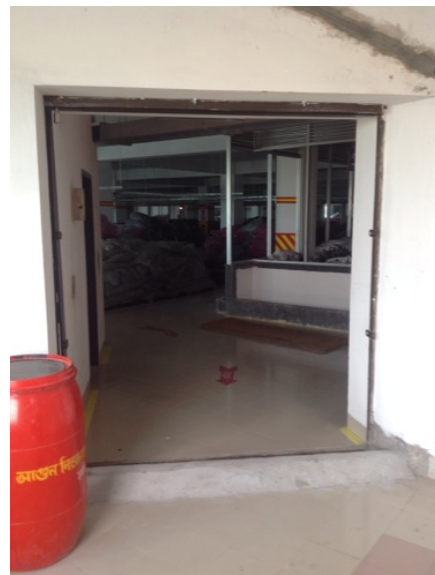
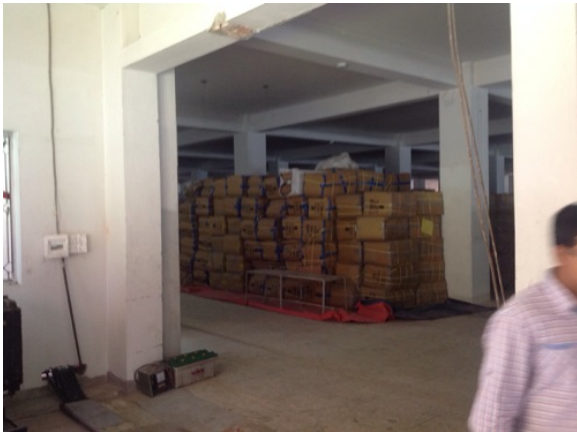
| F-2 | Fire Rated Construction | The exit stairs are not separated from work areas, other spaces on each floor by fire-rated construction. | Provide minimum 1.5-hr fire rated doors and seal all unprotected openings to separate the exit stairs from work areas and other building spaces on all floor levels. Ensure that the fire doors are self-closing and positive latching and that they are provided with fire exit (panic) hardware where serving production floors. | Within 3 months |

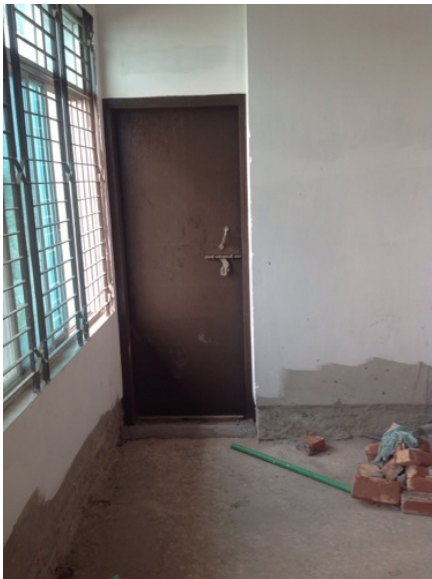
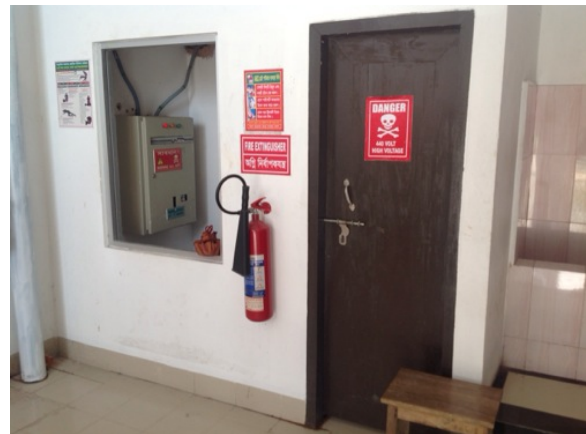
| F-3 | Fire Rated Construction | Unsealed penetrations and openings are located in exit stair enclosures. The east exit has these openings on all floors. | Seal all penetrations and openings in exit stair enclosure walls to maintain the fire separation. | Within 3 months |

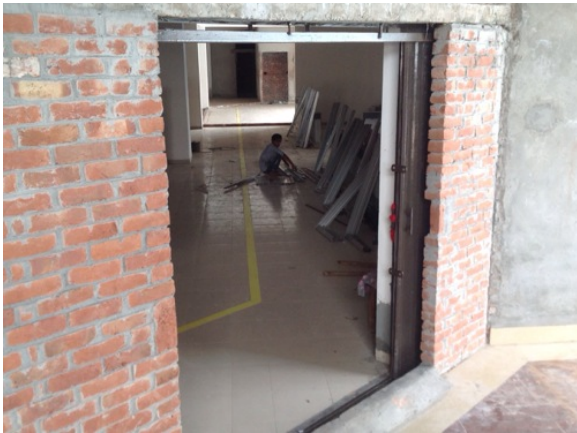
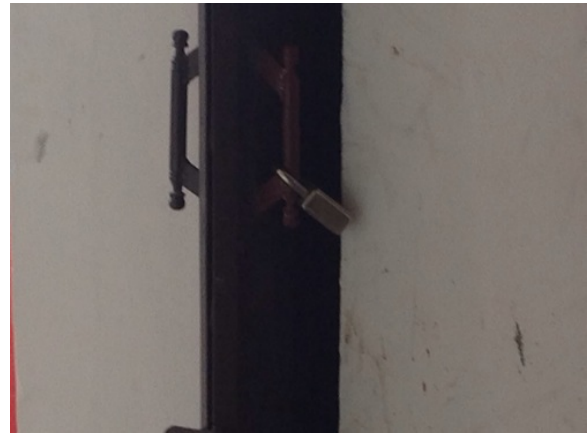
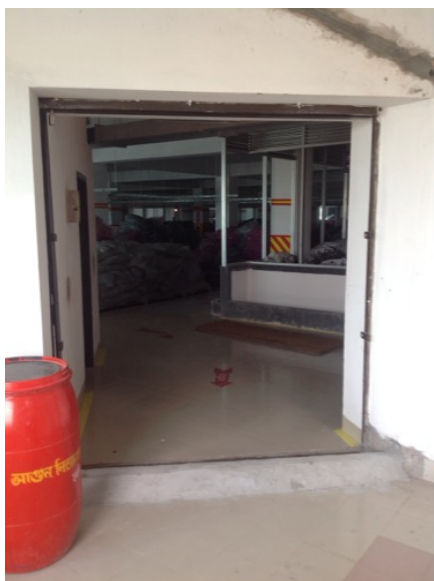
| F-4 | Egress | <p>Egress doors / gates with locking features are provided at building exits, exit stairs, along egress routes, exit discharge.</p> <p>These locking features can be found on all exits, on all floors throughout the factory.</p> | <p>Remove locking features from all egress doors / gates.</p> <p>If locks are required for security reasons, utilize special door locking features complying with NFPA 101.</p> | Immediate |

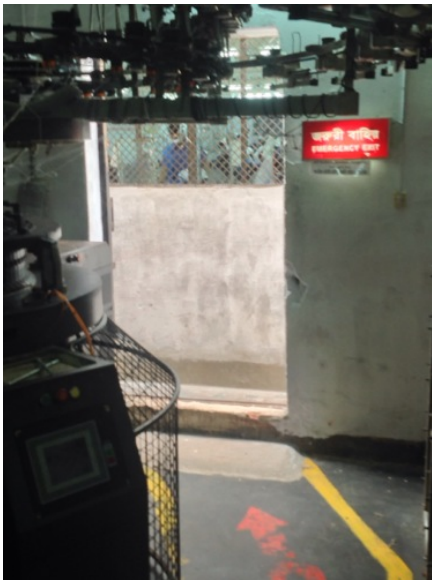
| F-5 | Egress | The width of egress aisles is less than 36-in. There is a knitting machine in the egress path of the west exit making it less than the required 36 inches. | Relocate the equipment and provide minimum aisle widths of 36-in. | Immediate |

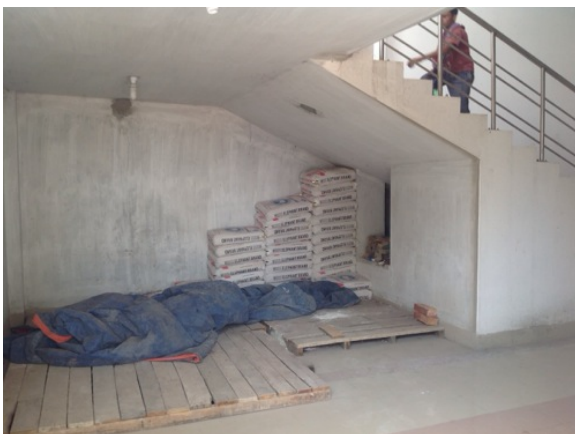
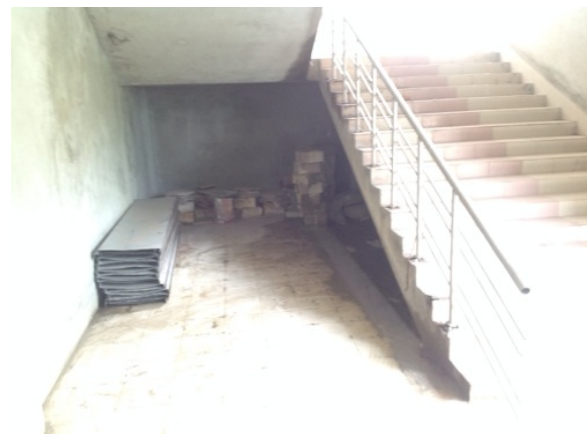
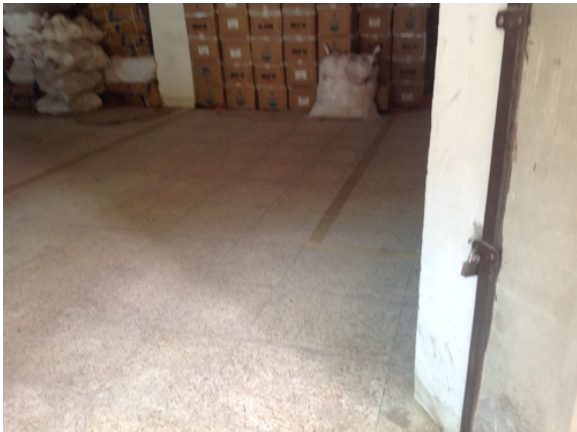
| F-6 | Egress | Storage was located in the exit stair in all three exit discharges on the ground floor. | Remove all storage from exit stairs and egress paths. | Immediate |

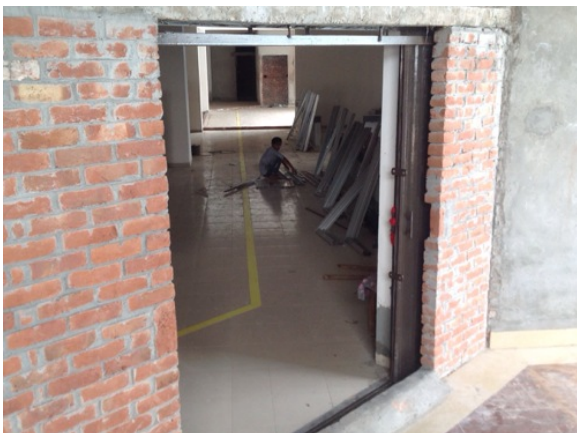
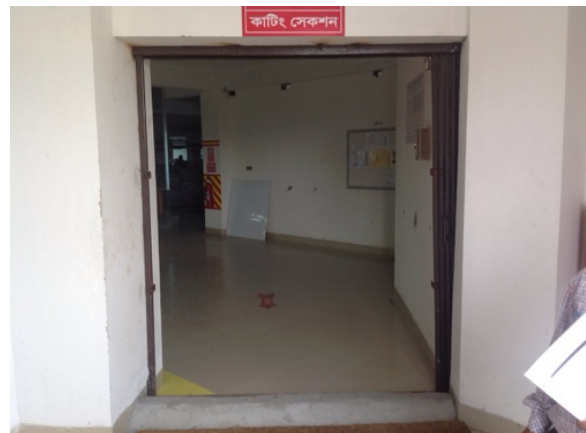
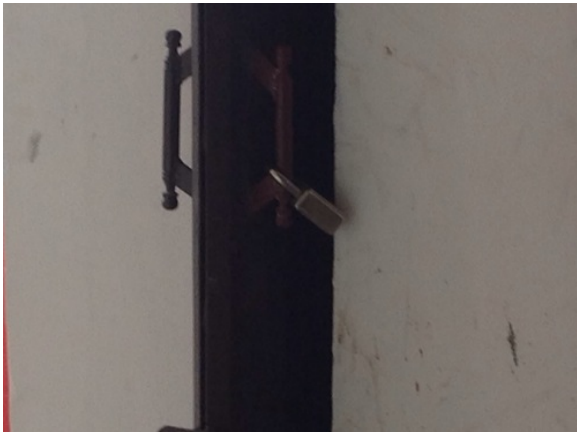
| F-7 | Egress | Collapsible gates are provided at building exits, exit stairs, along egress routes, exit discharge. These were at exit access on all floors for all four exit stairwells as well as all three exit discharges | Replace all gates / sliding doors along the means of egress with side-hinged, swinging egress doors.<br><br>If locks are required for security reasons, utilize special door locking features complying with NFPA 101. | Within 1 month |

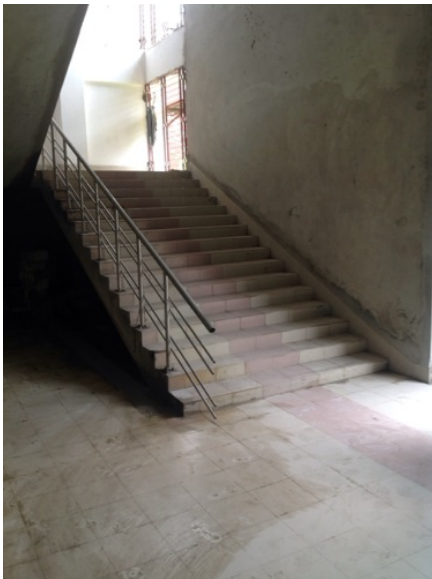
| F-8 | Egress | Exit stairs discharge inside the building on the ground floor in the west exit stairwell.. | Modify stair to discharge directly outside. | Within 6 months |

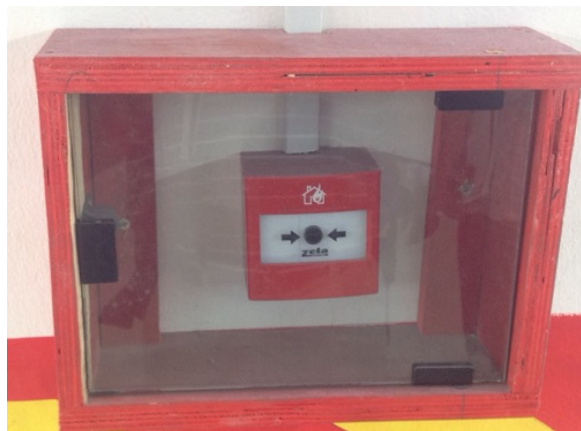
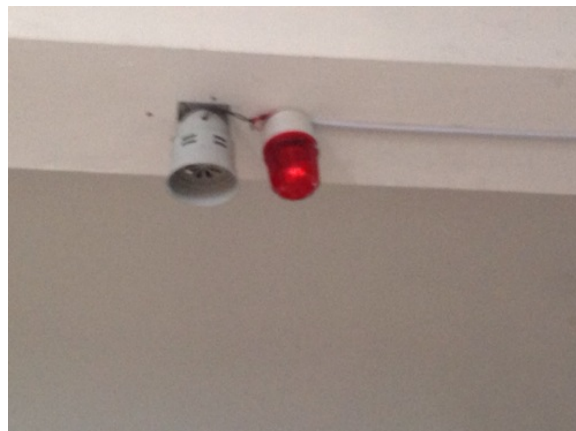
| F-9 | Fire Protection | The fire alarm system is antiquated, not a listed system, and does not provide alarm and notification features consistent with acceptable standards. | Replace the fire alarm system with a new, listed addressable fire alarm system in accordance with NFPA 72. | Design within 4 months, install within 9 months |

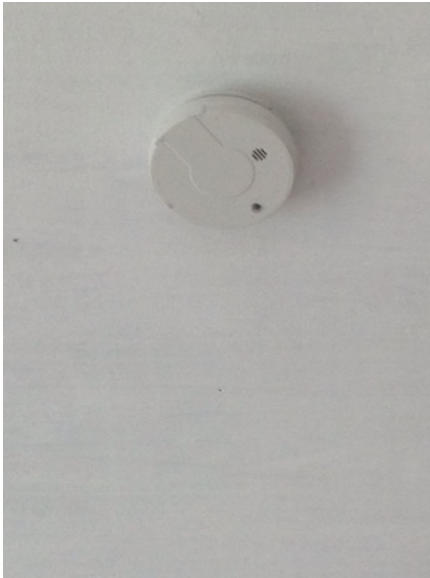
| F-12 | Fire Protection | The building is equipped with single-station smoke alarms. Smoke alarm activation sounds only a local alarm and does not provide automatic fire alarm notification of occupants. | Remove single-station smoke alarms. Provide automatic smoke detection throughout the building, tied into the fire alarm system, in accordance with NFPA 72. | Within 6 months |

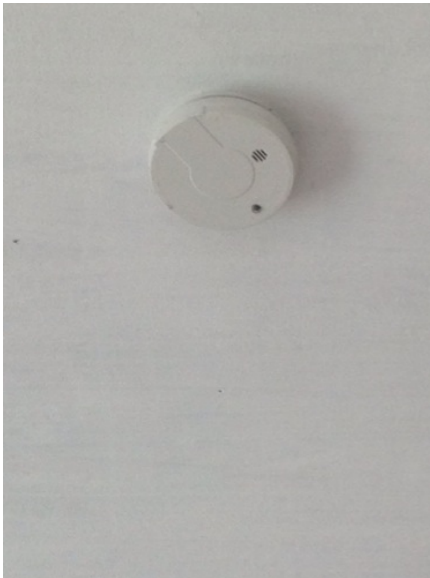
| F-13 | Fire Protection | The building is equipped with single-station smoke alarms. Smoke alarm activation sounds only a local alarm and does not provide automatic fire alarm notification of occupants. | Remove single-station smoke alarms. Provide automatic smoke detection throughout the building, tied into the fire alarm system, in accordance with NFPA 72. | Within 6 months |
