FIRE SAFETY INSPECTION REPORT

ONE UP SWEATERS LTD

ACCORD
on Fire and Building Safety in Bangladesh

August 11, 2014

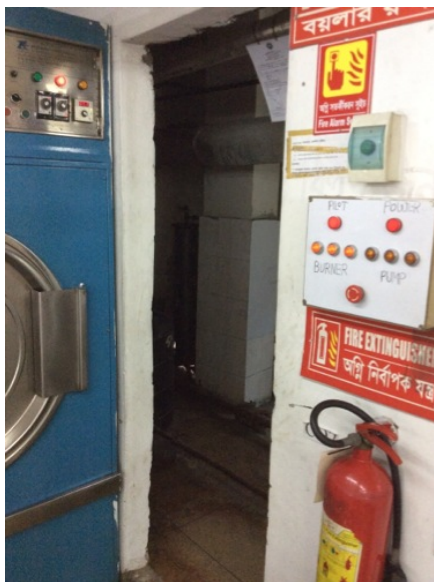
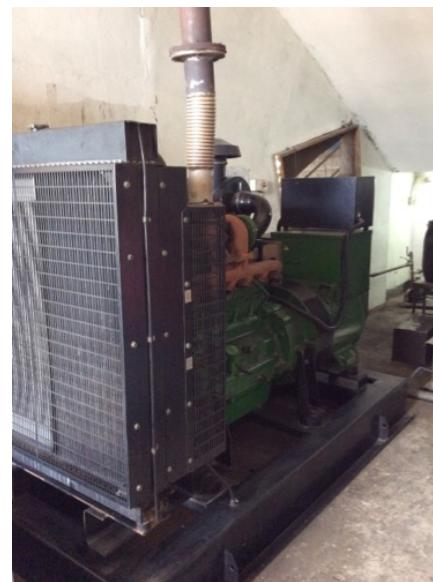
F-1	Fire Rated Construction	The boiler room is located in the ground floor adjacent to production operations with no adequate fire rated separations and the generator located in the North East ground floor stairwell landing is not separated by fire-rated construction openings, non-rated doors, penetrations all present.	Separate the boiler and generator room by a minimum 2-hr fire-rated construction. Seal and/or protected all openings to maintain the required fire separations	Within 3 months
-----	-------------------------	--	--	-----------------

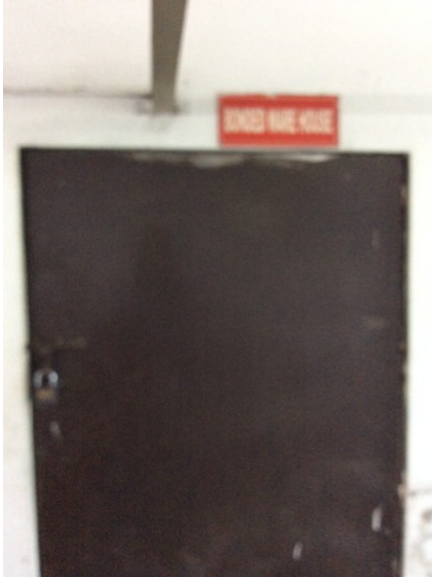
F-2	Fire Rated Construction	Rooms used for combustible storage are not separated by fire-rated construction with regards to non rated fire doors and penetrations.	Provide dedicated storage rooms separated by minimum 1-hr fire-rated construction.	Within 3 months
-----	-------------------------	--	--	-----------------

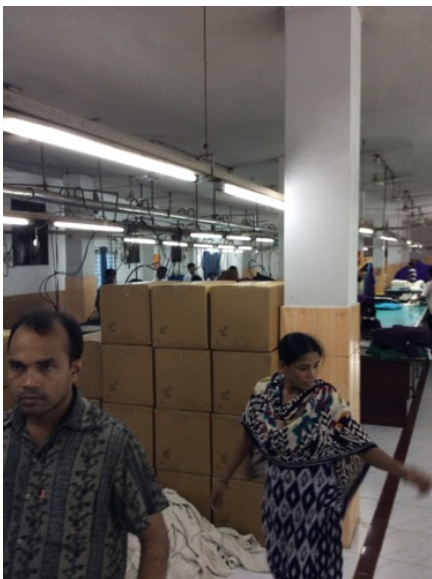
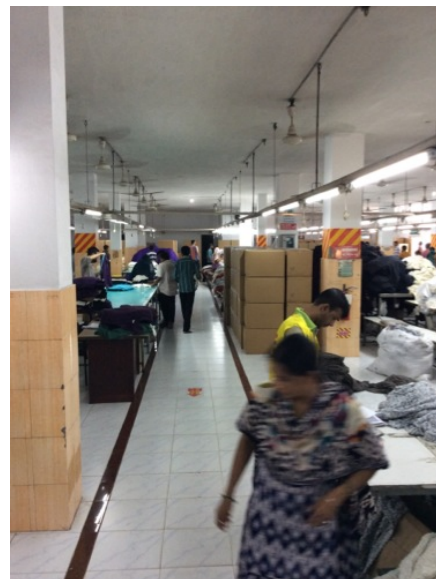
F-3	Fire Rated Construction	Areas used for combustibles storage are not separated by fire-rated construction on the ground floor packing sections.	Where separate storage rooms are not feasible, provide defined storage areas and limit the storage arrangement as follows: - Maximum height of 2.4m and maximum area of 23m ² - If sprinkler protected: maximum height of 3.66m and maximum area of 93m ²	Within 3 months
-----	-------------------------	--	---	-----------------

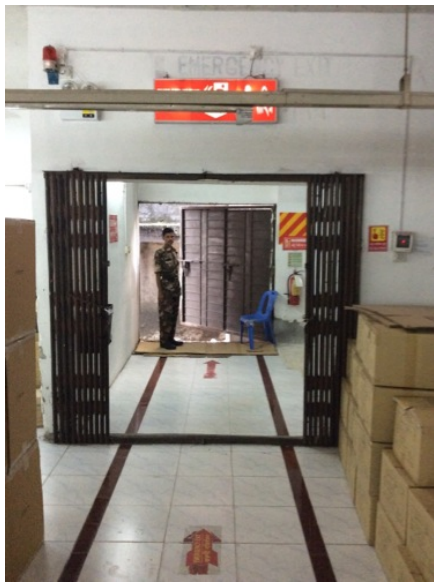
F-4	Fire Rated Construction	The exit stairs are not separated from work areas on each floor by fire-rated construction.	<p>Provide minimum 1.5-hr fire rated doors and seal all unprotected openings to separate the exit stairs from work areas and other building spaces on all floor levels. Ensure that the fire doors are self-closing and positive latching and that they are provided with fire exit (panic) hardware where serving production floors.</p>	Within 3 months
-----	-------------------------	---	---	-----------------

If fire doors are required to be held open for functional reasons, provide automatic-closing devices tied to the fire alarm system.

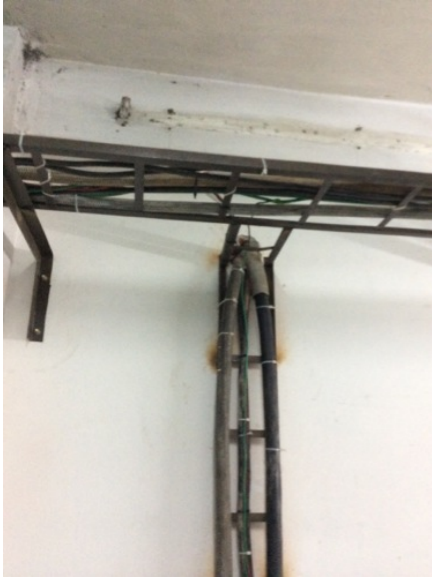
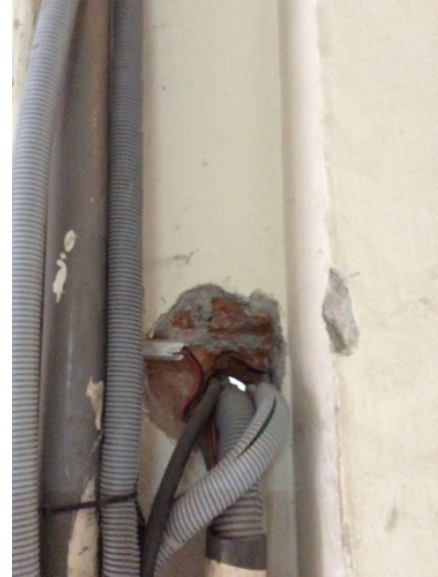
F-5	Fire Rated Construction	Unsealed penetrations and openings are located in both the exit stair enclosures.	Seal all penetrations and openings in exit stair enclosure walls to maintain the fire separation.	Within 3 months
-----	-------------------------	---	---	-----------------

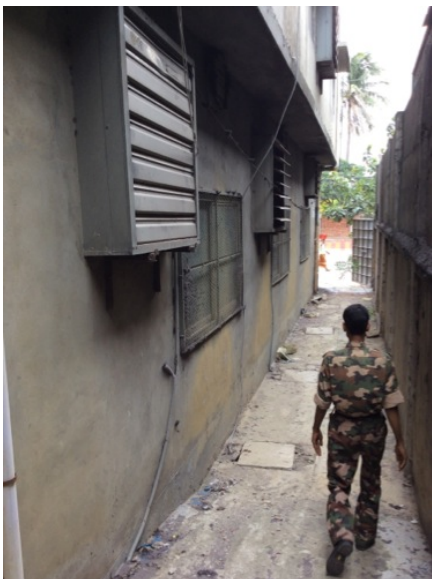
F-6	Fire Rated Construction	The exit discharge path serving the south exit is less than 10 ft wide and is not separated from the building interior.	Seal all penetrations and openings to the interior of the building along the discharge path, up to a height of 10 ft., to provide a minimum 1-hr fire separation. Alternatively, provide a second remote discharge path to the public way (only include this if feasible).	Within 6 months
-----	-------------------------	---	---	-----------------

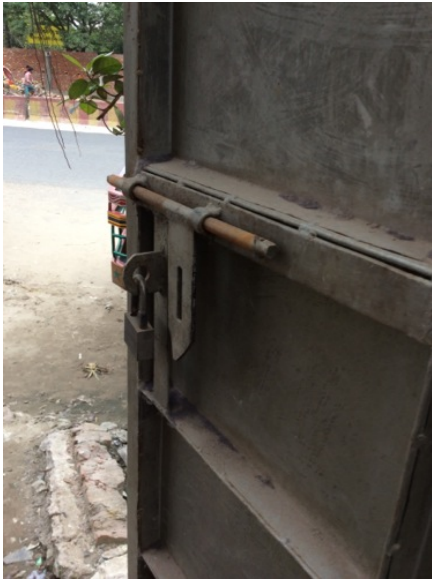
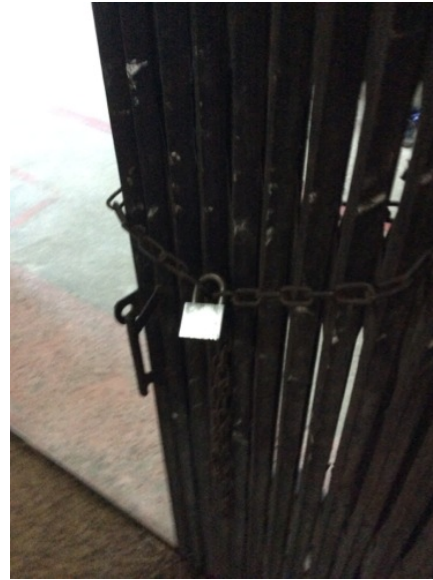
F-7	Egress	Egress doors and gates with locking features are provided at all building exits, exit stairs, along egress routes and main exit discharge. All gates and doors were open and unlocked during the inspection.	Remove locking features from all egress doors / gates. If locks are required for security reasons, utilize special door locking features complying with NFPA 101.	Immediate
-----	--------	--	--	-----------

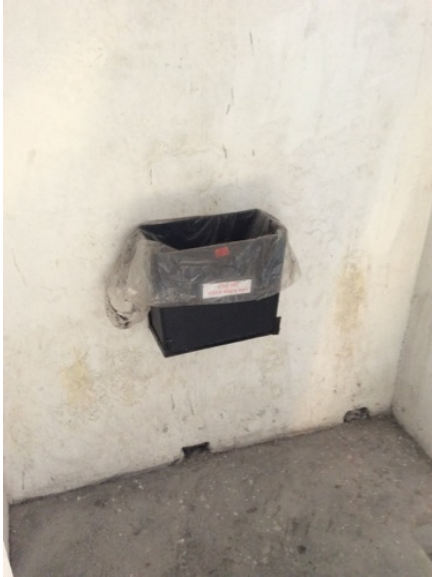
F-8	Egress	Storage such as trash cans where located in the South exit stair on all landings.	Remove all storage from exit stairs and egress paths.	Immediate
-----	--------	---	---	-----------

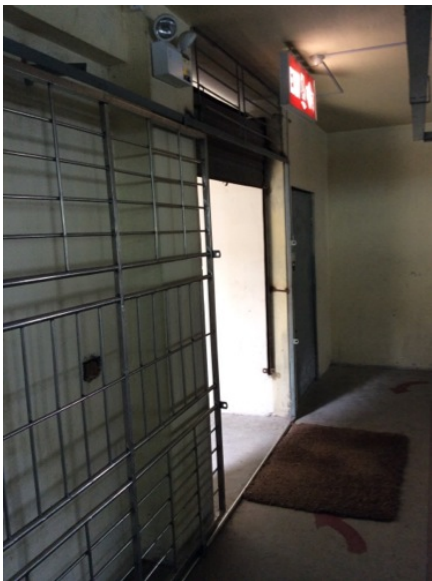
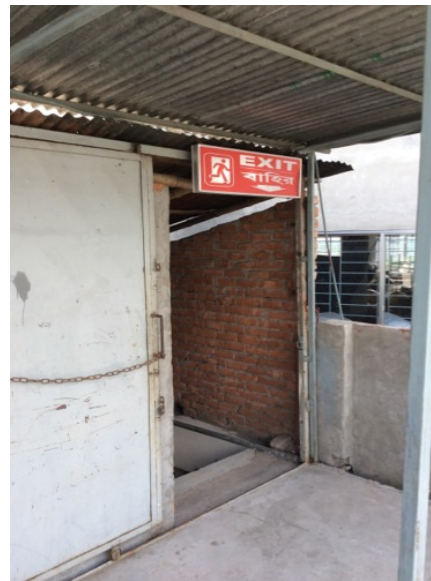
F-9	Egress	Collapsible gates and sliding doors are provided at building exits, exit stairs, along egress routes and main exit discharge throughout the factory building.	Replace all gates / sliding doors along the means of egress with side-hinged, swinging egress doors. If locks are required for security reasons, utilize special door locking features complying with NFPA 101.	Within 1 month
-----	--------	---	--	----------------

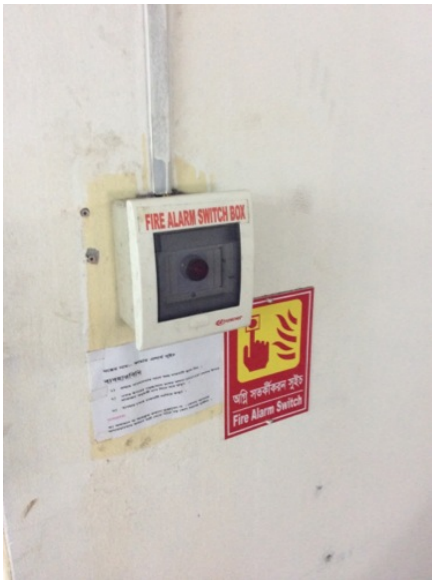
F-10	Fire Protection	The fire alarm system is antiquated, not a listed system, and does not provide alarm and notification features consistent with acceptable standards.	Replace the fire alarm system with a new, listed addressable fire alarm system in accordance with NFPA 72.	Design within 4 months, install within 9 months
------	-----------------	--	--	---

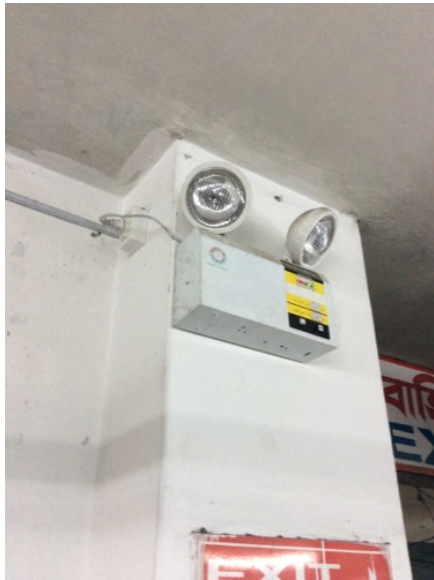
F-13	Egress Lighting	Manual on-off switch is provided for emergency lighting units.	Remove manual on/off switches from emergency lighting units to prevent them from being switched off.	Within 1 month
------	-----------------	--	--	----------------
