# **FIRE SAFETY INSPECTION REPORT**

**ALFA PATTERNS BANGLADESH LTD**  
**PLOT# 58, DEPZ, GANAKBARI, SAVAR**

**ACC**   **RD**  
on Fire and Building Safety in Bangladesh

August 14, 2014

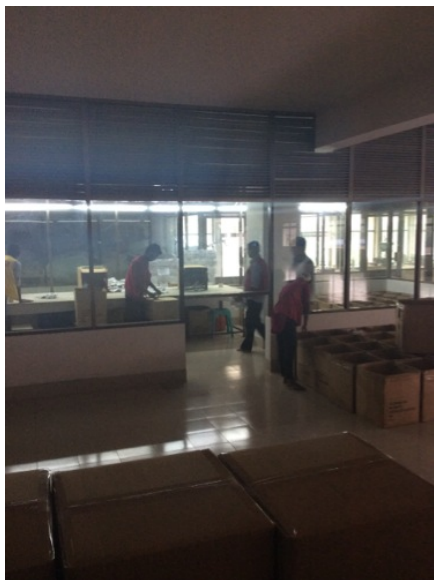
No.	Category	Finding	Recommendation	Remediation Timeframe
F-1	Fire Rated Construction	Rooms used for combustible storage are not separated by fire- rated construction on the ground and first floor.	Provide dedicated storage rooms separated by minimum 1-hr fire-rated construction.	Within 3 months

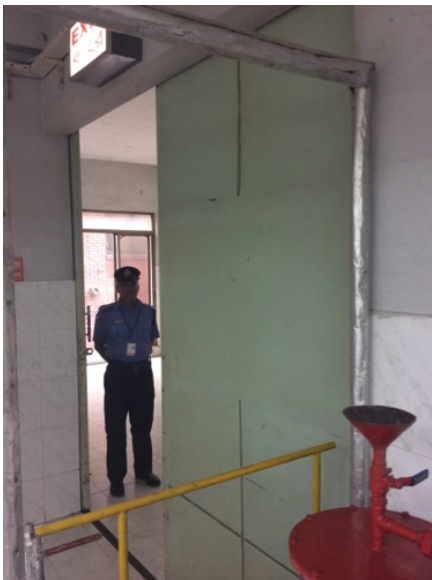
F-2	Fire Rated Construction	The exit stairs are not separated from work areas on each floor by fire-rated construction.	Provide minimum 1.5-hr fire rated doors and seal all unprotected openings to separate the exit stairs from work areas and other building spaces on all floor levels. Ensure that the fire doors are self-closing and positive latching and that they are provided with fire exit (panic) hardware where serving production floors.  If fire doors are required to be held open for functional reasons, provide automatic-closing devices tied to the fire alarm system.	Within 3 months
-----	-------------------------	---	---	-----------------

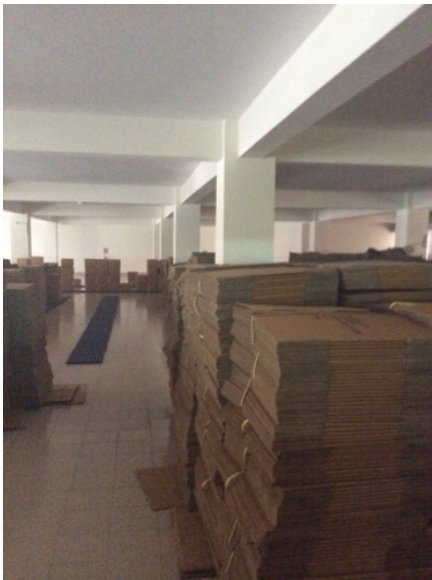
F-3	Fire Rated Construction	Areas used for combustible storage are not separated by fire-rated construction on the ground and third floor.	Where separate storage rooms are not feasible, provide defined storage areas and limit the storage arrangement as follows: - Maximum height of 2.4m and maximum area of 23m <sup>2</sup> - If sprinkler protected: maximum height of 3.66m and maximum area of 93m <sup>2</sup>	Within 3 months
-----	-------------------------	--	---	-----------------

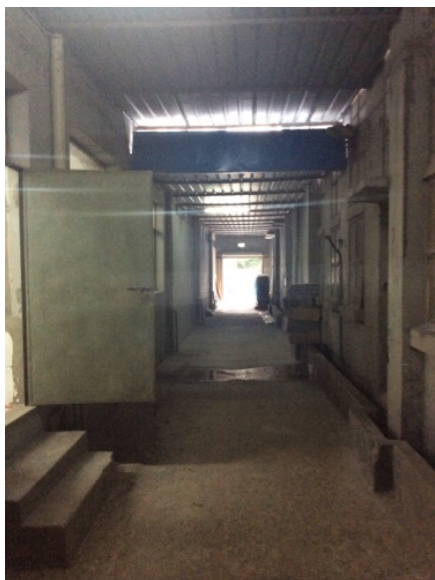
F-4	Fire Rated Construction	The exit discharge path serving the South East exit is less than 10 ft wide and is not separated from the building interior.	Seal all penetrations and openings to the interior of the building along the discharge path, up to a height of 10 ft., to provide a minimum 1-hr fire separation.  Alternatively, provide a second remote discharge path to the public way (only include this if feasible).	Within 6 months
-----	-------------------------	--	---	-----------------

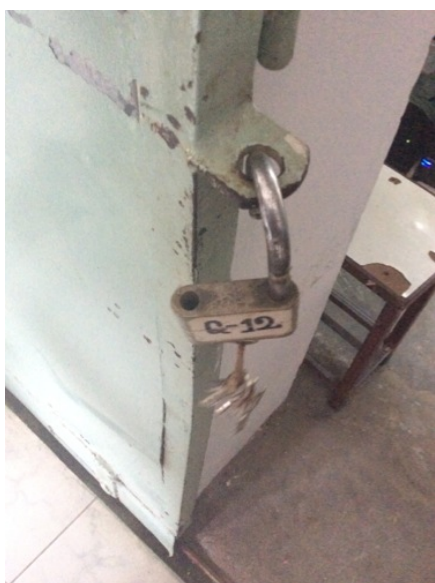
F-5 Egress

Egress doors and gates with locking features are provided at building exits, exit stairs, along egress routes and main exit discharge throughout the factory high-rise building. All gates and doors were open and unlocked during the inspection.

Remove locking features from all egress doors and gates.

If locks are required for security reasons, utilize special door locking features complying with NFPA 101.

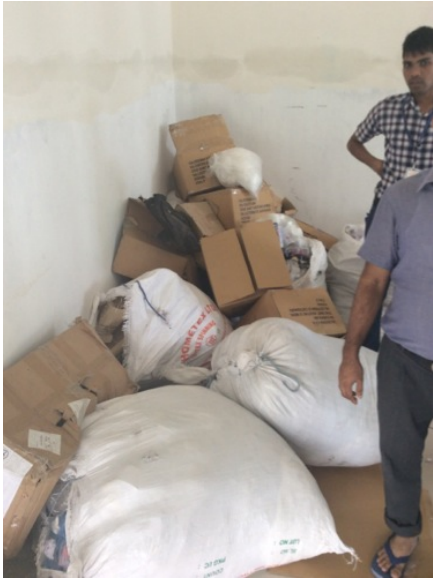
F-6	Egress	Storage was located in the South East exit stair on the fifth floor.	Remove all storage from exit stairs and egress paths.	Immediate
-----	--------	--	---	-----------

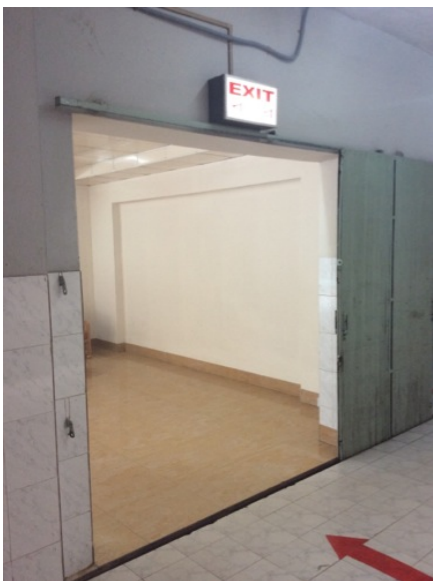
F-7	Egress	Collapsible gates and sliding doors are provided at building exits, exit stairs, along egress routes and main exit discharge throughout the factory high-rise building.	<p>Replace all gates and sliding doors along the means of egress with side-hinged, swinging egress doors.</p> <p>If locks are required for security reasons, utilize special door locking features complying with NFPA 101.</p>	Within 1 month
-----	--------	---	---	----------------

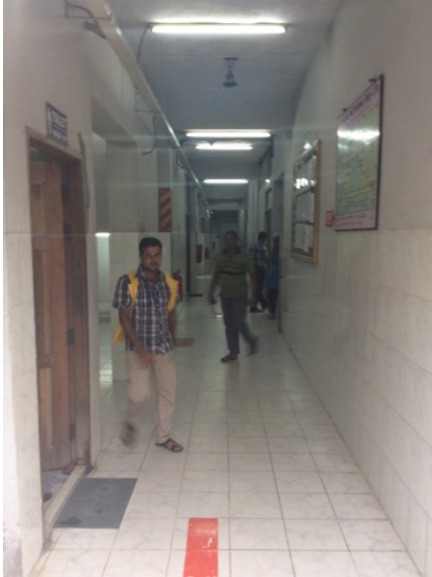
F-8	Egress	The day-care room travel distance exceeds 9m on the ground floor of the factory building.	Relocate day-care room to ground floor with maximum travel distance of 9m (30 ft).	Within 3 months
-----	--------	---	--	-----------------

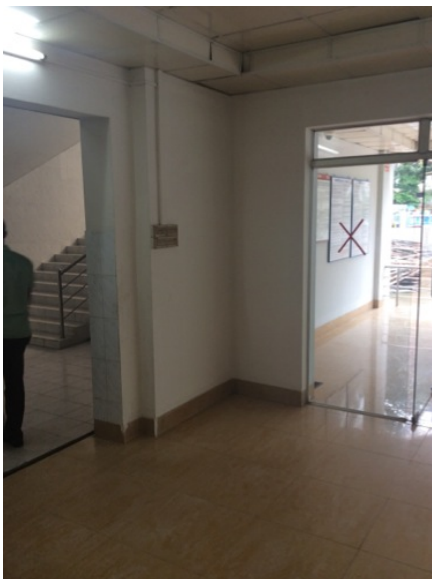
F-9	Egress	The two (2) exit stairs discharge inside the building and opens into the production and storage process on the ground floor.	Provide 2-hr fire-rated exit passageway leading directly outside (vestibules to separate any storage areas).	Within 6 months
-----	--------	--	--	-----------------

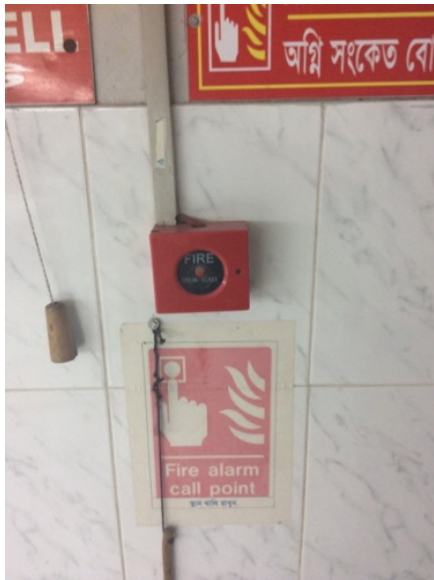
F-10	Fire Protection	The fire alarm system is antiquated, not a listed system, and does not provide alarm and notification features consistent with acceptable standards.	Replace the fire alarm system with a new, listed addressable fire alarm system in accordance with NFPA 72.	Design within 4 months, install within 9 months
------	-----------------	--	--	---

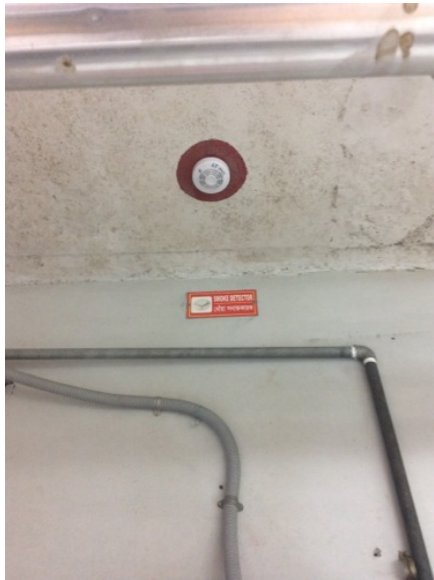
F-12	Fire Protection	The building is equipped with single-station smoke alarms. Smoke alarm activation sounds only a local alarm and does not provide automatic fire alarm notification of occupants.	Remove single-station smoke alarms. Provide automatic smoke detection throughout the building, tied into the fire alarm system, in accordance with NFPA 72.	Within 6 months
------	-----------------	--	---	-----------------

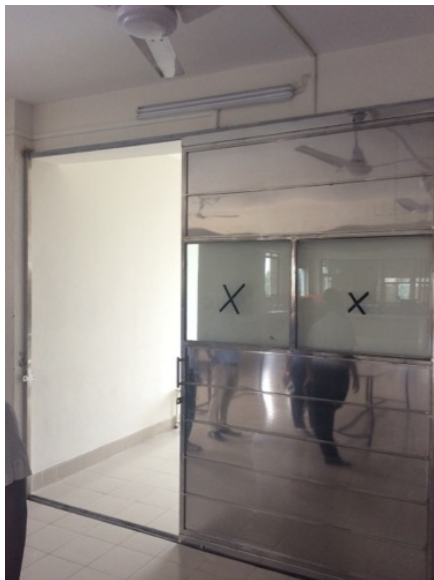
F-13	Egress Lighting	Exit signage is not provided on the fifth floor dining exit points.	Provide exit signs above all exits to the exterior and all doors to the exit stairs.	Within 1 month
------	-----------------	---	--	----------------

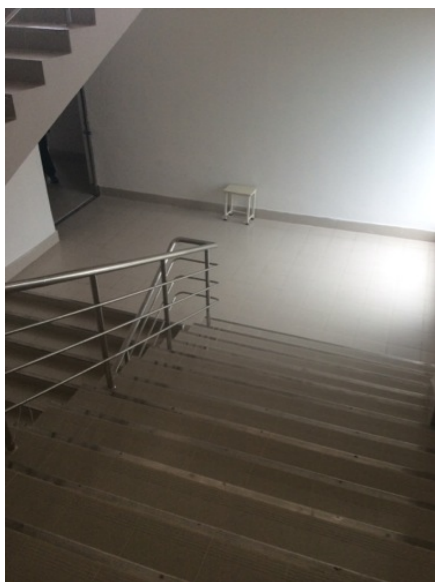
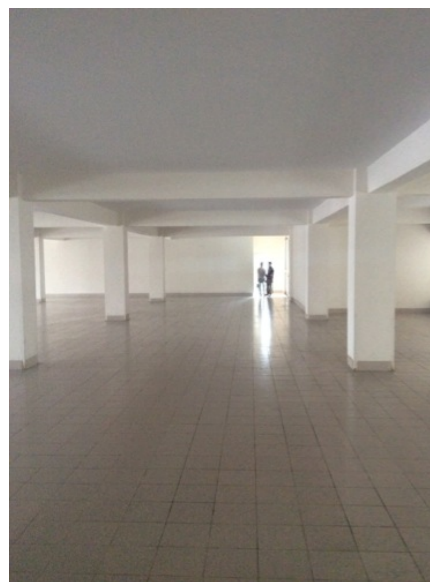
F-15	Egress Lighting	Based on the number and location of emergency lights observed, adequate illumination levels are not anticipated along egress routes on floors 2,3,4 and 5. The two (2) exit stairs on floors 2,3,4 and 5 have no emergency lighting amenities in place.	Test the emergency lighting system on each floor and provide additional emergency fixtures to provide adequate illumination along the means of egress. Provide a minimum illumination of 10 lux at the floor level within exit stairs and exit discharge paths and minimum 2.5 lux along exit access aisles.	Within 3 months
------	-----------------	---	--	-----------------
