# **FIRE SAFETY INSPECTION REPORT**

## **GEEBEE GARMENTS INDUSTRIES LTD**

**DHAKA EXPORT PROCESSING ZONE (DEPZ),  
GANAKBARI, SAVAR, DHAKA, BANGLADESH**

August 16, 2014

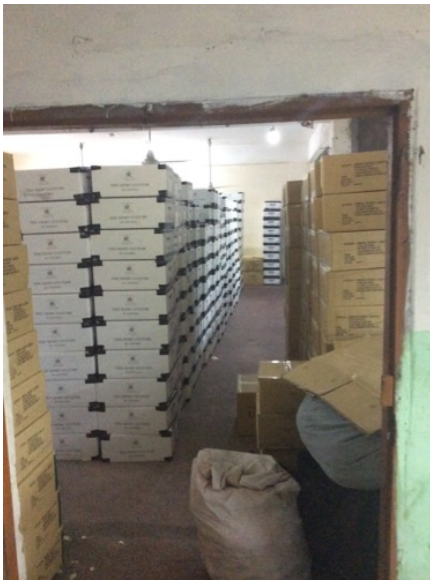
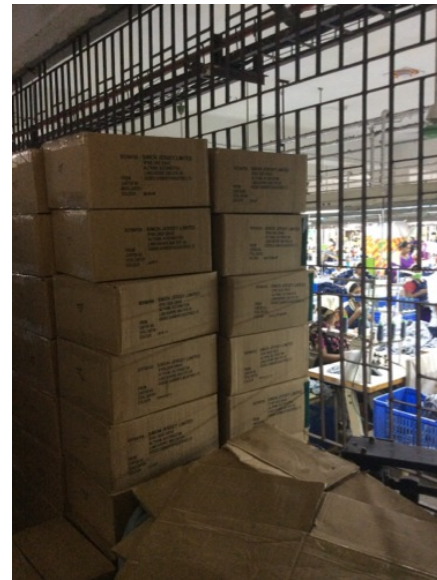
| No. | Category | Finding | Recommendation | Remediation Timeframe |
|---|---|---|---|---|
| F-1 | Fire Rated Construction | Rooms used for combustible storage are not separated by fire-rated construction on all floors of the factory building. | Provide dedicated storage rooms separated by minimum 1-hr fire-rated construction. | Within 3 months |

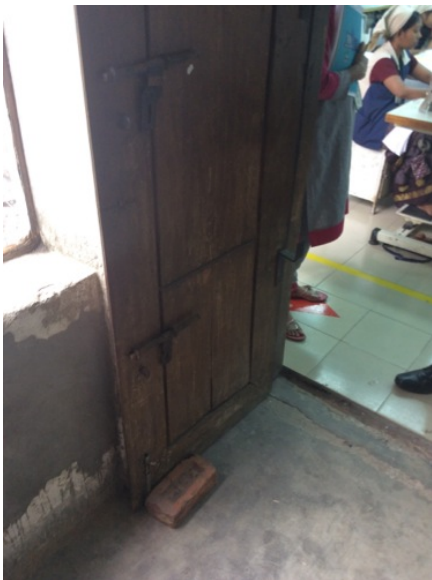
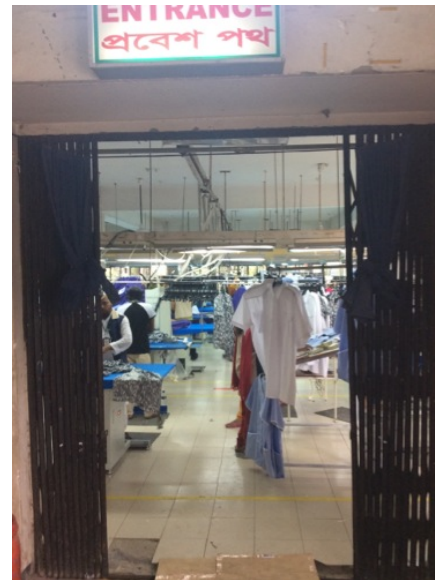
| F-2 | Fire Rated Construction | The exit stairs are not separated from work areas on each floor by fire-rated construction throughout the factory building. | Provide minimum 1.5-hr fire rated doors and seal all unprotected openings to separate the exit stairs from work areas and other building spaces on all floor levels. Ensure that the fire doors are self-closing and positive latching and that they are provided with fire exit (panic) hardware where serving production floors.<br><br>If fire doors are required to be held open for functional reasons, provide automatic-closing devices tied to the fire alarm system. | Within 3 months |

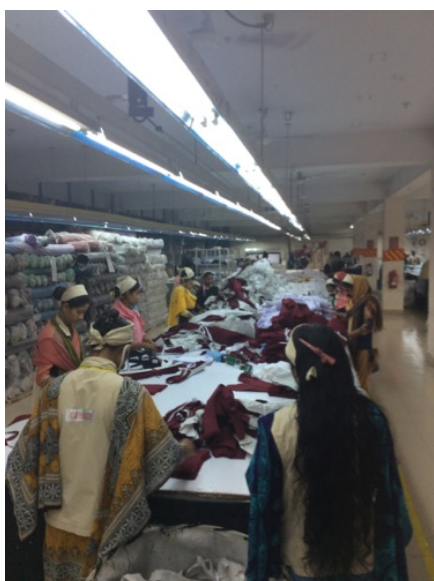
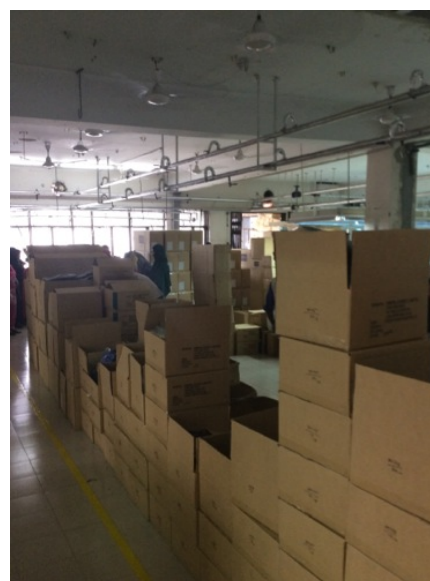
| F-3 | Fire Rated Construction | Areas used for combustible storage are not separated by fire-rated construction on the ground, first and second floors of the factory building. | Where separate storage rooms are not feasible, provide defined storage areas and limit the storage arrangement as follows:<br>- Maximum height of 2.4m and maximum area of 23m <sup>2</sup><br>- If sprinkler protected: maximum height of 3.66m and maximum area of 93m <sup>2</sup> | Within 3 months |

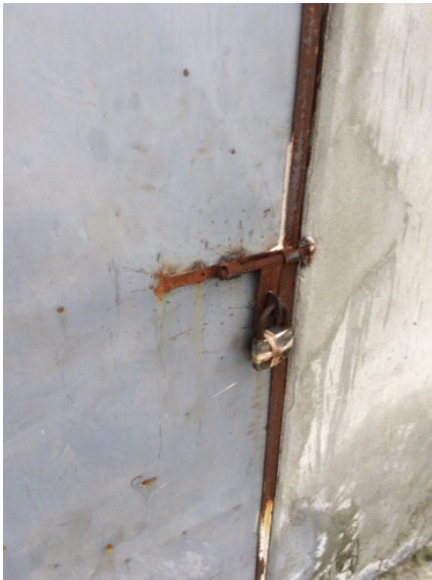
| F-4 | Egress | Egress doors and gates with locking features are provided at building exits, exit stairs, along egress routes and main exit discharge. All gates and doors were open and unlocked during the inspection. | Remove locking features from all egress doors and gates.<br><br>If locks are required for security reasons, utilize special door locking features complying with NFPA 101. | Immediate |

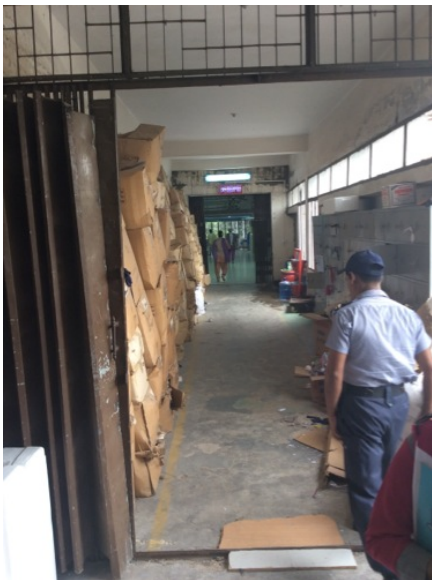
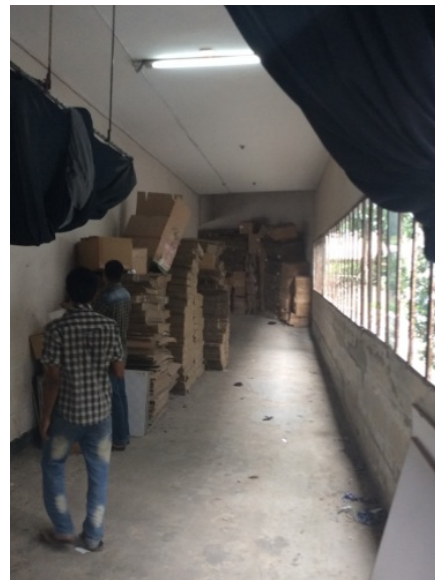
| F-5 | Egress | Storage was located in the South facing exit ramp from the second to ground floor level. | Remove all storage from exit stairs and egress paths. | Immediate |

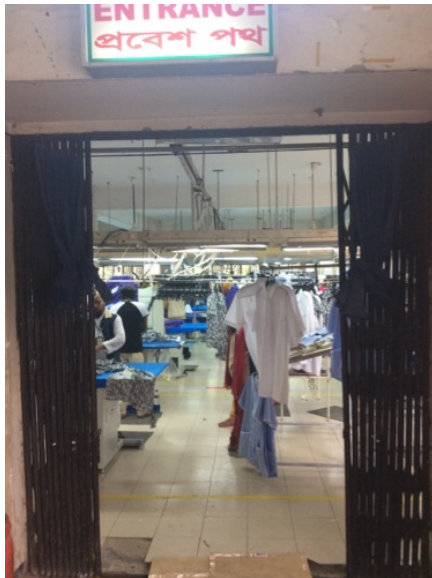
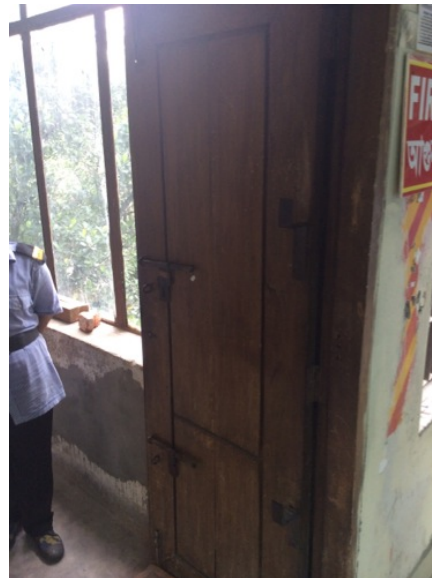
| F-7 | Egress | Collapsible gates and sliding doors are provided at building exits, exit stairs, along egress routes and main exit discharge throughout the factory building. | <p>Replace all gates and sliding doors along the means of egress with side-hinged, swinging egress doors.</p> <p>If locks are required for security reasons, utilize special door locking features complying with NFPA 101.</p> | Within 1 month | |

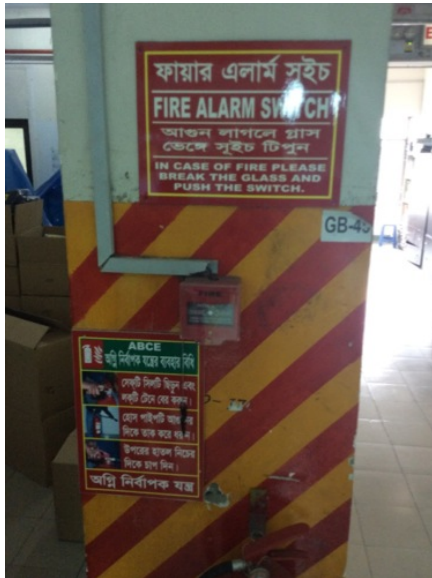
| F-8 | Fire Protection | The fire alarm system is antiquated, not a listed system, and does not provide alarm and notification features consistent with acceptable standards. | Replace the fire alarm system with a new, listed addressable fire alarm system in accordance with NFPA 72. | Design within 4 months, install within 9 months | |

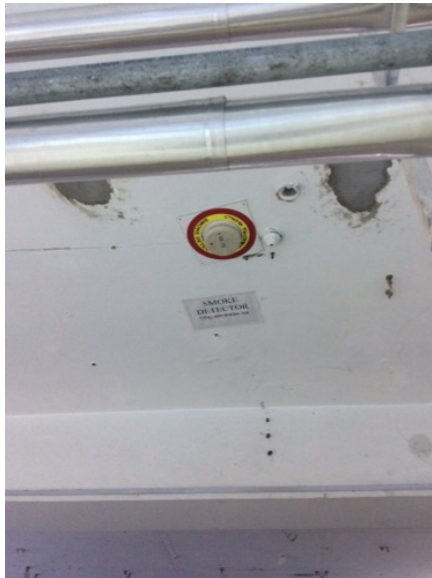
| F-10 | Fire Protection | The building is equipped with single-station smoke alarms. Smoke alarm activation sounds only a local alarm and does not provide automatic fire alarm notification of occupants. | Remove single-station smoke alarms. Provide automatic smoke detection throughout the building, tied into the fire alarm system, in accordance with NFPA 72. | Within 6 months |

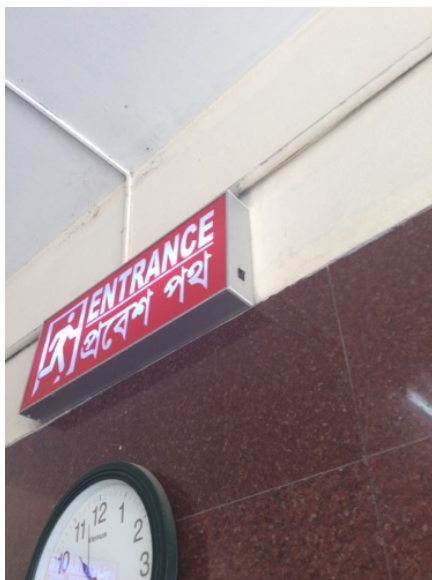
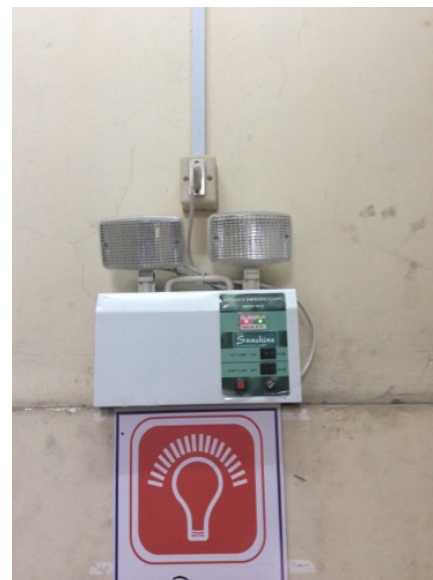
| F-11 | Egress Lighting | Manual on-off switch is provided for all emergency lighting and exit signage units throughout the factory building. | Remove manual on/off switches from emergency lighting / exit signage units to prevent them from being switched off. | Within 1 month |
