# **FIRE SAFETY INSPECTION REPORT**

## **BASIC SHIRTS LTD**

**BASIC TOWER, PLOT # 341, MAJUKHAN, HARBAID,  
GAZIPUR SADAR**

July 21, 2014

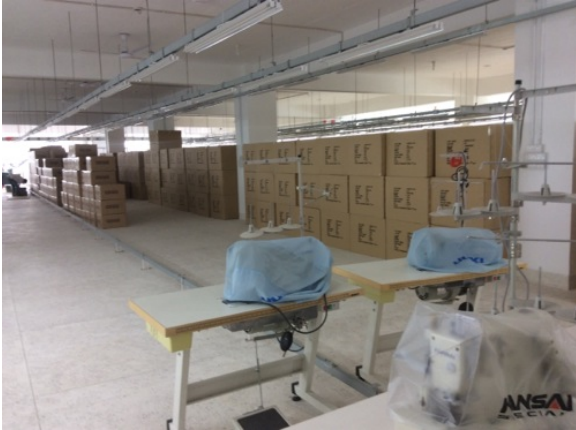
| No. | Category | Finding | Recommendation | Remediation Timeframe |
|---|---|---|---|---|
| F-1 | Fire Rated Construction | Rooms used for combustible storage are not separated by fire-rated construction on the ground floor. | Provide dedicated storage rooms separated by minimum 1-hr fire-rated construction. | Within 3 months |

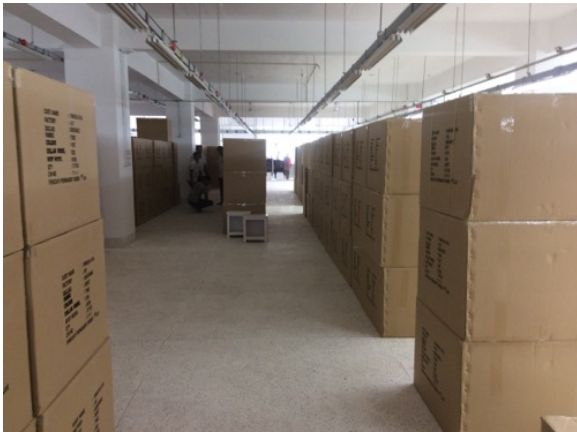
| No. | Category | Finding | Recommendation | Remediation Timeframe |
|---|---|---|---|---|
| F-2 | Fire Rated Construction | Areas used for combustible storage are not separated by fire-rated construction on the 2nd floor. | <p>Provide defined storage areas and limit the storage arrangement as follows:</p> <ul style="list-style-type: none"> <li>- Maximum height of 2.4m and maximum area of 23m<sup>2</sup></li> <li>- If sprinkler protected: maximum height of 3.66m and maximum area of 93m<sup>2</sup></li> </ul> <p>Separate areas of unenclosed combustible storage by a minimum clear distance of 3m.</p> | Within 3 months |

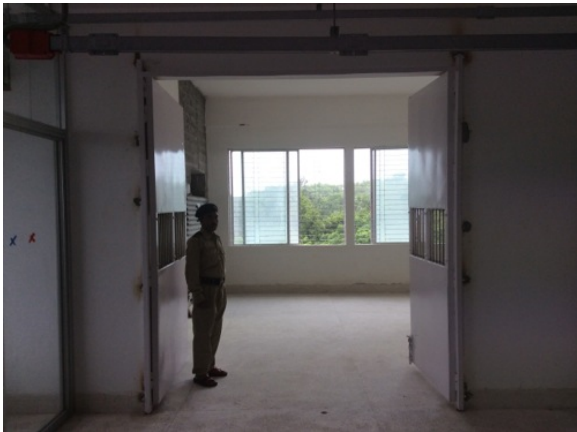
| F-3 | Fire Rated Construction | The exit stairs are not separated from work areas on each floor by fire-rated construction. | <p>Provide minimum 1.5-hr fire rated doors and seal all unprotected openings to separate the exit stairs from work areas and other building spaces on all floor levels. Ensure that the fire doors are self-closing and positive latching and that they are provided with fire exit (panic) hardware where serving production floors.</p> <p>If fire doors are required to be held open for functional reasons, provide automatic-closing devices tied to the fire alarm system.</p> | Within 3 months |

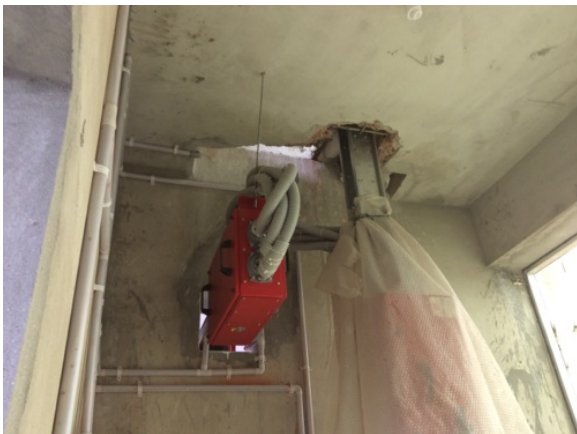
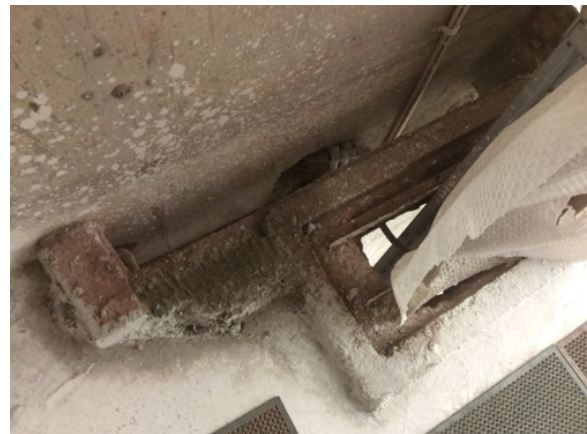
| F-4 | Fire Rated Construction | Unsealed penetrations and openings are located in exit stair enclosures. | Seal all penetrations and openings in exit stair enclosure walls to maintain the fire separation. | Within 3 months |
