# **FIRE SAFETY INSPECTION REPORT**

**SABARANG FASHIONS LTD.**

**PLOT # 85-88, BLOCK- K, RUPNAGAR, MIRPUR**

August 14, 2014

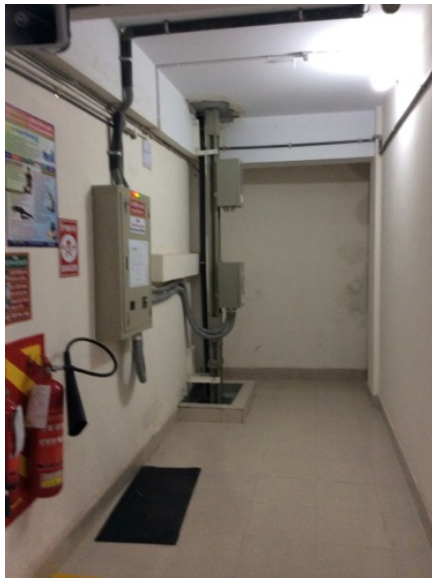
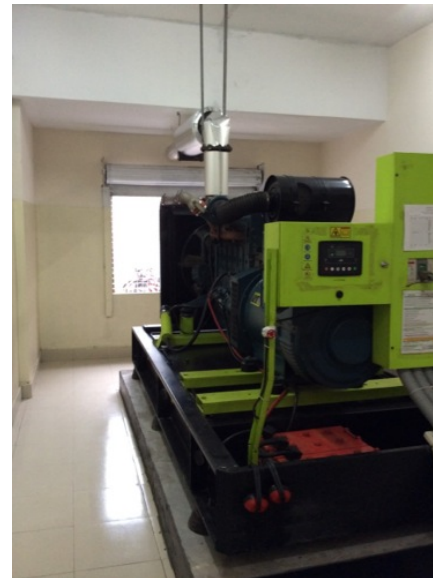
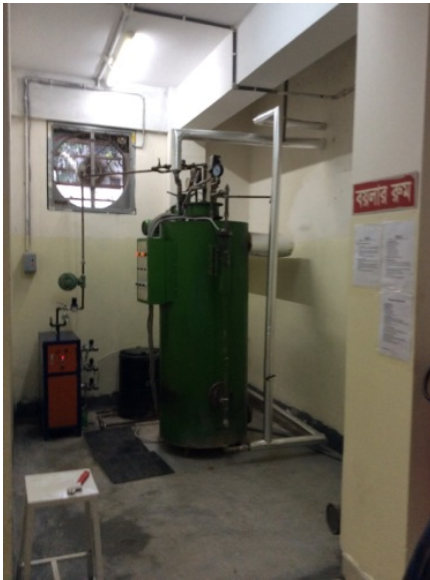
| No. | Category | Finding | Recommendation | Remediation Timeframe |
|---|---|---|---|---|
| F-1 | Fire Rated Construction | The boiler, generator, and transformer rooms are not separated by fire-rated construction that is openings, and non-rated doors, on ground floor. | Separate the boiler, generator, and transformer rooms by a minimum 2-hr fire-rated construction. Seal and/or protected all openings to maintain the required fire separations | Within 3 months |

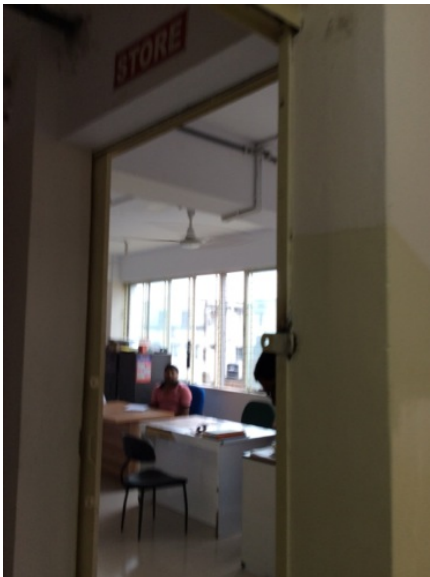
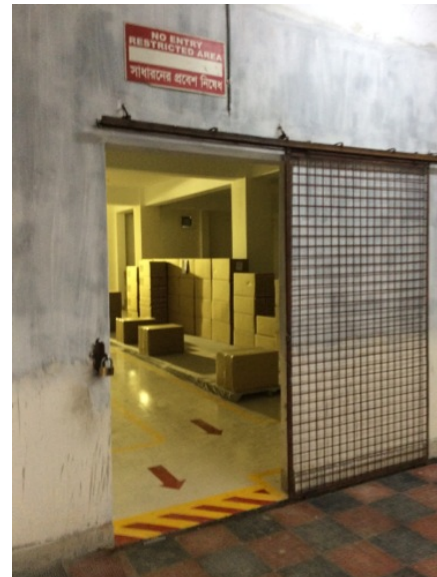
| F-2 | Fire Rated Construction | Rooms used for combustible storage are not separated by fire-rated construction on ground and 5th floors. | Provide dedicated storage rooms separated by minimum 1-hr fire-rated construction. | Within 3 months |

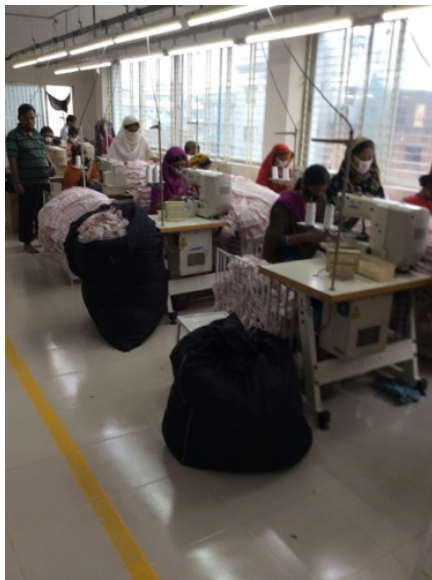
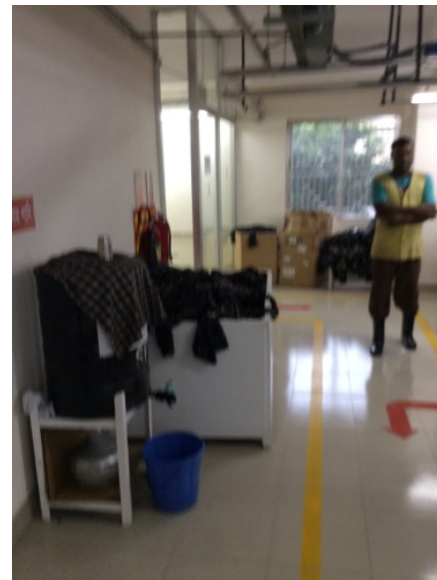
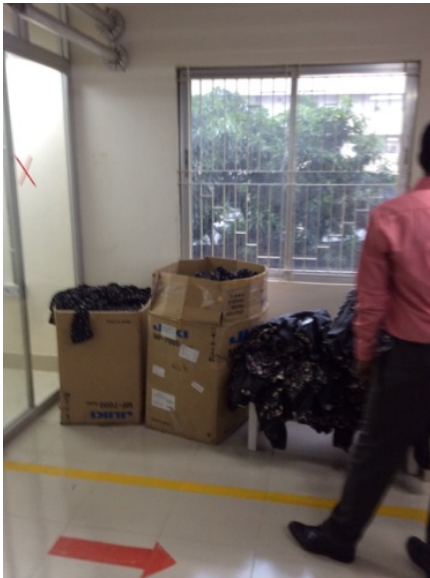
| F-3 | Fire Rated Construction | Areas used for combustible storage are not separated by fire-rated construction on 2nd, 3rd and 4th floors | <p>Provide dedicated storage rooms separated by minimum 1-hr fire-rated construction.</p> <p>Where separate storage rooms are not feasible, provide defined storage areas and limit the storage arrangement as follows:</p> <ul style="list-style-type: none"><li>- Maximum height of 2.4m and maximum area of 23m<sup>2</sup></li><li>- If sprinkler protected: maximum height of 3.66m and maximum area of 93m<sup>2</sup></li></ul> <p>Separate areas of unenclosed combustible storage by a minimum clear distance of 3m.</p> | Within 3 months |

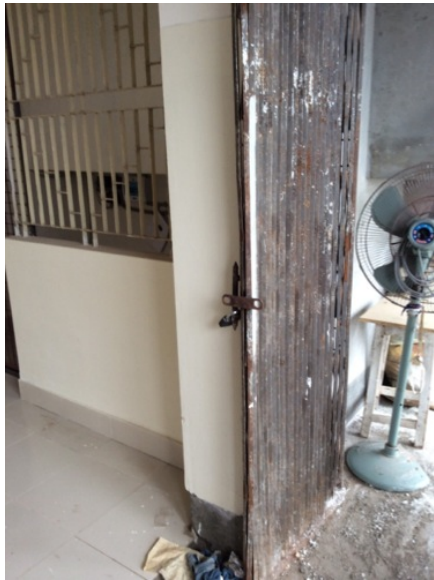
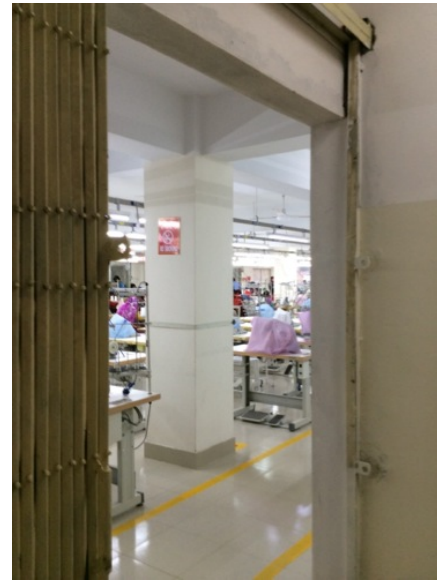
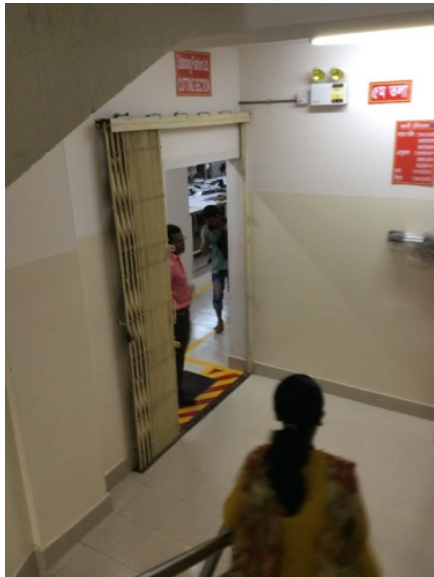
| F-4 | Fire Rated Construction | The exit stairs are not separated from work areas and other spaces on each floor by fire-rated construction. | <p>Provide minimum 1.5-hr fire rated doors and seal all unprotected openings to separate the exit stairs from work areas and other building spaces on all floor levels. Ensure that the fire doors are self-closing and positive latching and that they are provided with fire exit (panic) hardware where serving production floors.</p> <p>If fire doors are required to be held open for functional reasons, provide automatic-closing devices tied to the fire alarm system.</p> | Within 3 months |

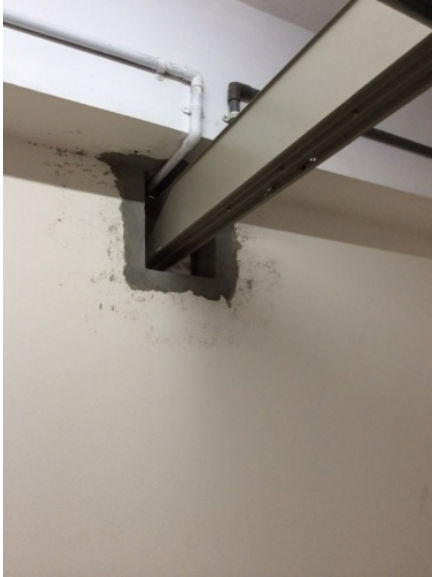
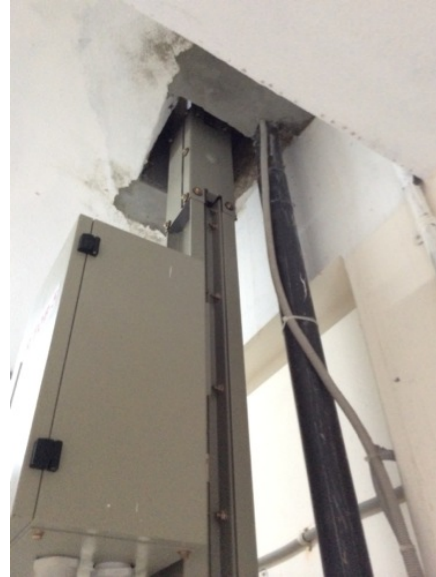
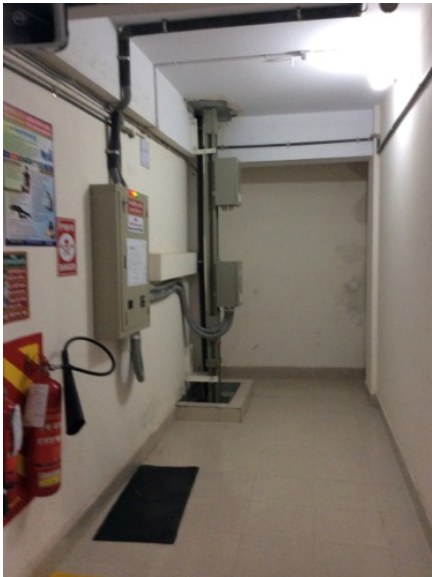
| F-5 | Fire Rated Construction | Unsealed penetrations and openings are located in the fire-rated floor/ceiling assemblies. | <p>Provide a minimum 2-hr fire-rated shaft to separate the utility risers from each floor level.</p> <p>Seal all penetrations and openings in floor/ceiling assemblies to maintain the fire separation.</p> | Within 3 months |

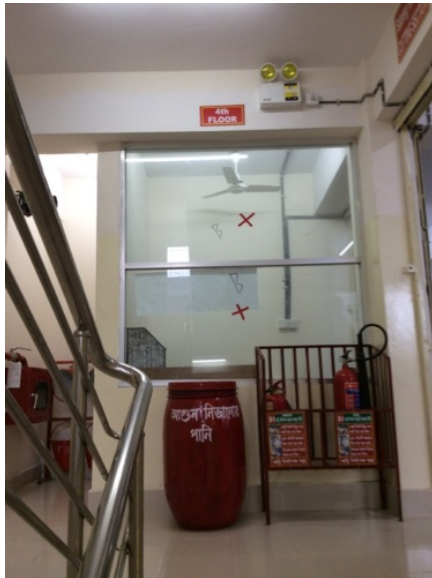
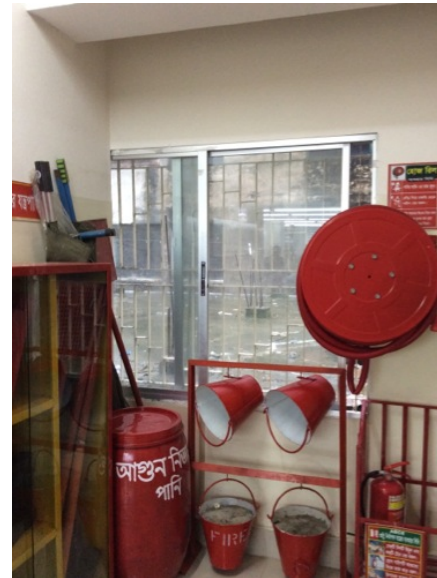
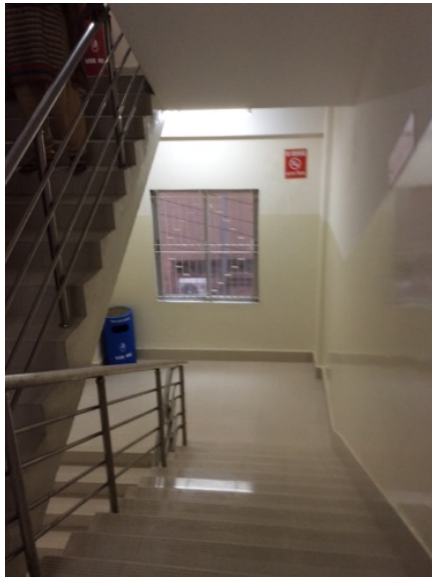
| F-6 | Fire Rated Construction | Unsealed penetrations and openings are located in exit stair enclosures. | Seal all penetrations and openings in exit stair enclosure walls to maintain the fire separation. | Within 3 months |

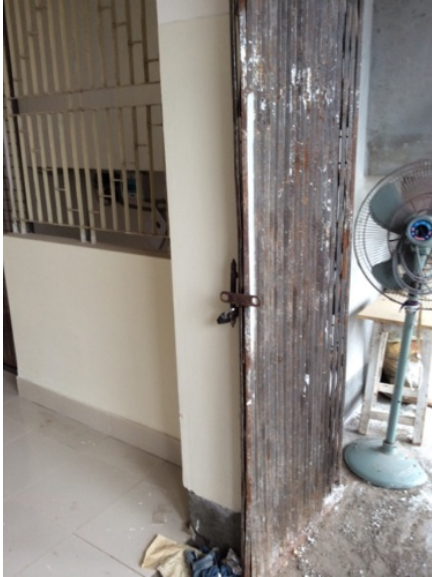
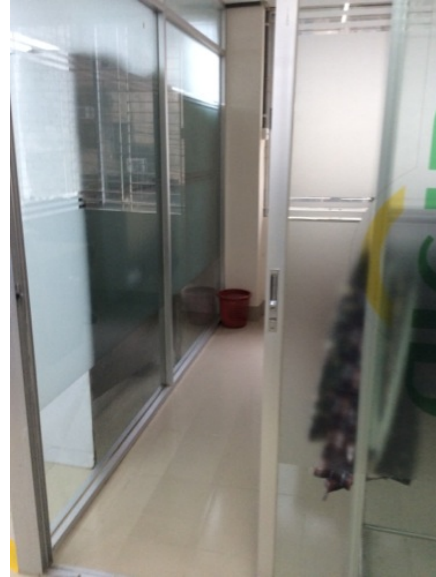
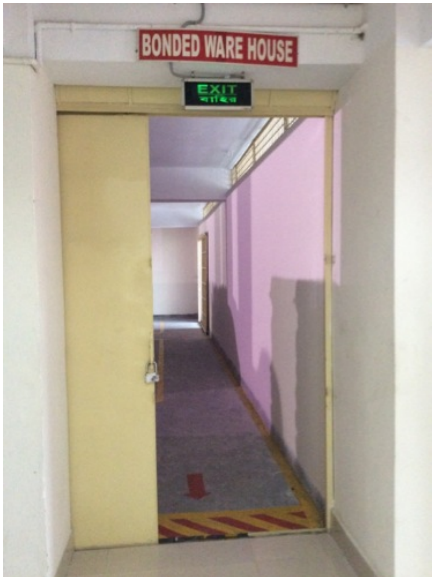
| F-7 | Egress | Egress doors / gates with locking features are provided at building exits, exit stairs, along egress routes and exit discharge on all floors. All gates/doors were open and unlocked during the inspection. | Remove locking features from all egress doors / gates.<br><br>If locks are required for security reasons, utilize special door locking features complying with NFPA 101. | Immediate |

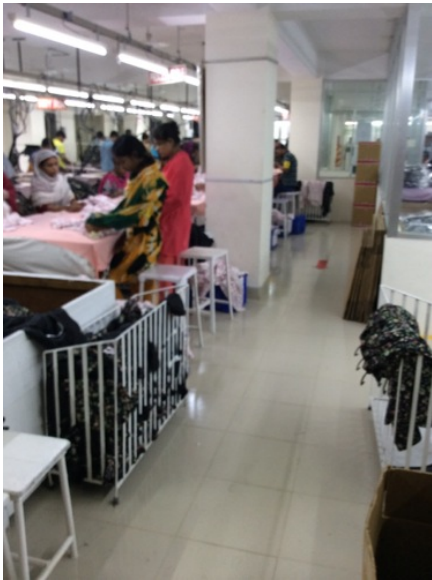
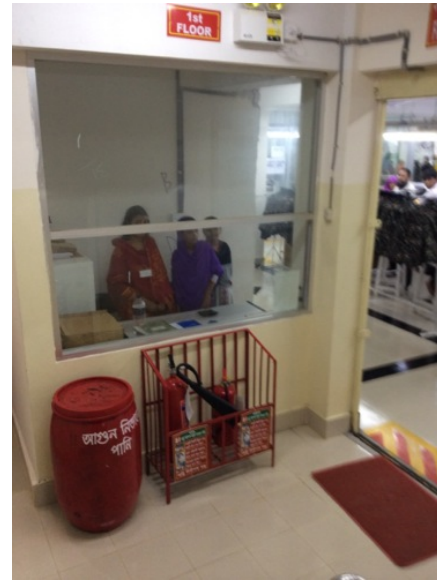
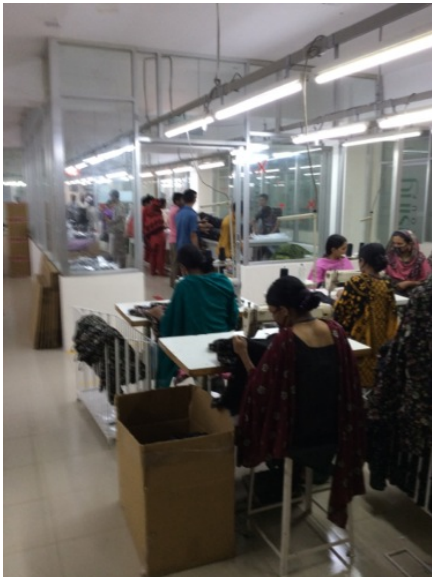
| F-8 | Egress | Storage was located in the egress path on 1st and 3rd floors. | Keep egress paths and stairs clear of storage. | Immediate |

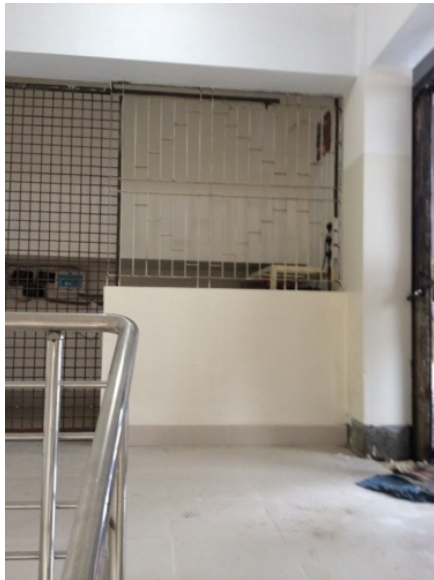
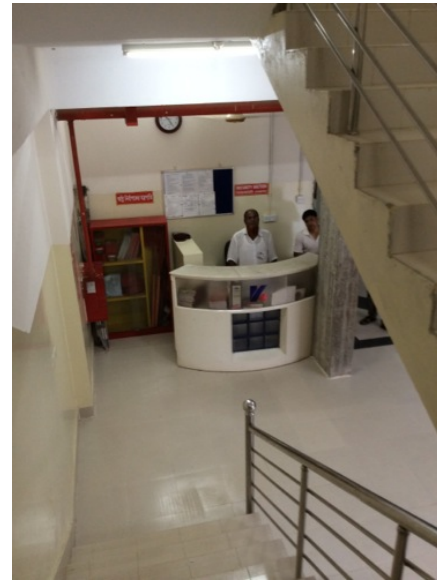
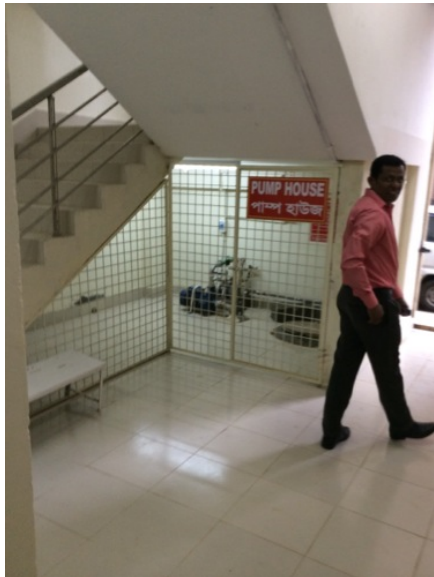
| F-9 | Egress | Storage was located in the southeast exit stair on ground and 6th floors. | Remove all storage from exit stairs and egress paths. | Immediate |

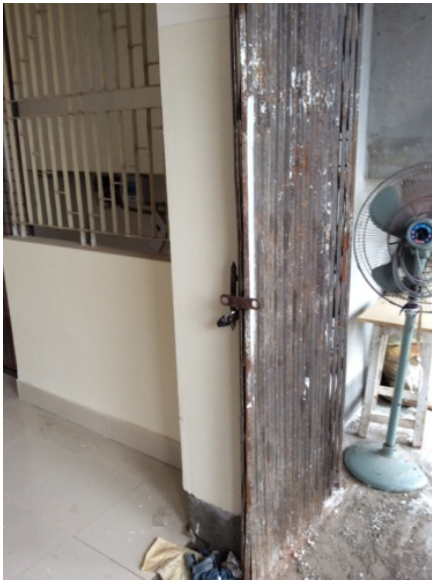
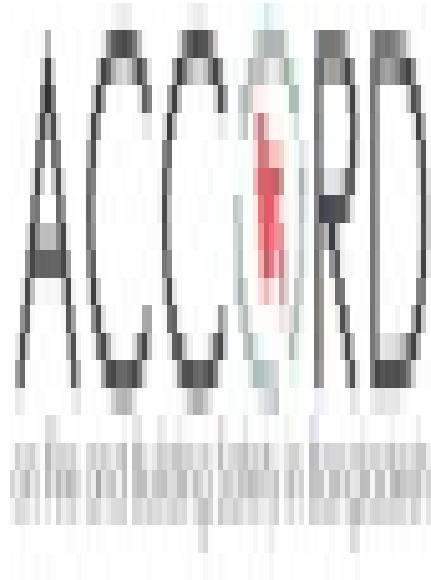
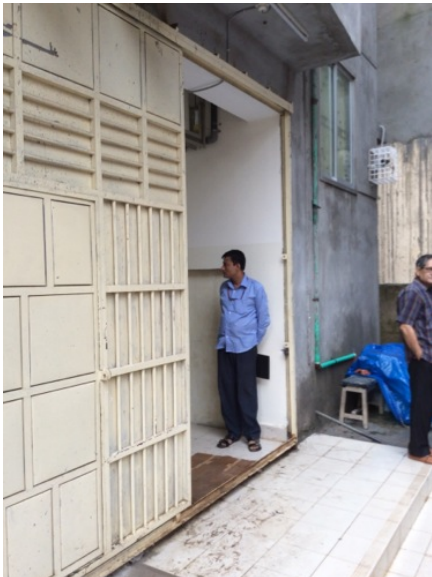
| F-10 | Egress | Collapsible gates / sliding doors are provided at building exits, exit stairs, along egress routes and exit discharge on all floors. | <p>Replace all gates / sliding doors along the means of egress with side-hinged, swinging egress doors.</p> <p>If locks are required for security reasons, utilize special door locking features complying with NFPA 101.</p> | Within 1 month |

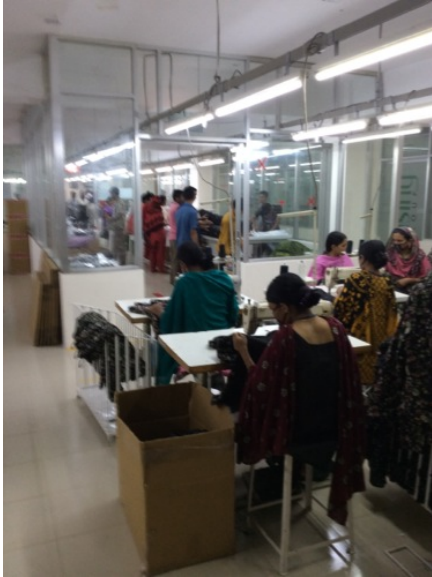
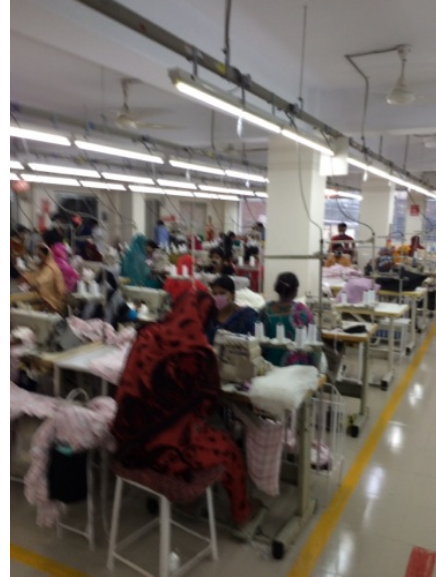
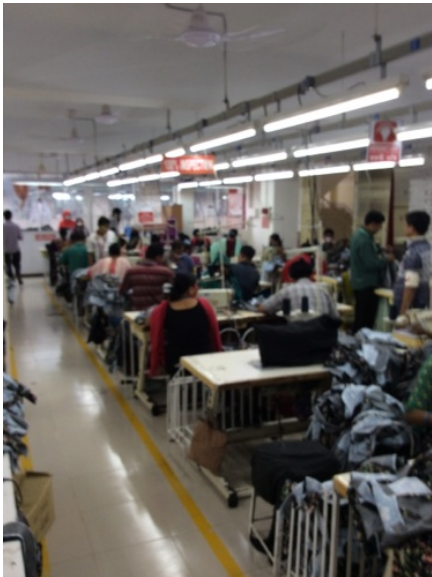
| F-11 | Egress | The width of egress aisles is less than 36-in. on 2nd and 3rd floors. | Provide minimum aisle widths of 36-in. | Within 3 months |

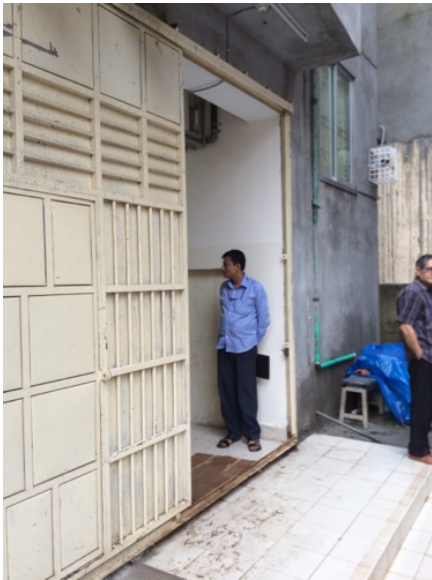
| F-12 | Egress | Handrails are not provided in the southeast exit discharge. | Provide handrails on at least one side of exit stair. | Within 3 months |

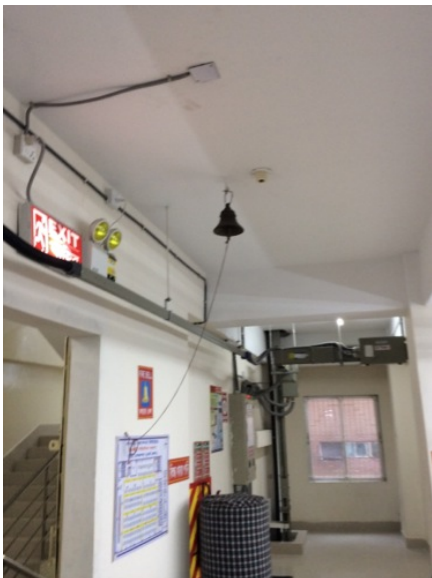
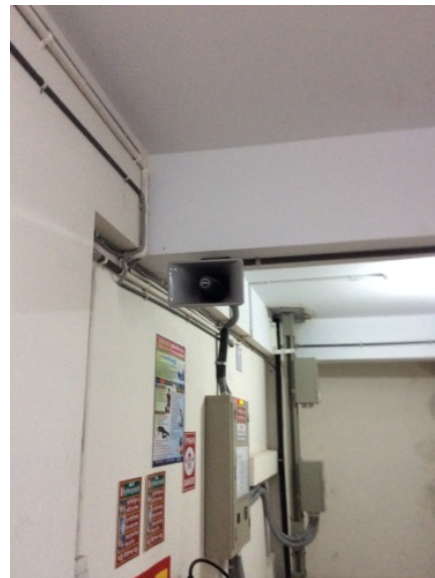
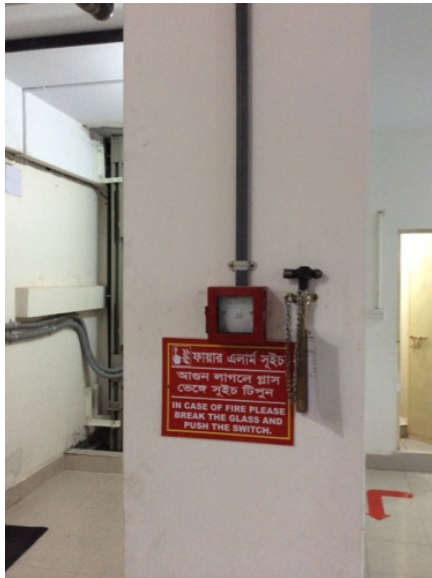
| F-13 | Fire Protection | The fire alarm system is antiquated, not a listed system, and does not provide alarm and notification features consistent with acceptable standards. | Replace the fire alarm system with a new, listed addressable fire alarm system in accordance with NFPA 72. | Design within 4 months, install within 9 months |

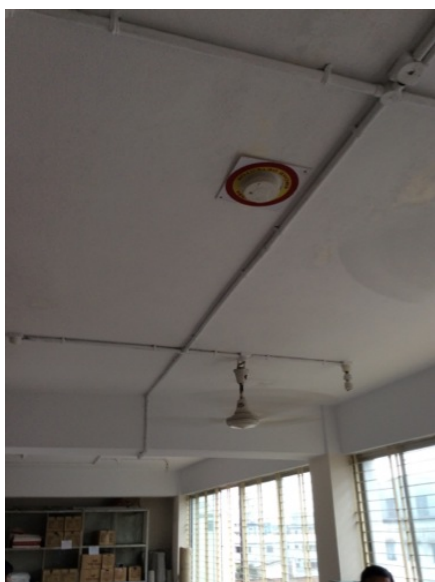
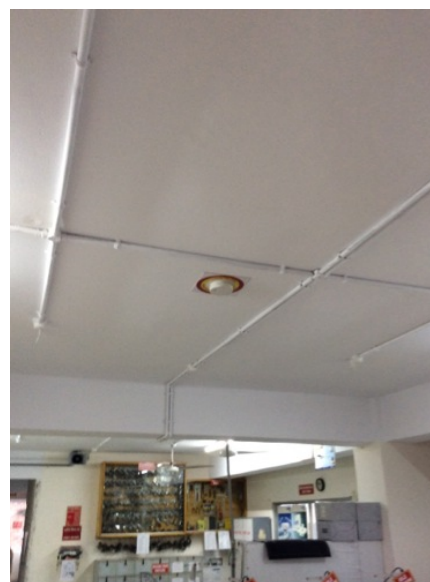
| F-15 | Fire Protection | The building is equipped with single-station smoke alarms. Smoke alarm activation sounds only a local alarm and does not provide automatic fire alarm notification of occupants. | Remove single-station smoke alarms. Provide automatic smoke detection throughout the building, tied into the fire alarm system, in accordance with NFPA 72. | Within 6 months |
